The Project for Capacity Development on Bridge Maintenance and Management in Laos JICA-BMM

Nam Mone Bridge and Xe Bangnouan Bridges Detailed Inspection Report

March 2022

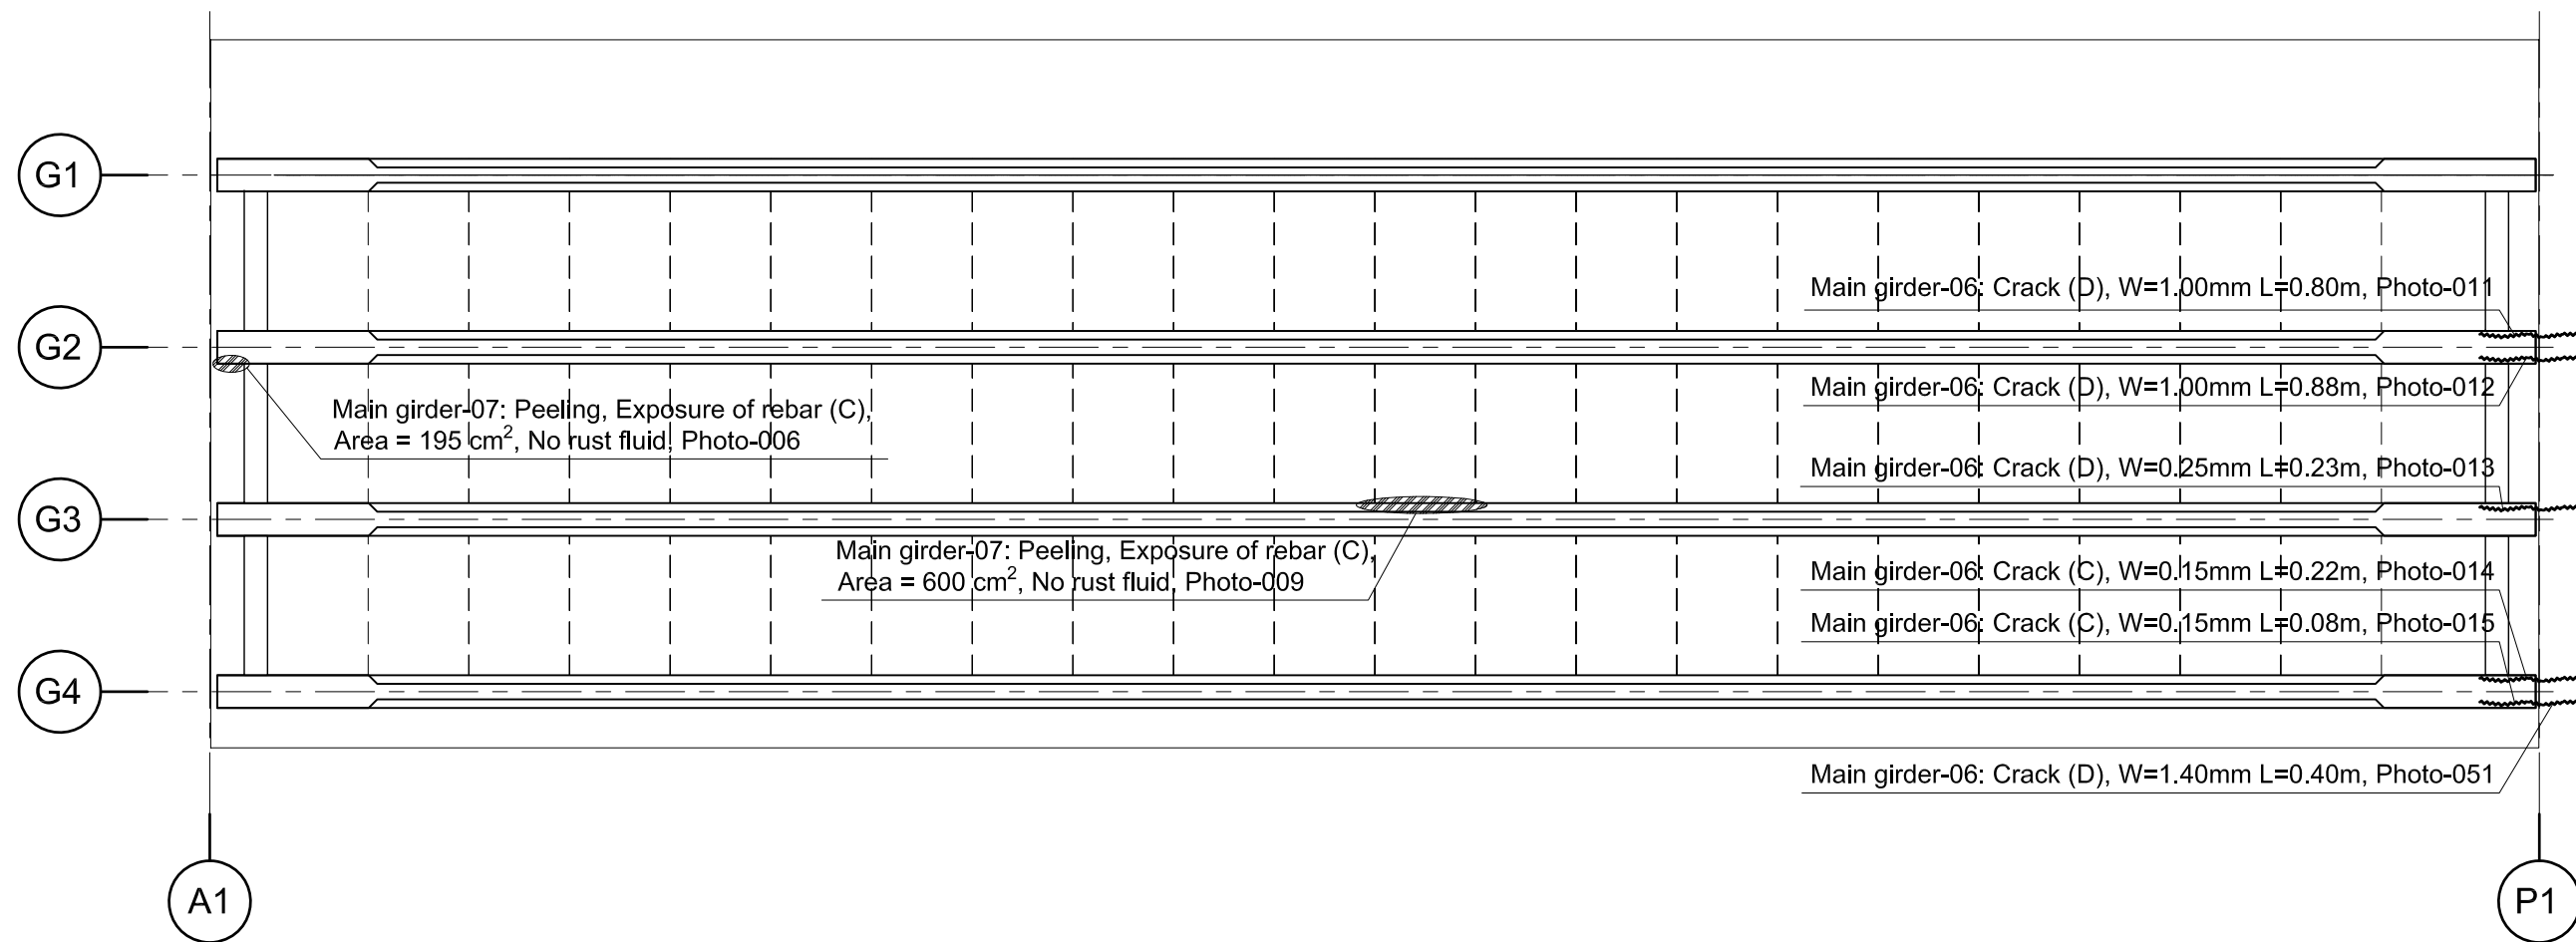
Damage Drawings Bottom View (Main Girder) Span - 1

*Note1: Main girder-13: Unusual or Abnormal Gap. The gap between girder and stop block is unusually wide (less than 10mm). Photo-020

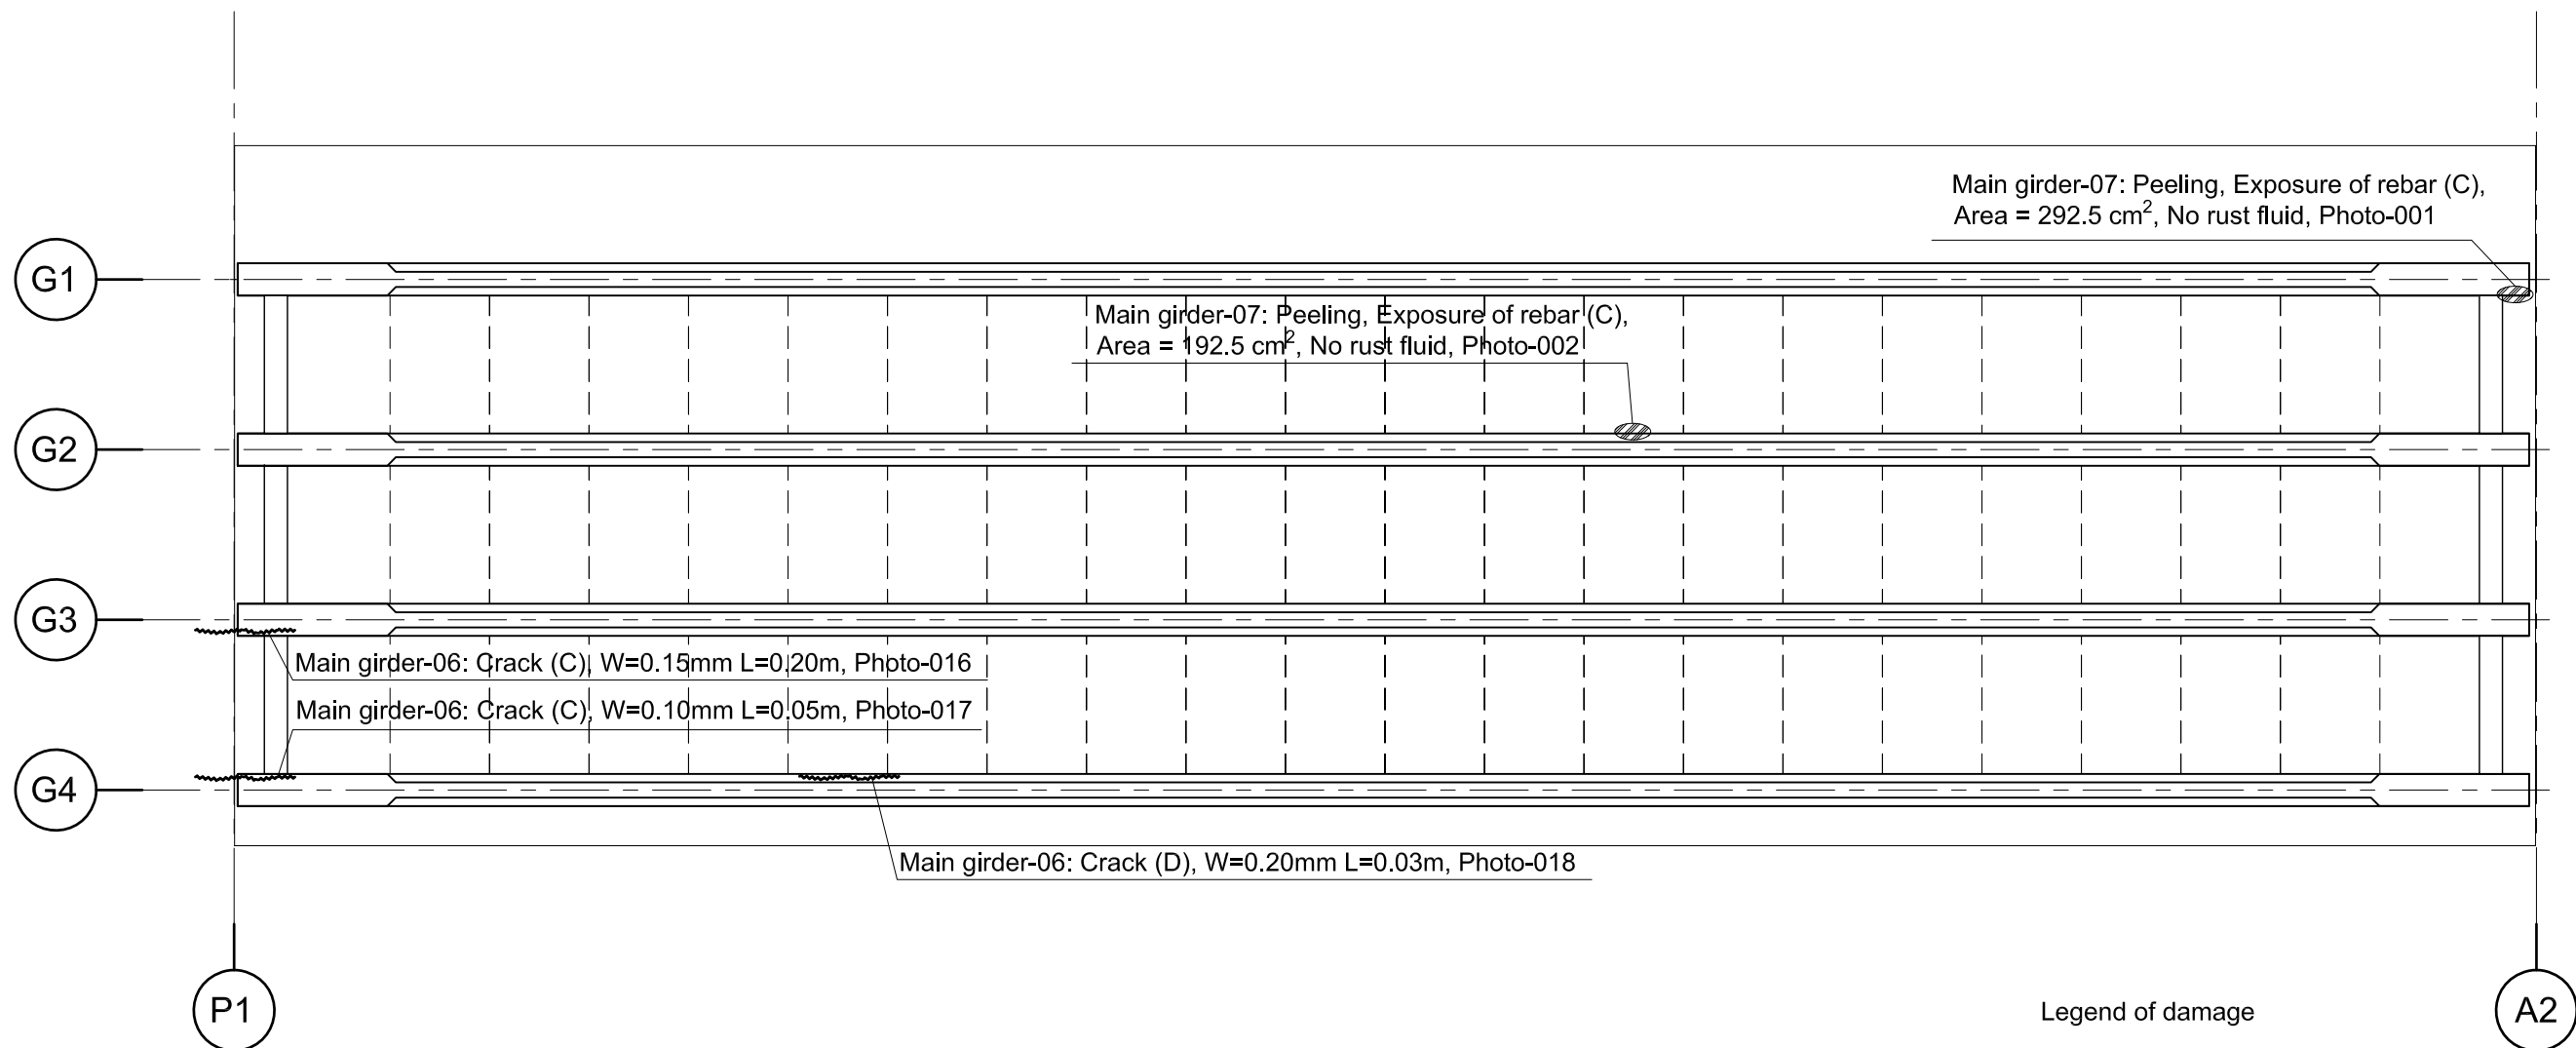
Damage Drawing Bottom View (Main Girder) Span - 2

*Note1: Main girder-13: Unusual or Abnormal Gap. The gap between girder and stop block is unusually wide (less than 10mm). Photo-020

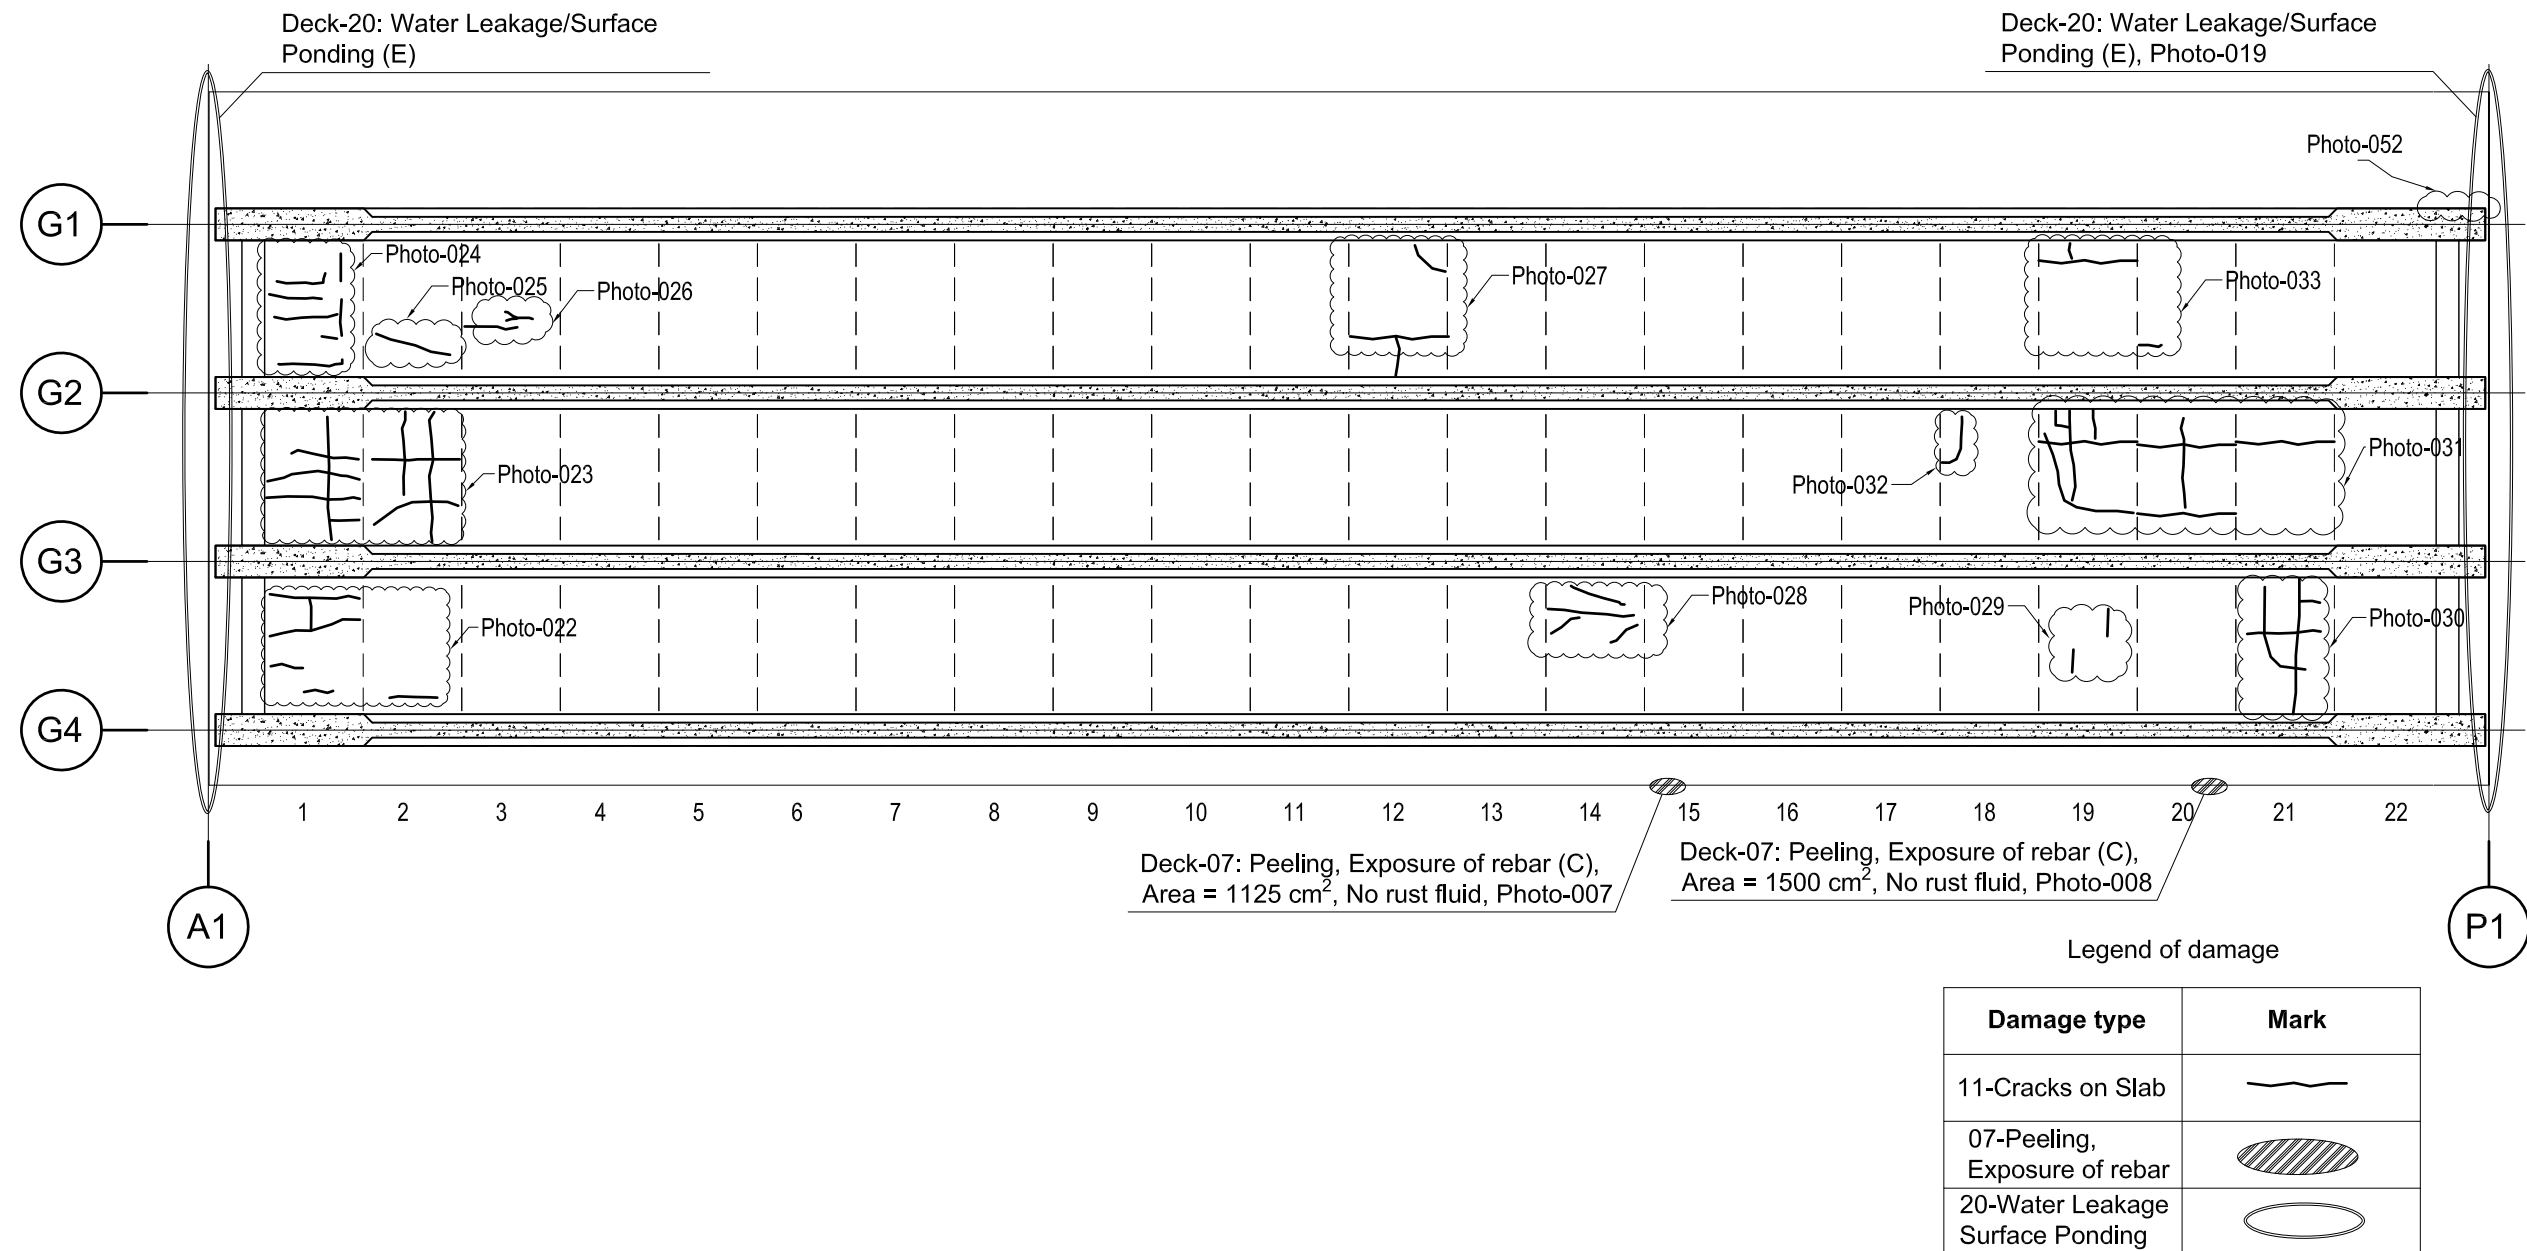
Damage Drawing Bottom View (Deck) Span - 1

*Note1: Deck RC pre-cast slab-07: Peeling/Exposure of Rebar. The damage grade C is generally observed at the joint between each pre-cast slab, but grade D cracks can be observed locally. Photo-021

*Note 3: Due to the area between pre-cast slab No.4 to No.18 is hard to access. Therefore, only the cracks with the width of more than and equal to 0.2mm are recorded.

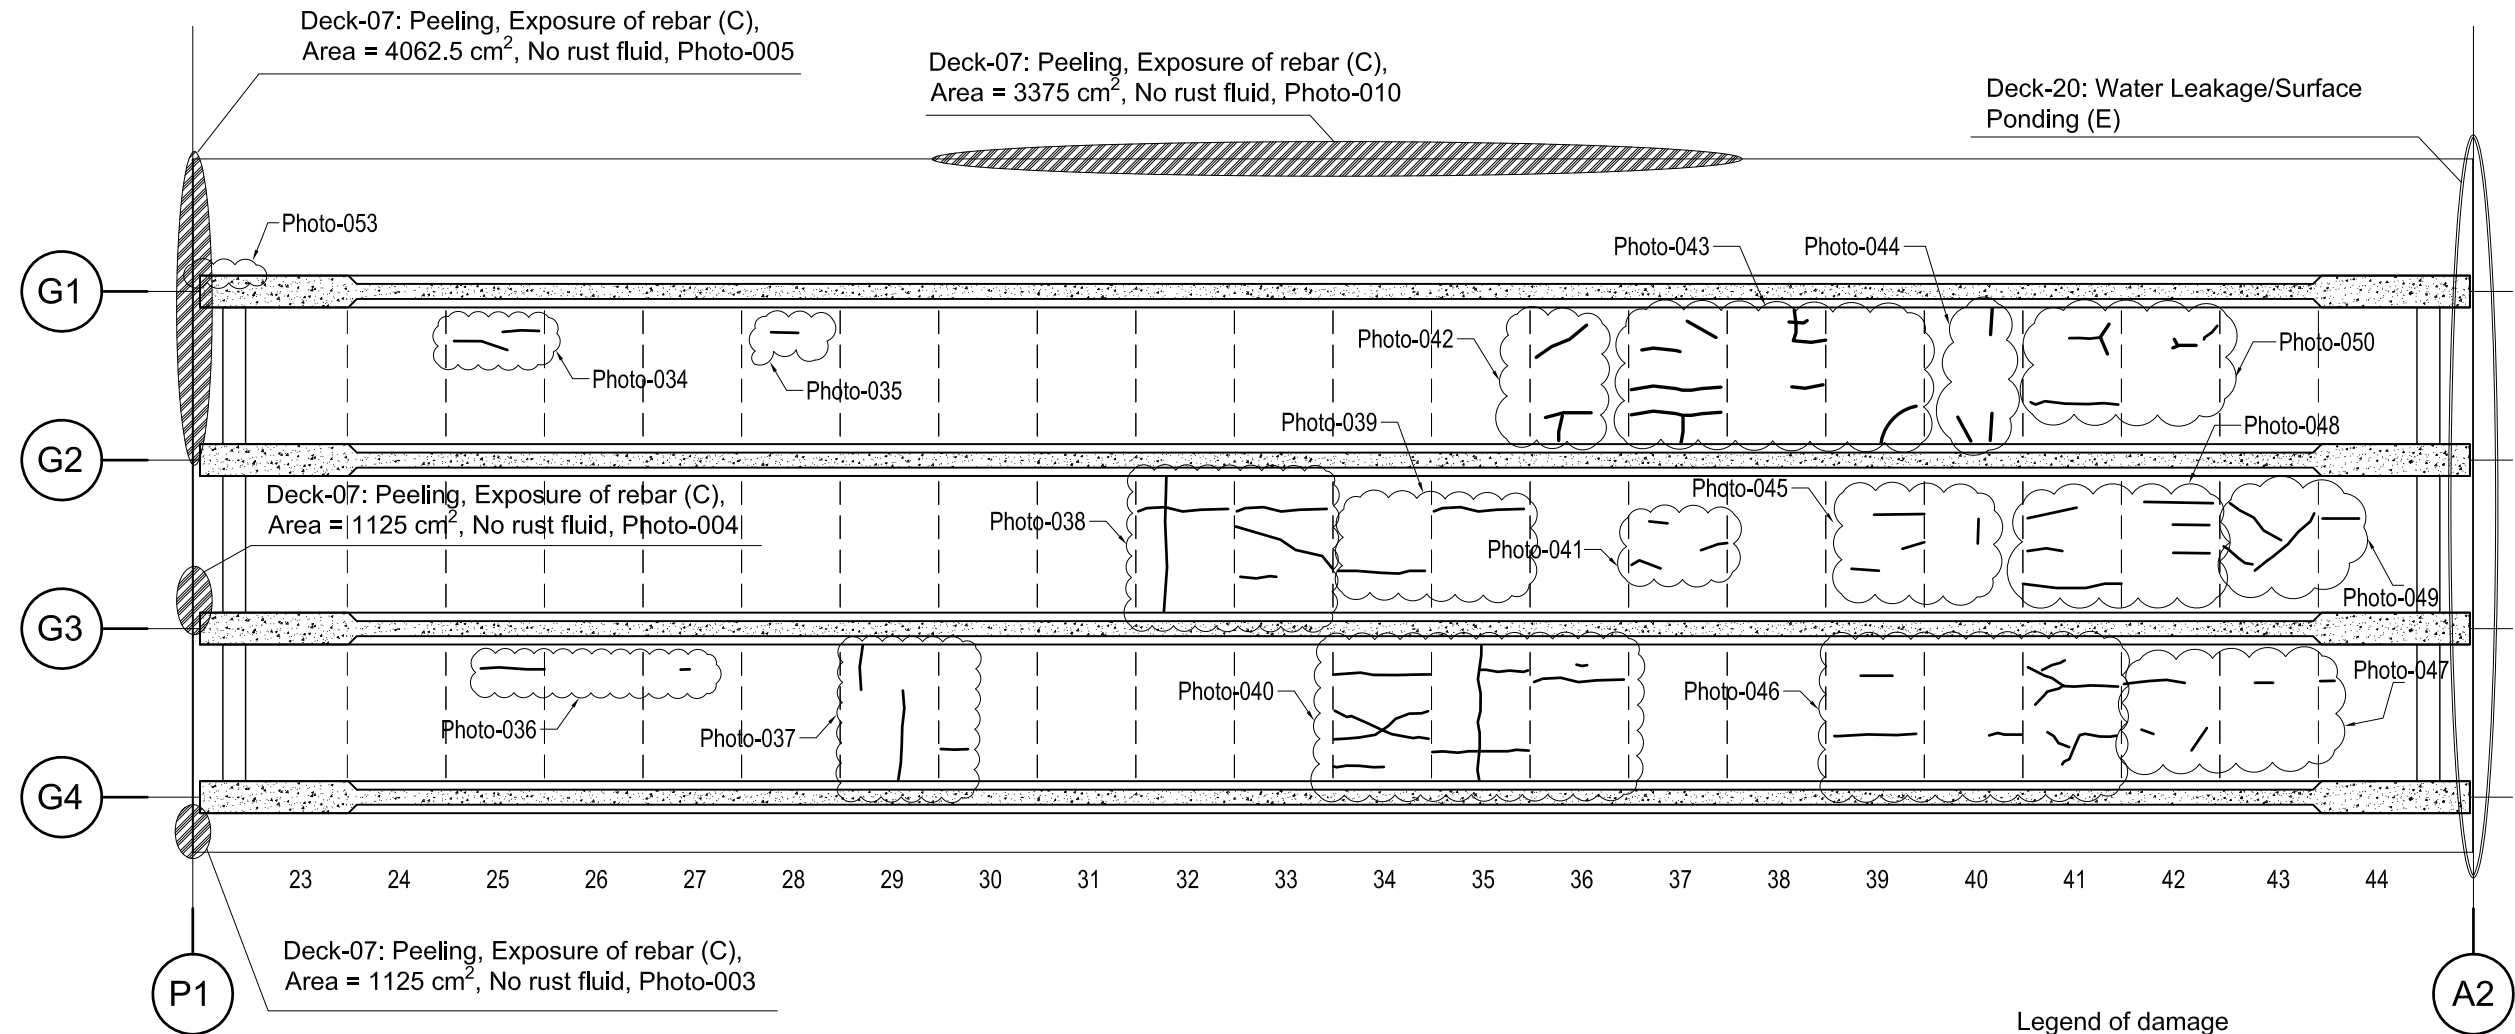
Damage Drawing Bottom View (Deck) Span - 2

*Note1: Deck RC pre-cast slab-07: Peeling/Exposure of Rebar. The damage grade C is generally observed at the joint between each pre-cast slab, but grade D cracks can be observed locally. Photo-021

*Note 3: Due to the area between pre-cast slab No.25 to No.33 is hard to access. Therefore, only the cracks with the width of more than and equal to 0.2mm are recorded.

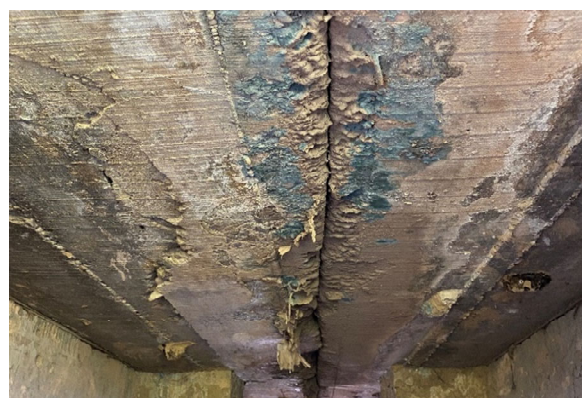
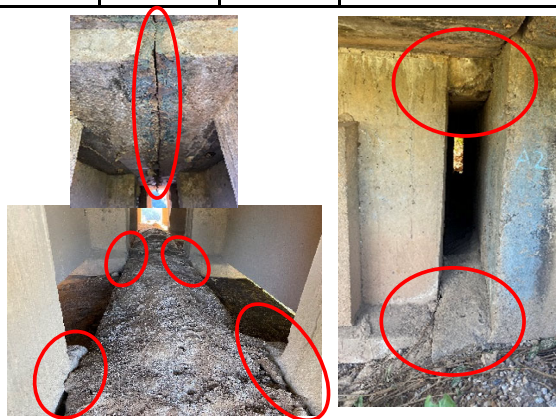
Photo No.	019	Component	Superstructure	Photo No.	020	Component	Superstructure
Element name	Deck			Element name	Main structure (Girder & Deck)		
Damage type	20	Damage grade	E	Damage type	13	Damage grade	E

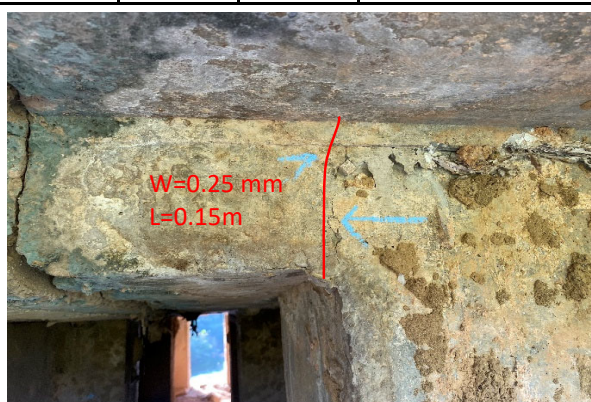
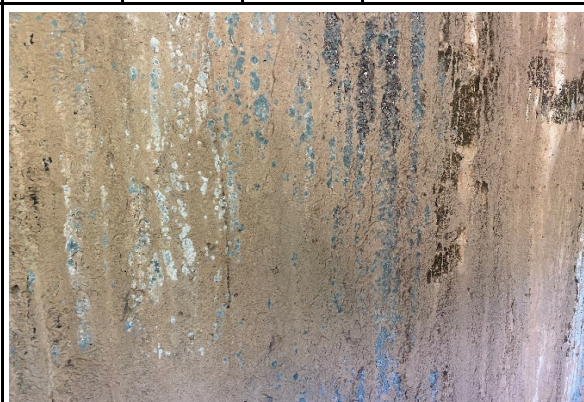
Photo No.	053	Component	Superstructure	Photo No.	054	Component	Substructure
Element name	Deck			Element name	Abutment A1		
Damage type	11	Damage grade	E	Damage type	20	Damage grade	E

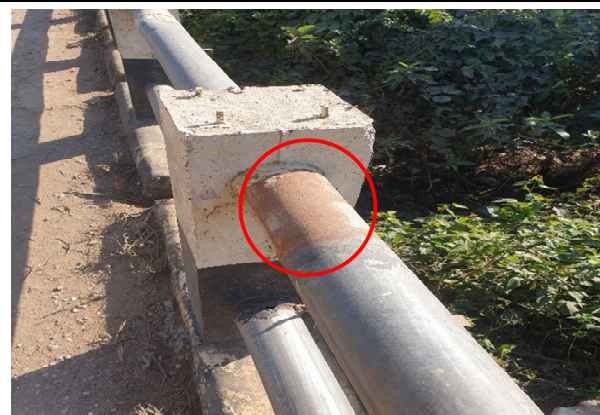
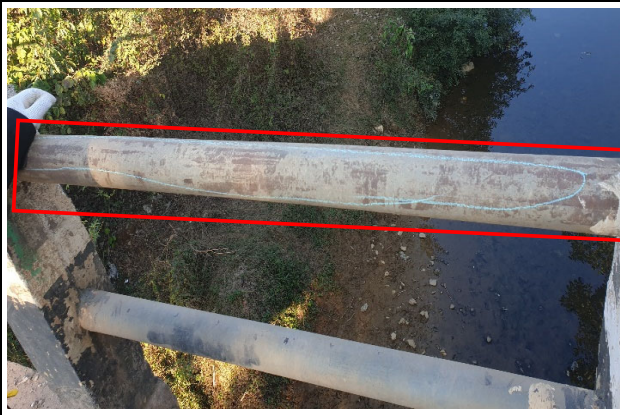
Photo No.	061	Component	On the road	Photo No.	062	Component	On the road
Element name	Railling			Element name	Railling		
Damage type	01	Damage grade	C	Damage type	01	Damage grade	C

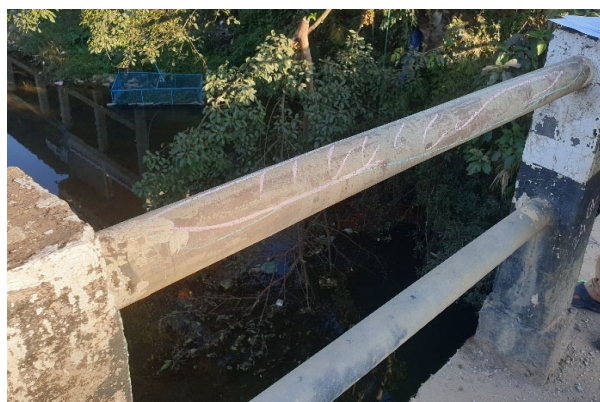
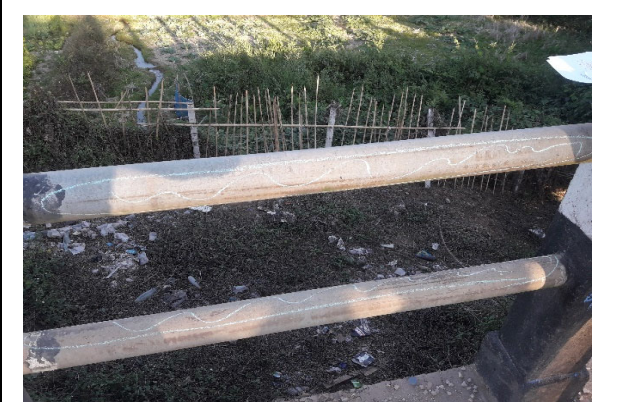
Photo No.	063	Component	On the road	Photo No.	064	Component	On the road
Element name	Railling			Element name	Railling		
Damage type	01	Damage grade	C	Damage type	01	Damage grade	C

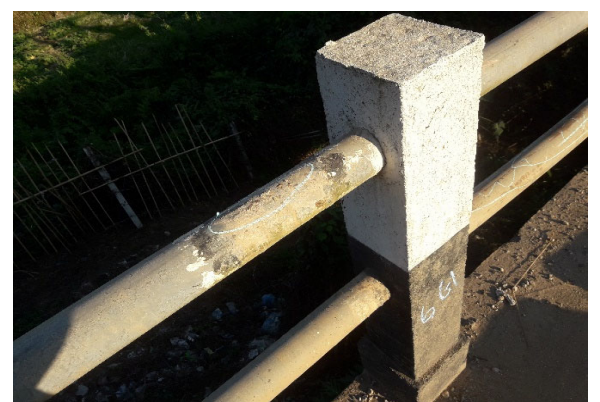
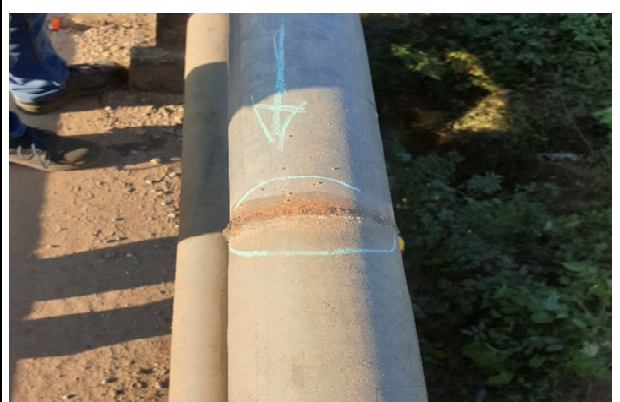
Photo No.	065	Component	On the road	Photo No.	066	Component	On the road
Element name	Railling			Element name	Railling		
Damage type	01	Damage grade	C	Damage type	01	Damage grade	C

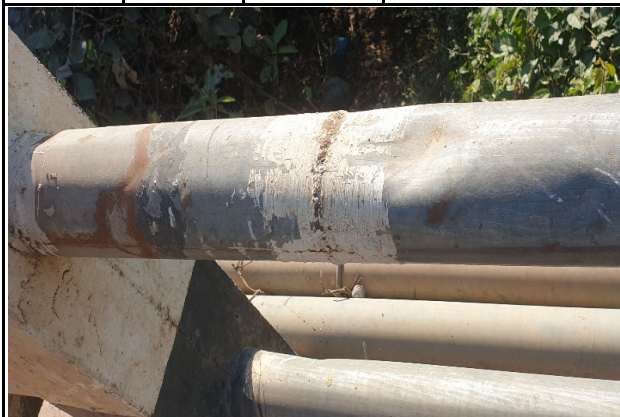
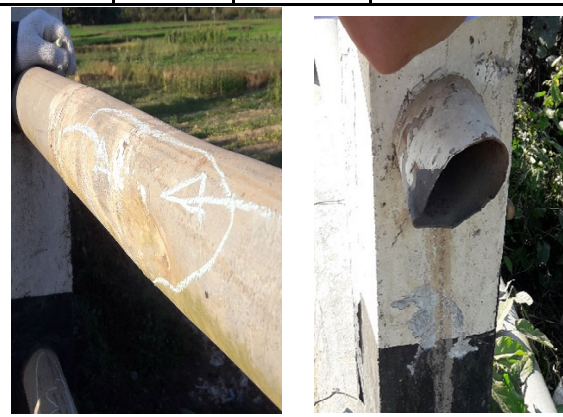
Photo No.	097	Component	On the road	Photo No.	098	Component	On the road
Element name	Railling			Element name	Railling		
Damage type	23	Damage grade	C	Damage type	23	Damage grade	C

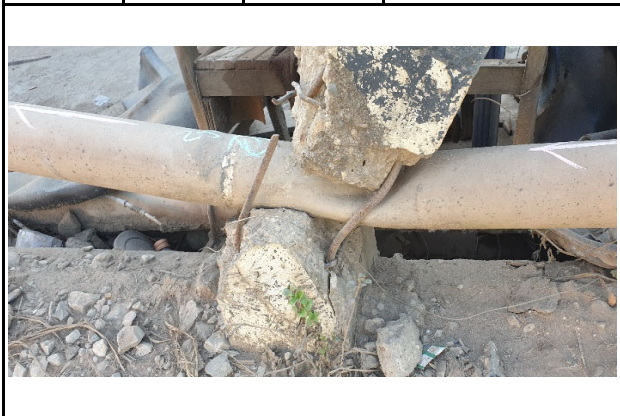
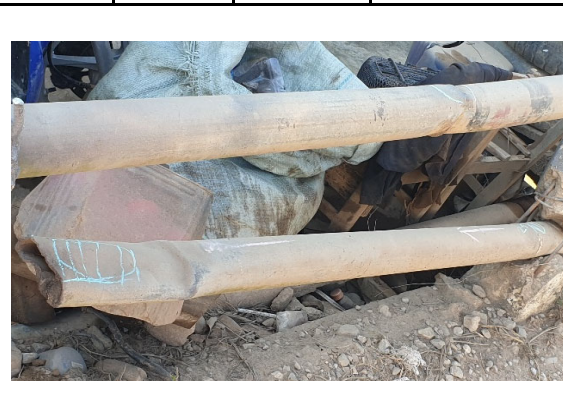
Photo No.	099	Component	On the road	Photo No.	100	Component	On the road
Element name	Railling			Element name	Railling		
Damage type	23	Damage grade	E	Damage type	23	Damage grade	E

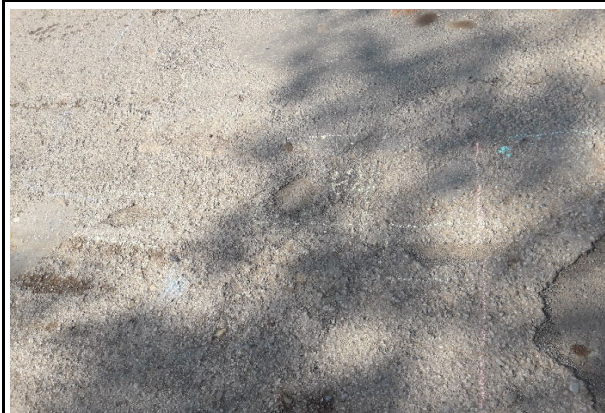
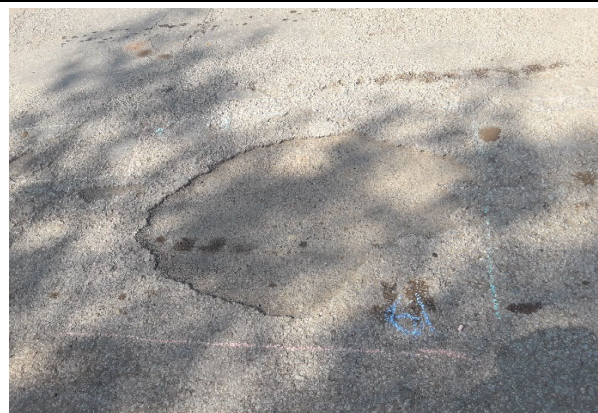
Photo No.	101	Component	Road surface	Photo No.	102	Component	Road surface
Element name	Pavement			Element name	Pavement		
Damage type	14	Damage grade	C	Damage type	14	Damage grade	C

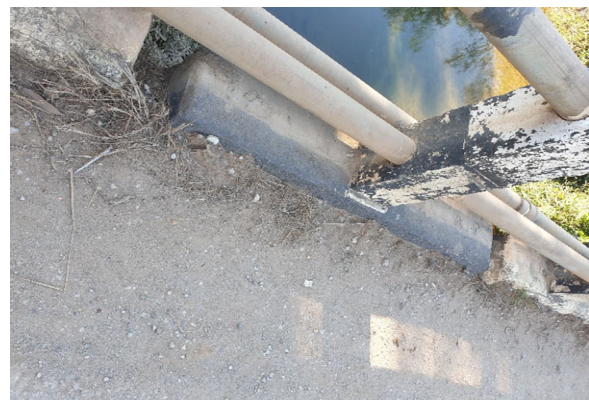
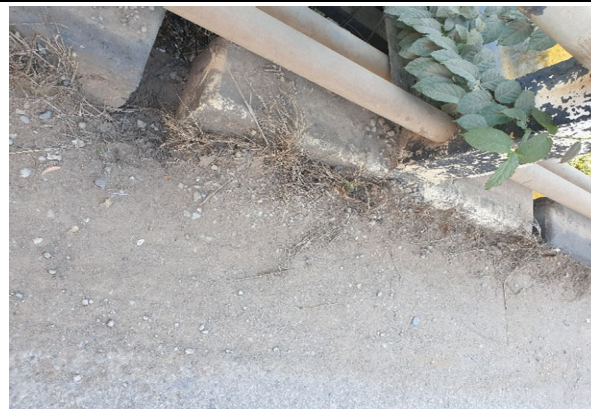
Photo No.	119	Component	Road surface	Photo No.	120	Component	Road surface
Element name	Sediment clogging (Drainage prblems)			Element name	Sediment clogging (Drainage prblems)		
Damage type	24	Damage grade	E	Damage type	24	Damage grade	E
