Appendix 2: Xe Bangnouan Bridge

**THE PROJECT FOR CAPACITY DEVELOPMENT ON BRIDGE
MAINTENANCE AND MANAGEMENT**

Appendix 2-c: Damage Drawings

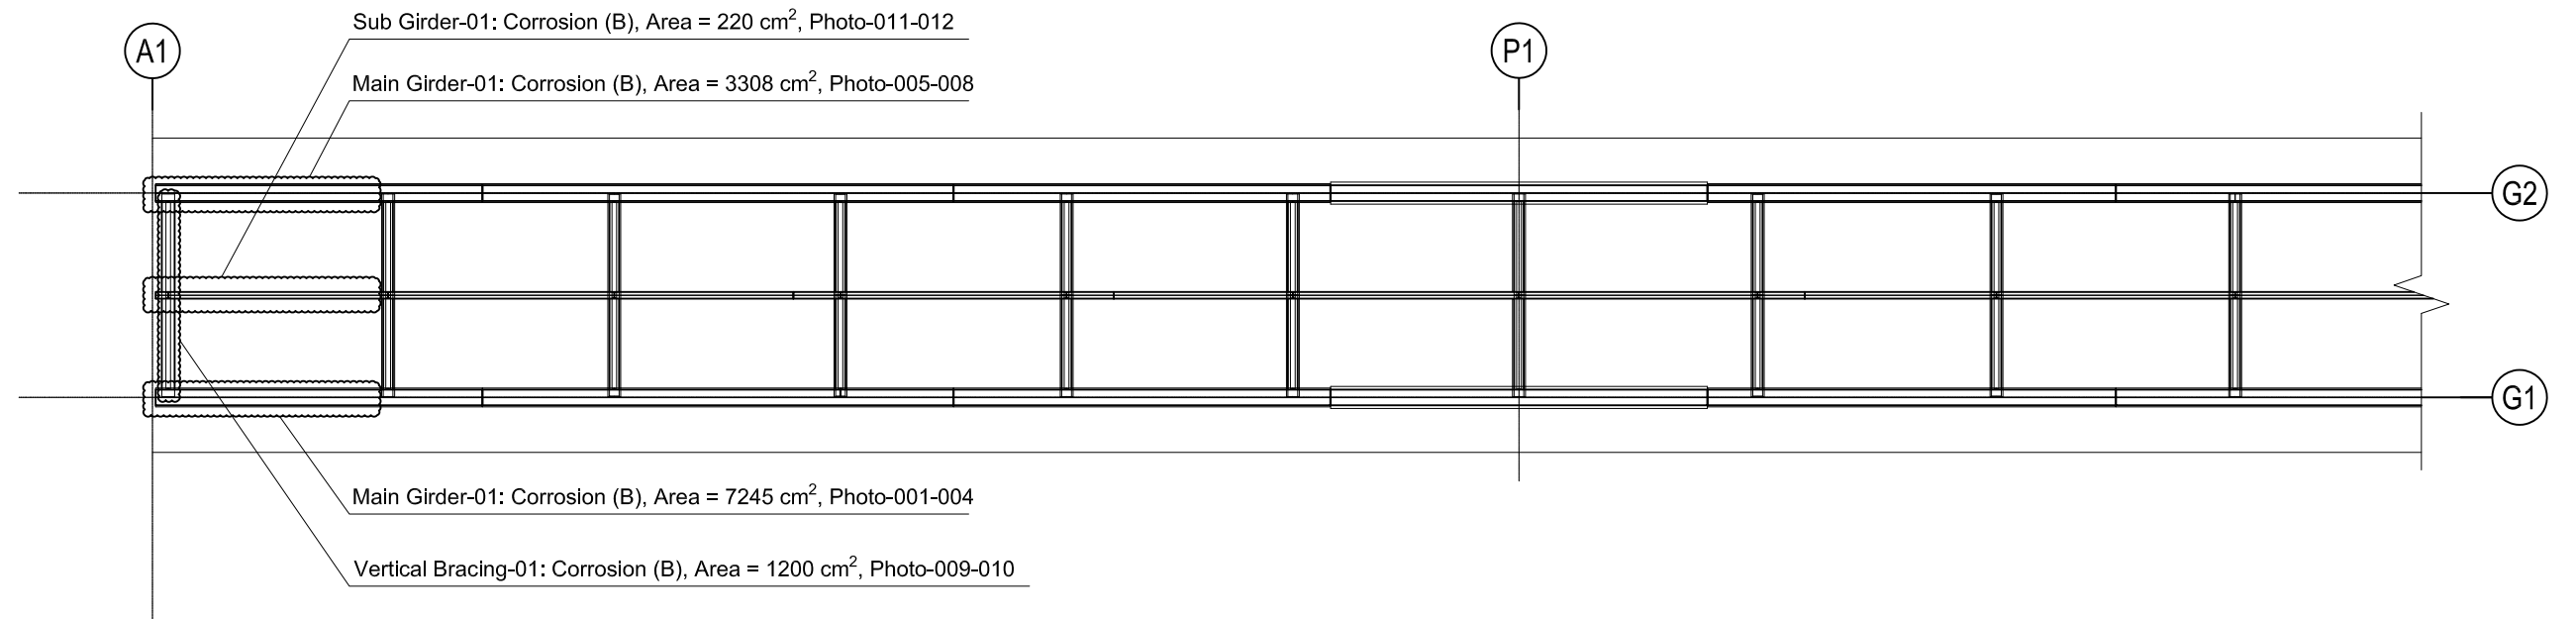
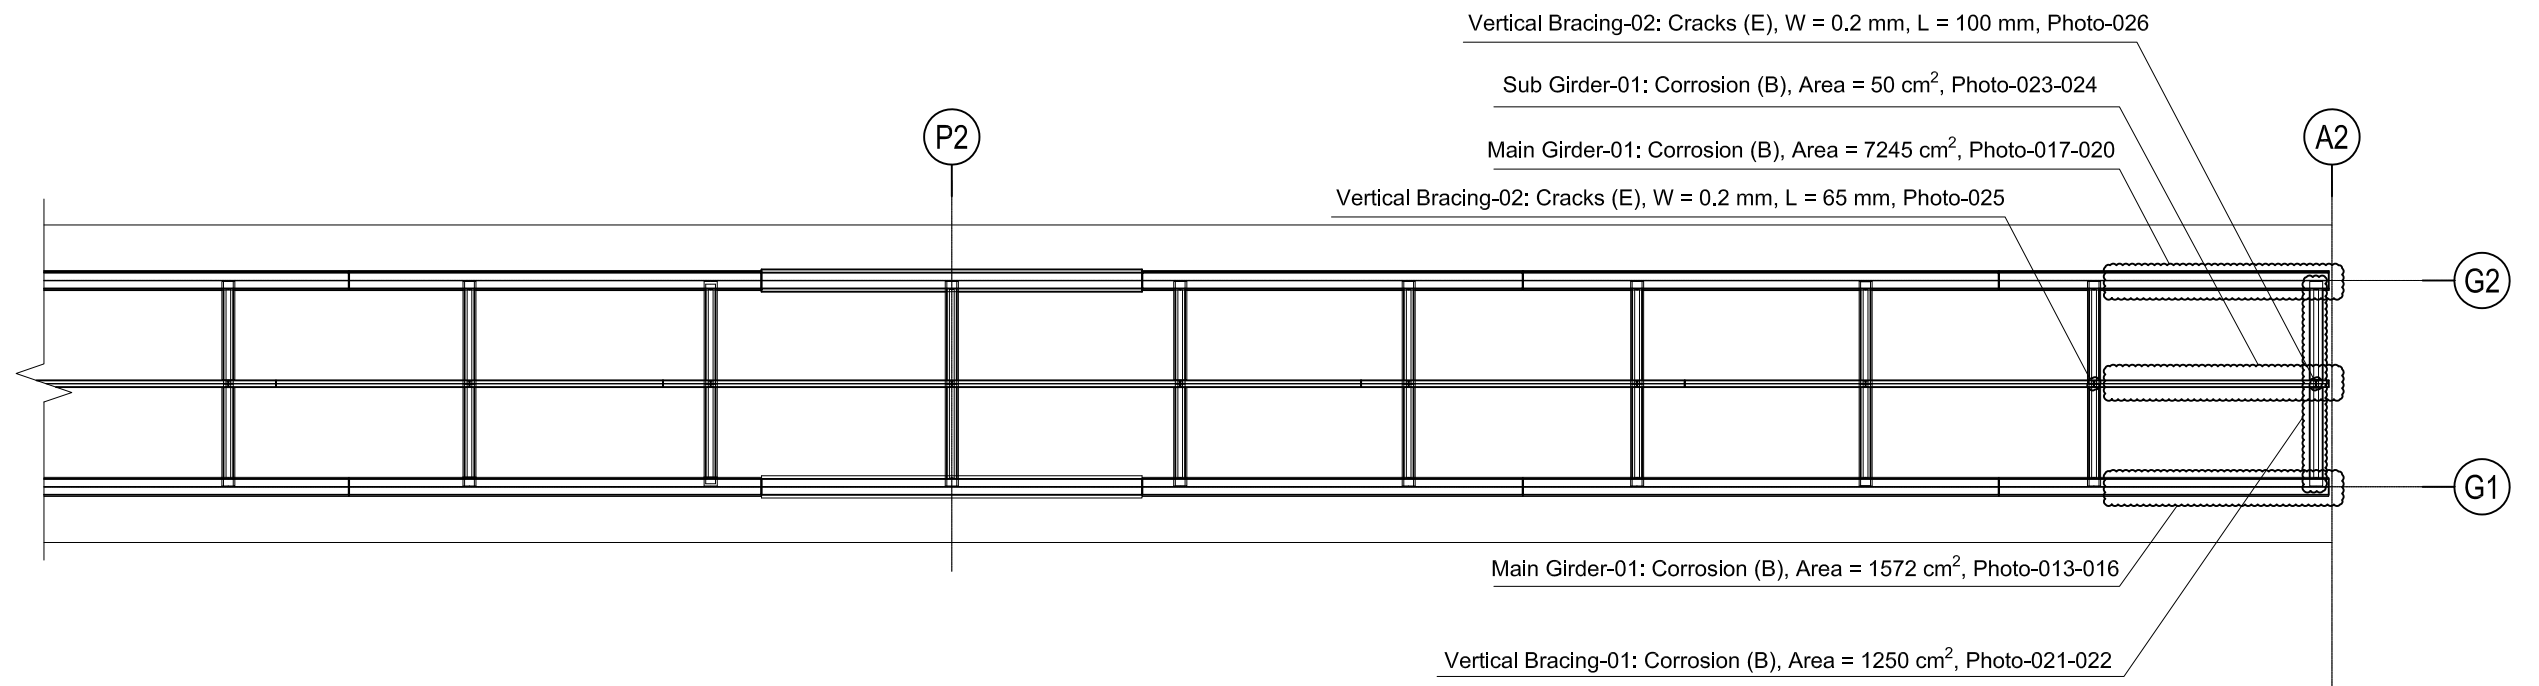
Damage Drawings Bottom View (Steel Member: Main Girder, Sub Girder and Vertical Bracing)

*Note1: Main Girder-05: Degradation of Anticorrosion Performance. The damage grade C is generally observed. The outermost anticorrosion coating has discoloration and loosened locally.
 *Note2: Vertical Bracing-05: Degradation of Anticorrosion Performance. The damage grade C is generally observed. The outermost anticorrosion coating has discoloration and loosened locally.
 *Note3: Sub Girder-05: Degradation of Anticorrosion Performance. The damage grade C is generally observed. The outermost anticorrosion coating has discoloration and loosened locally.
 *Note4: Damages between 1st and 2nd bracing (8.5m-long) counted from abutment A1 and A2 have been recorded by closely conducting a visual inspection.

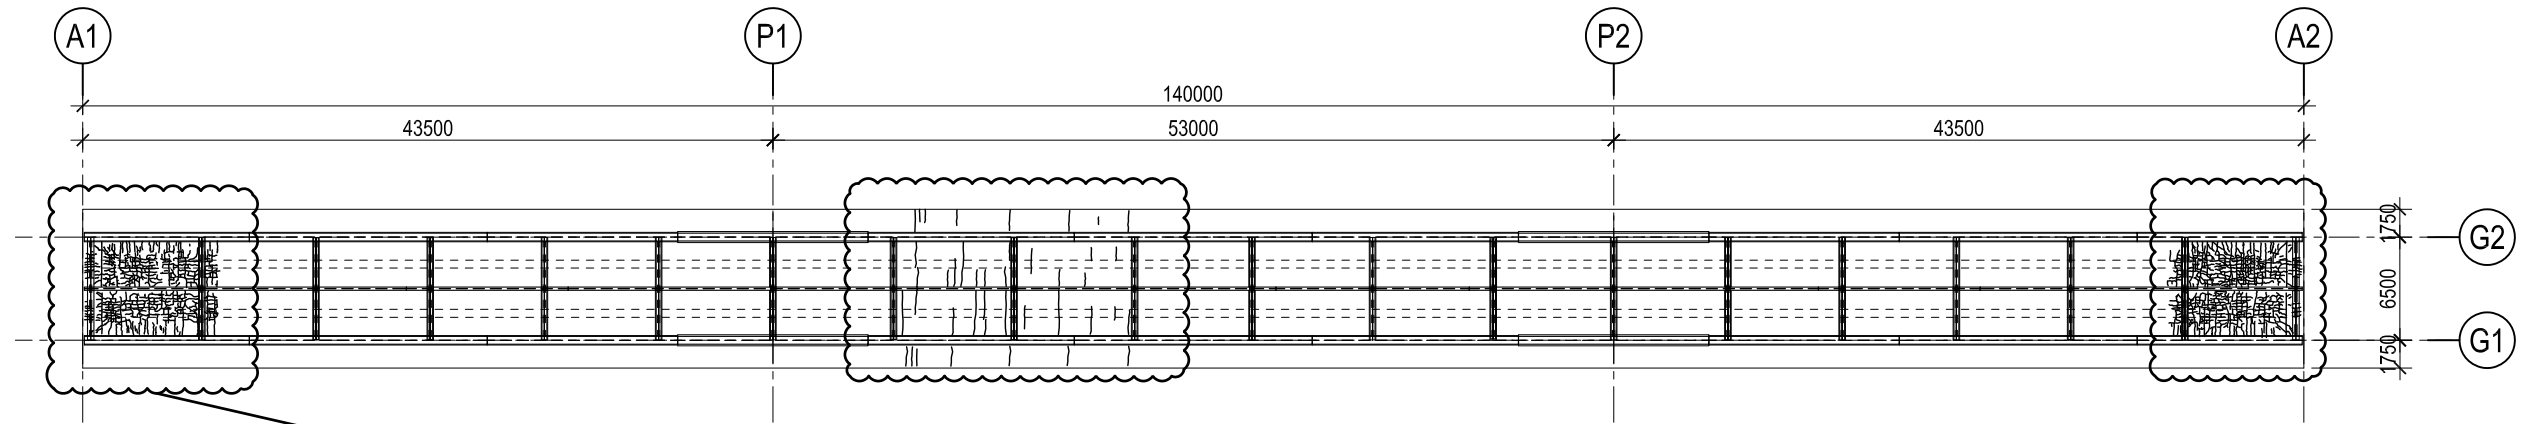
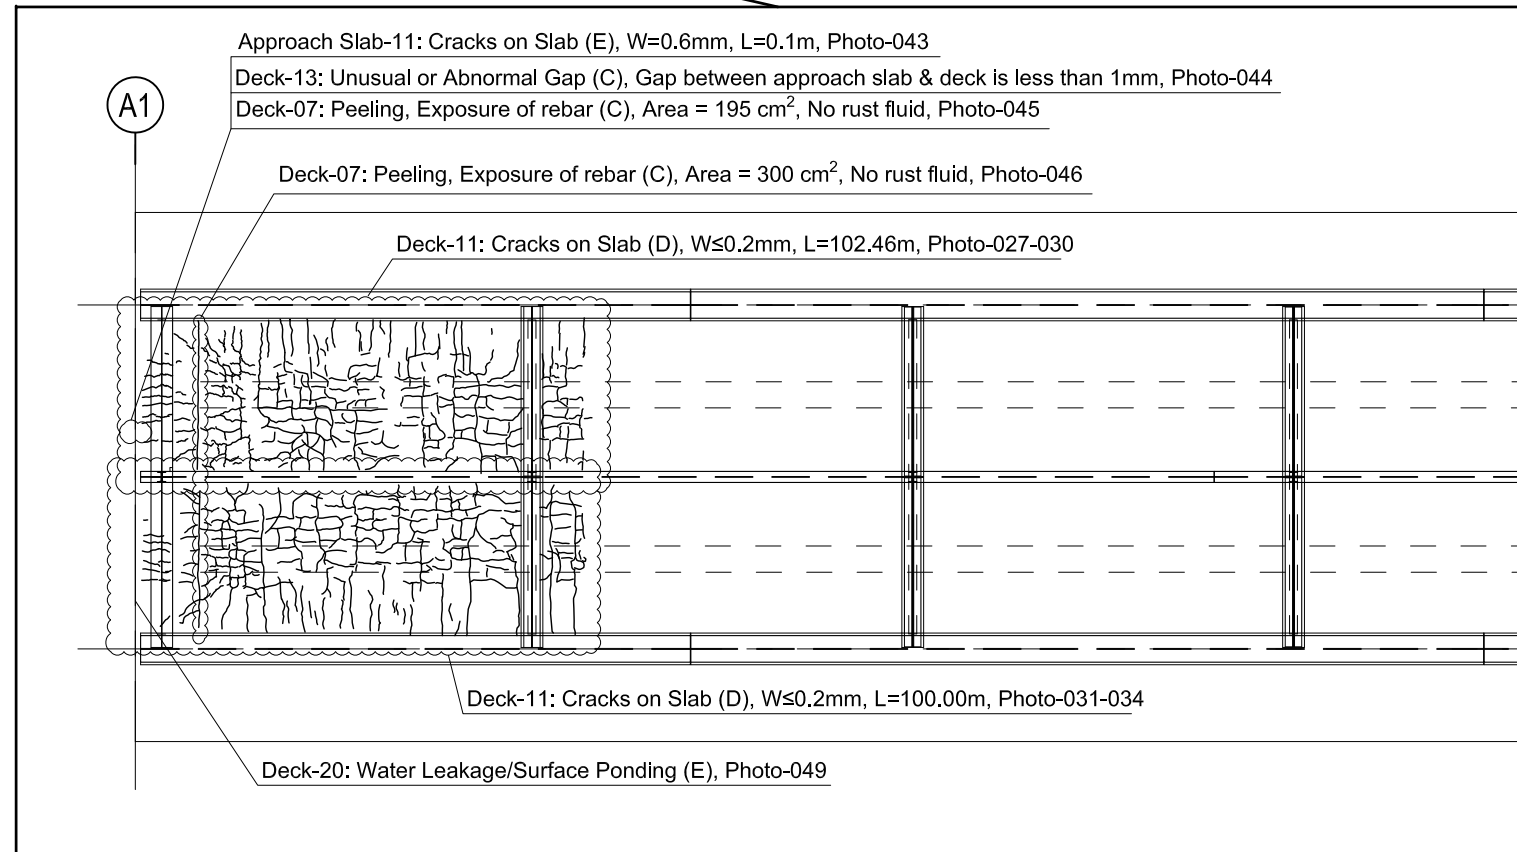
Damage Drawings Bottom View (Concrete Member: Deck) Span - 1

*Note1: Damages between 1st and 2nd bracing (8.5m-long) counted from abutment A1 and A2 have been recorded by closely conducting a visual inspection.
 *Note2: Damages between pier P1 and P2 have been recorded by using binoculars and telephoto camera due to site constraints.

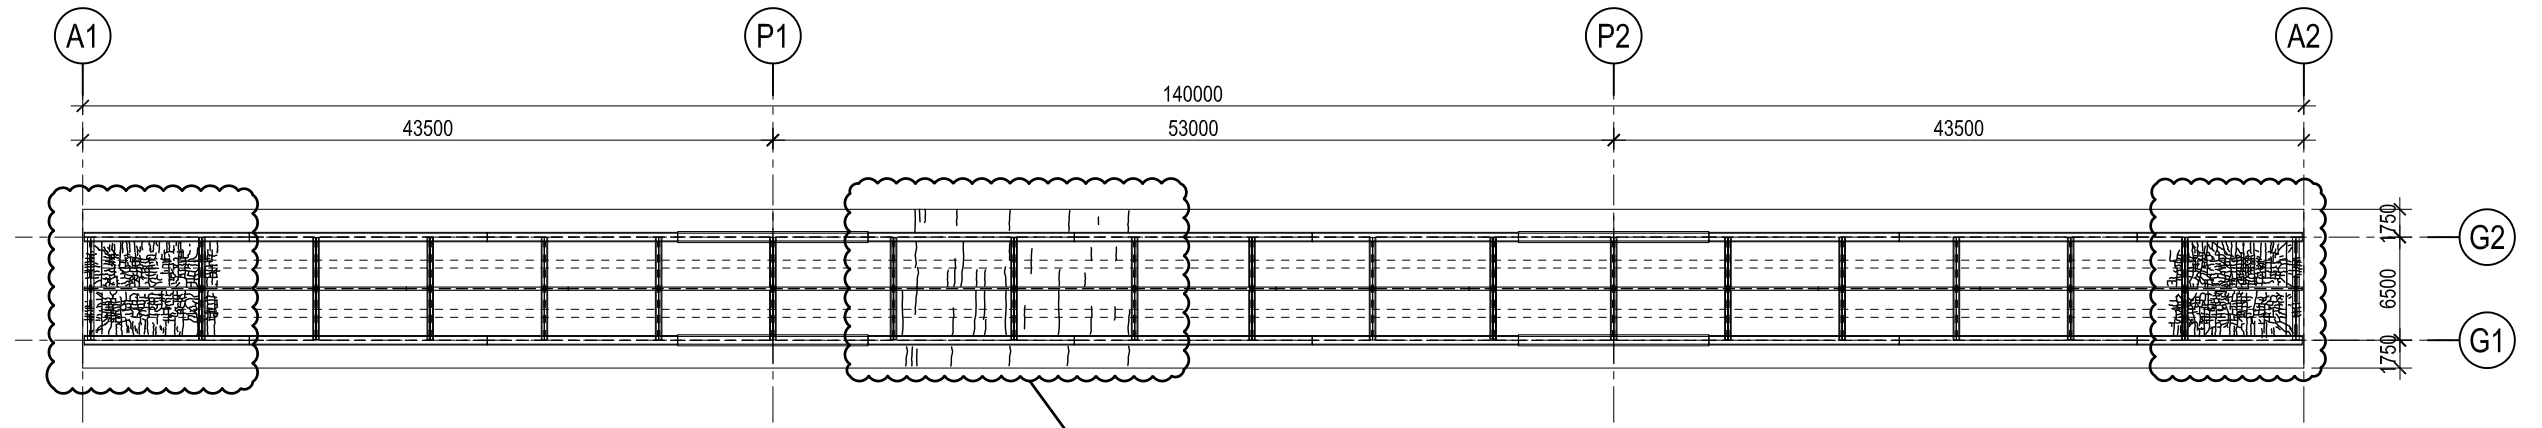
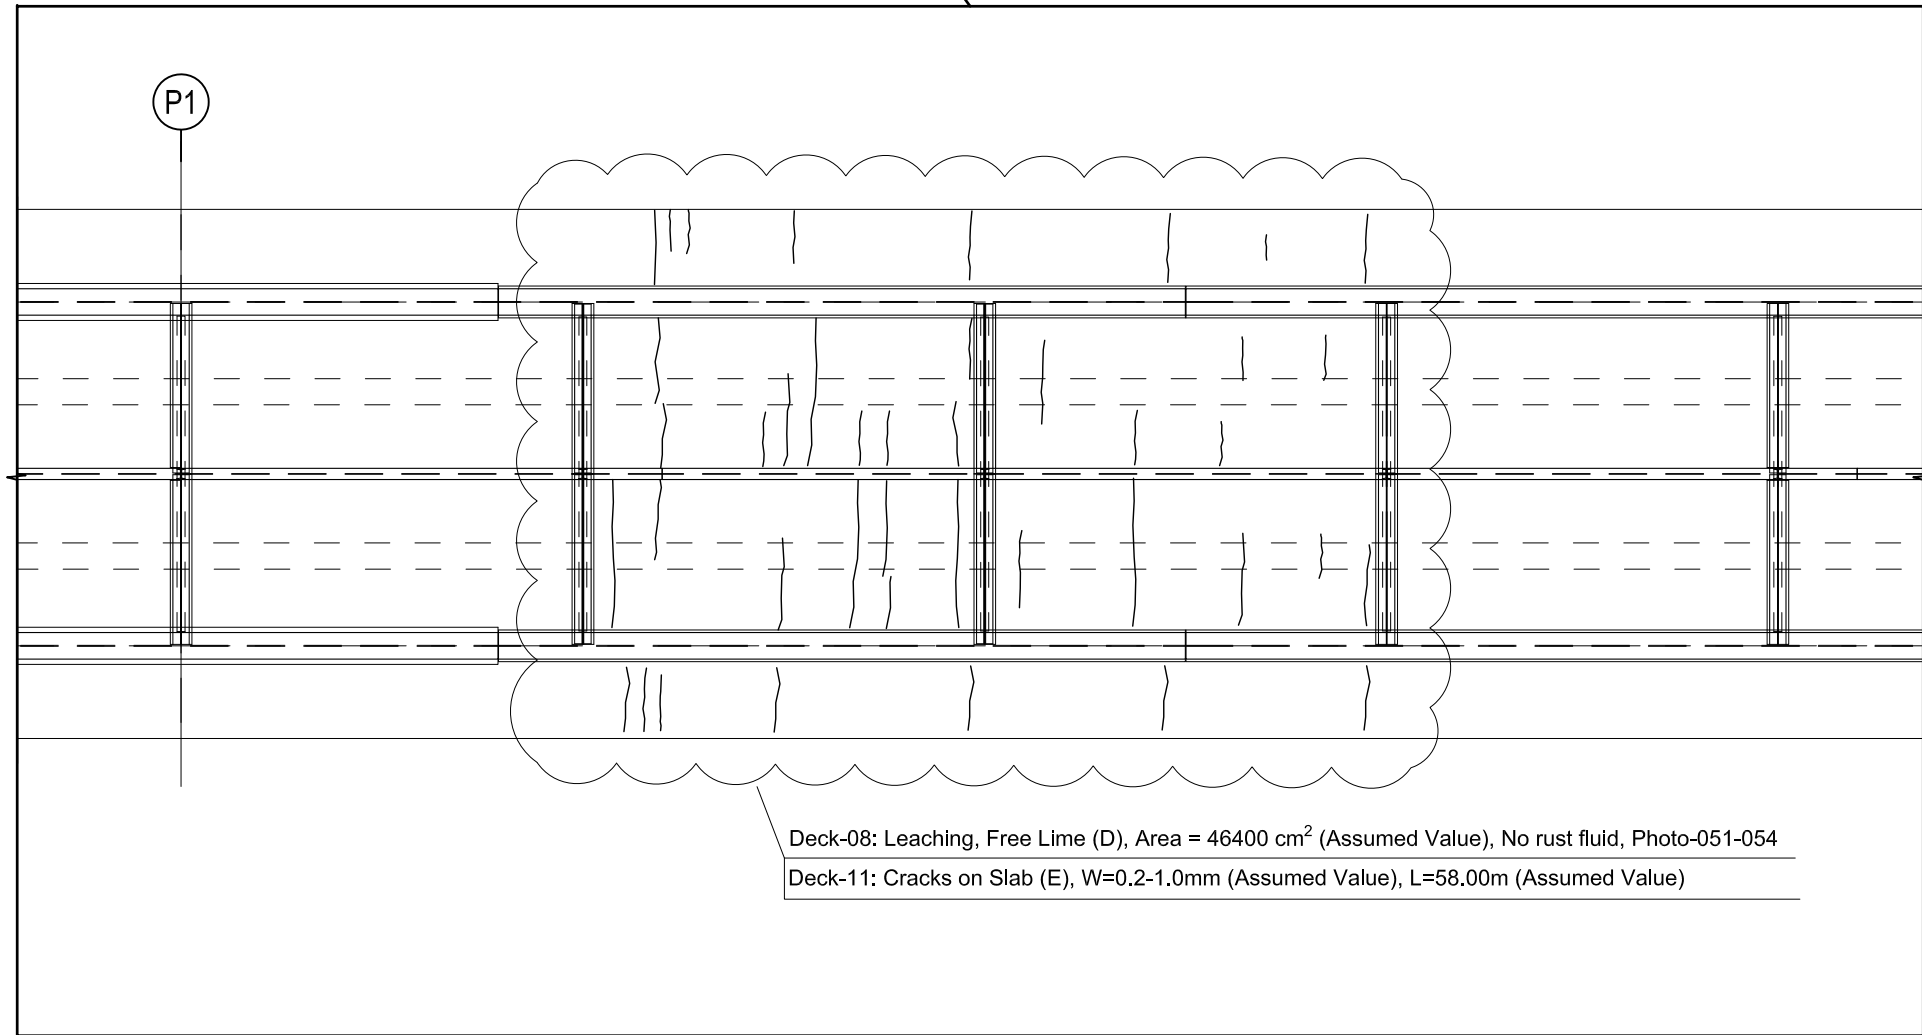
Damage Drawings Bottom View (Concrete Member: Deck) Span - 2

*Note1: Damages between 1st and 2nd bracing (8.5m-long) counted from abutment A1 and A2 have been recorded by closely conducting a visual inspection.
 *Note2: Damages between pier P1 and P2 have been recorded by using binoculars and telephoto camera due to site constraints.

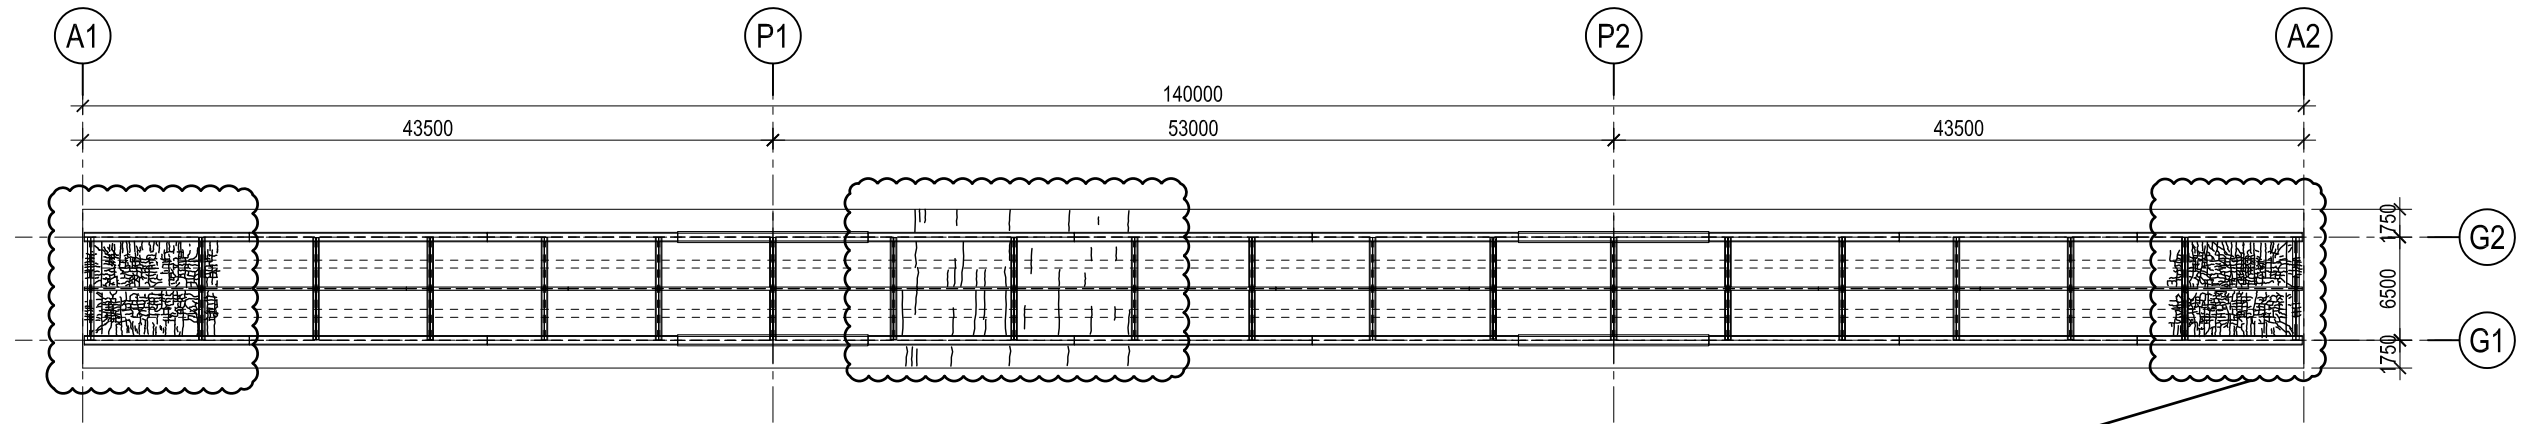
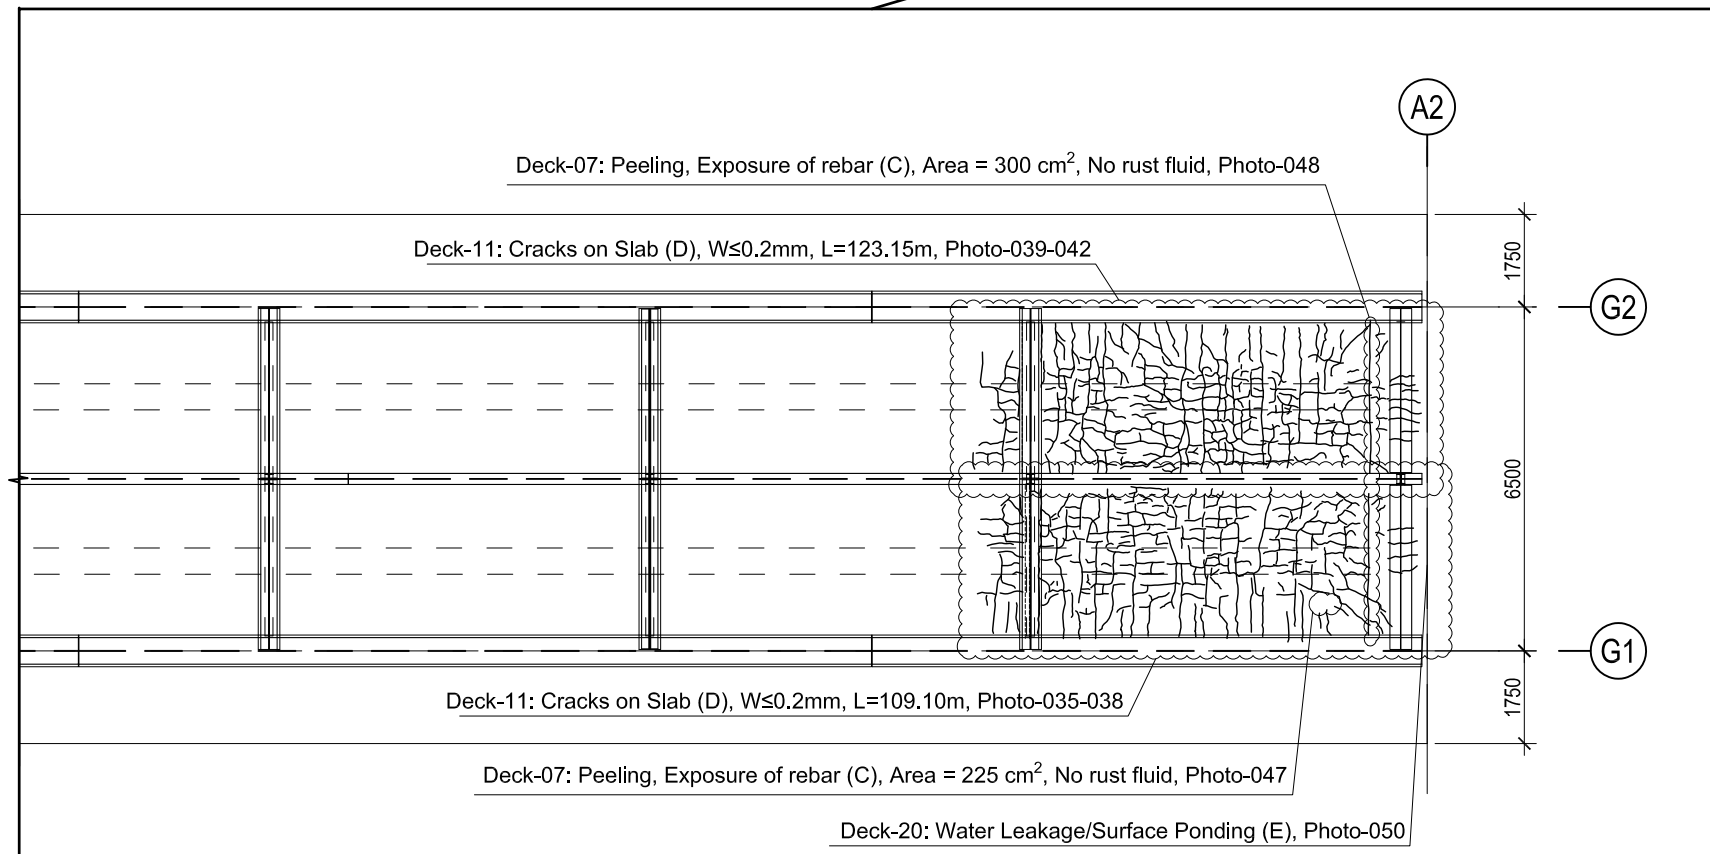
Damage Drawings Bottom View (Concrete Member: Deck) Span - 3

*Note1: Damages between 1st and 2nd bracing (8.5m-long) counted from abutment A1 and A2 have been recorded by closely conducting a visual inspection.
 *Note2: Damages between pier P1 and P2 have been recorded by using binoculars and telephoto camera due to site constraints.

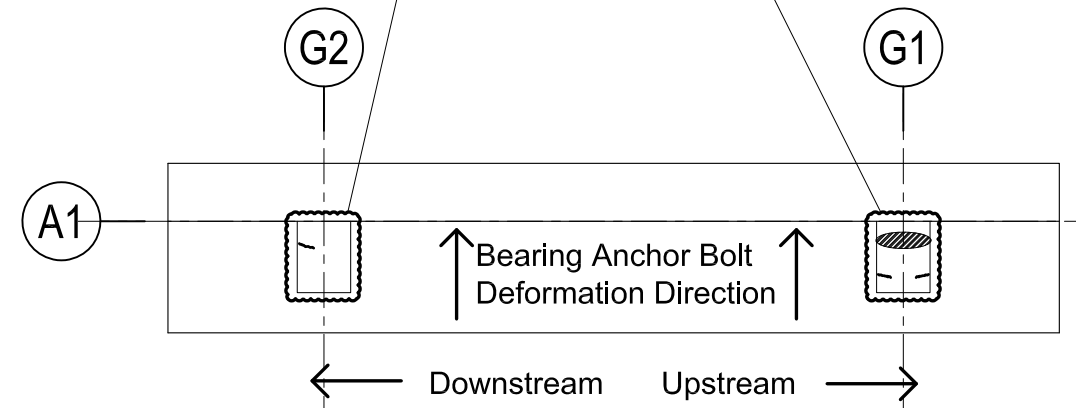
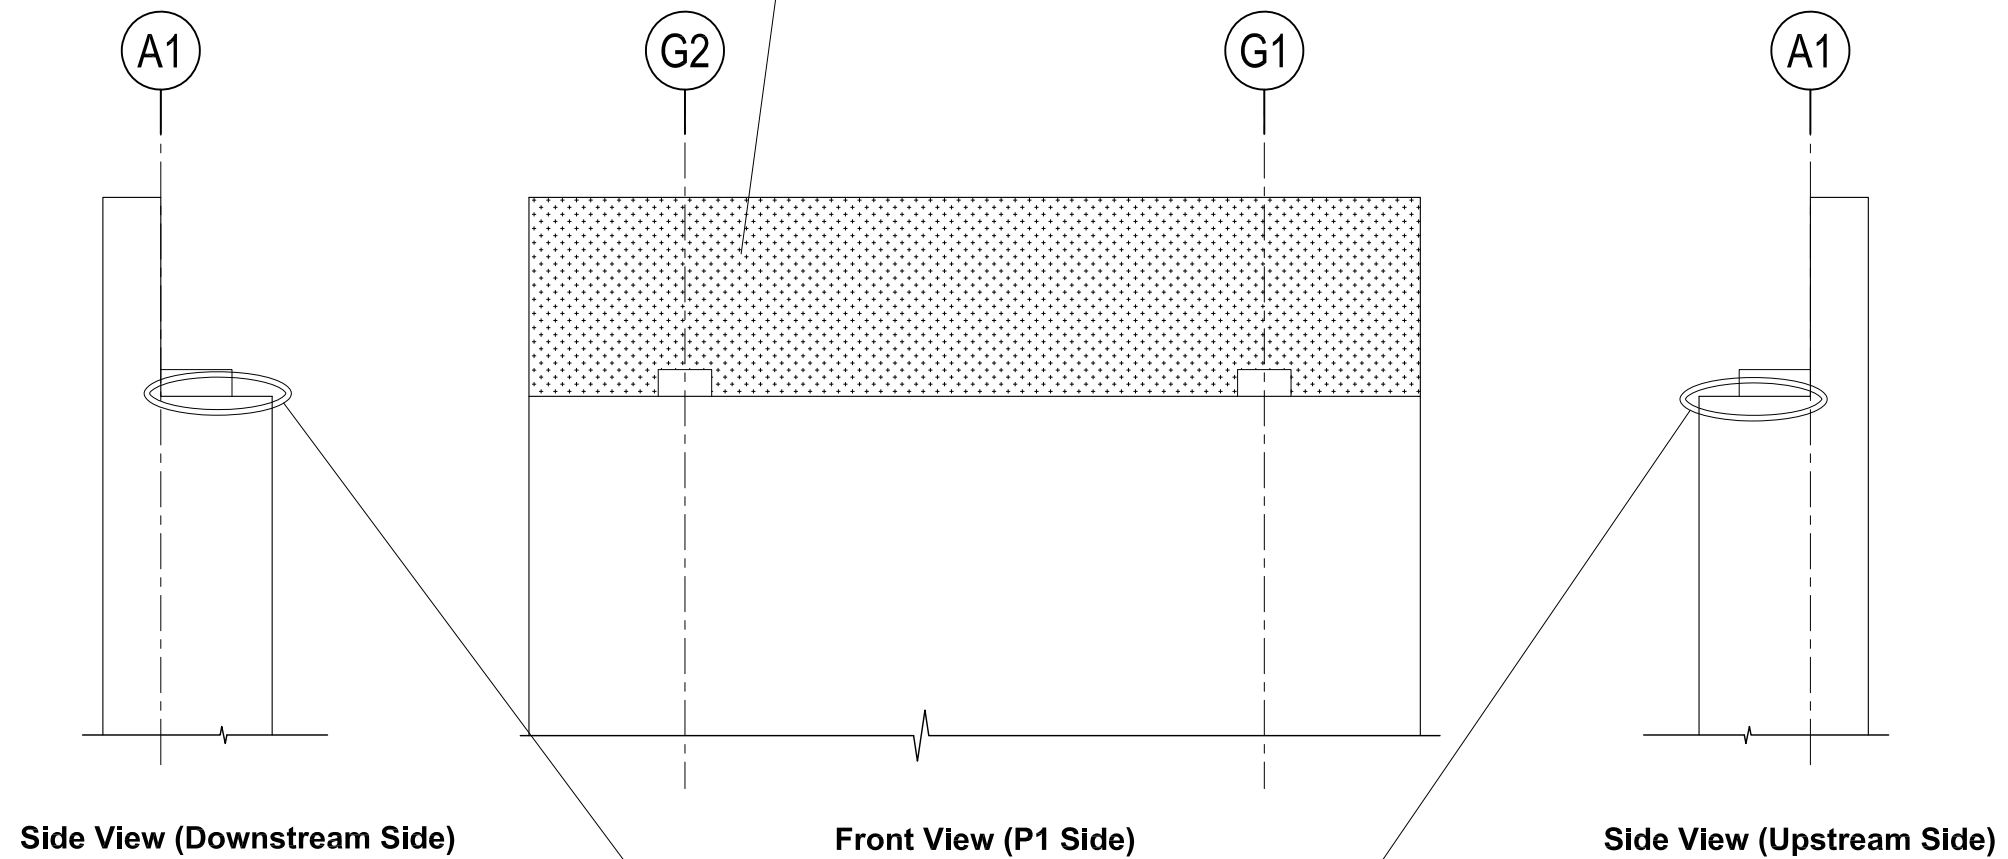
Abutment A1 Damage Drawings

Bearing Body-01: Corrosion (C), Photo-055
Bearing Body-05: Degradation of Anticorrosion Performance (C), Photo-056
Mortar (Grout Pad)-06: Cracks (E), W=0.55mm, L=0.07m, Photo-057
Bearing Body-17: Others (E), Rubber is damaged, Photo-058
Bearing Anchor Bolt-23: Deformation/Loss (E), Photo-059

Bearing Body-01: Corrosion (C), Photo-060
Bearing Body-05: Degradation of Anticorrosion Performance (C), Photo-061
Mortar (Grout Pad)-06: Cracks (B), W=0.10mm, L=0.08m, Photo-062
Mortar (Grout Pad)-06: Cracks (B), W=0.15mm, L=0.07m, Photo-063
Mortar (Grout Pad)-07: Peeling, Exposure of Rebar (C), Area = 570 cm², Photo-064
Bearing Body-17: Others (E), Rubber is damaged, Photo-065
Bearing Anchor Bolt-23: Deformation/Loss (C), Photo-066

Body-20: Water Leakage Surface Ponding (E), Photo-067

Body-24: Sediment Clogging (E), Photo-068

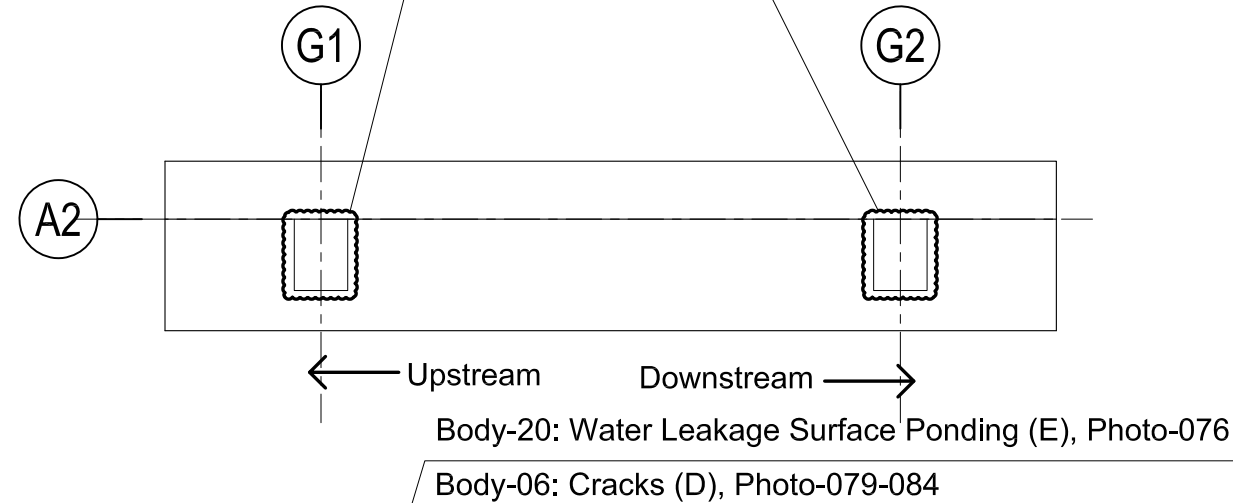
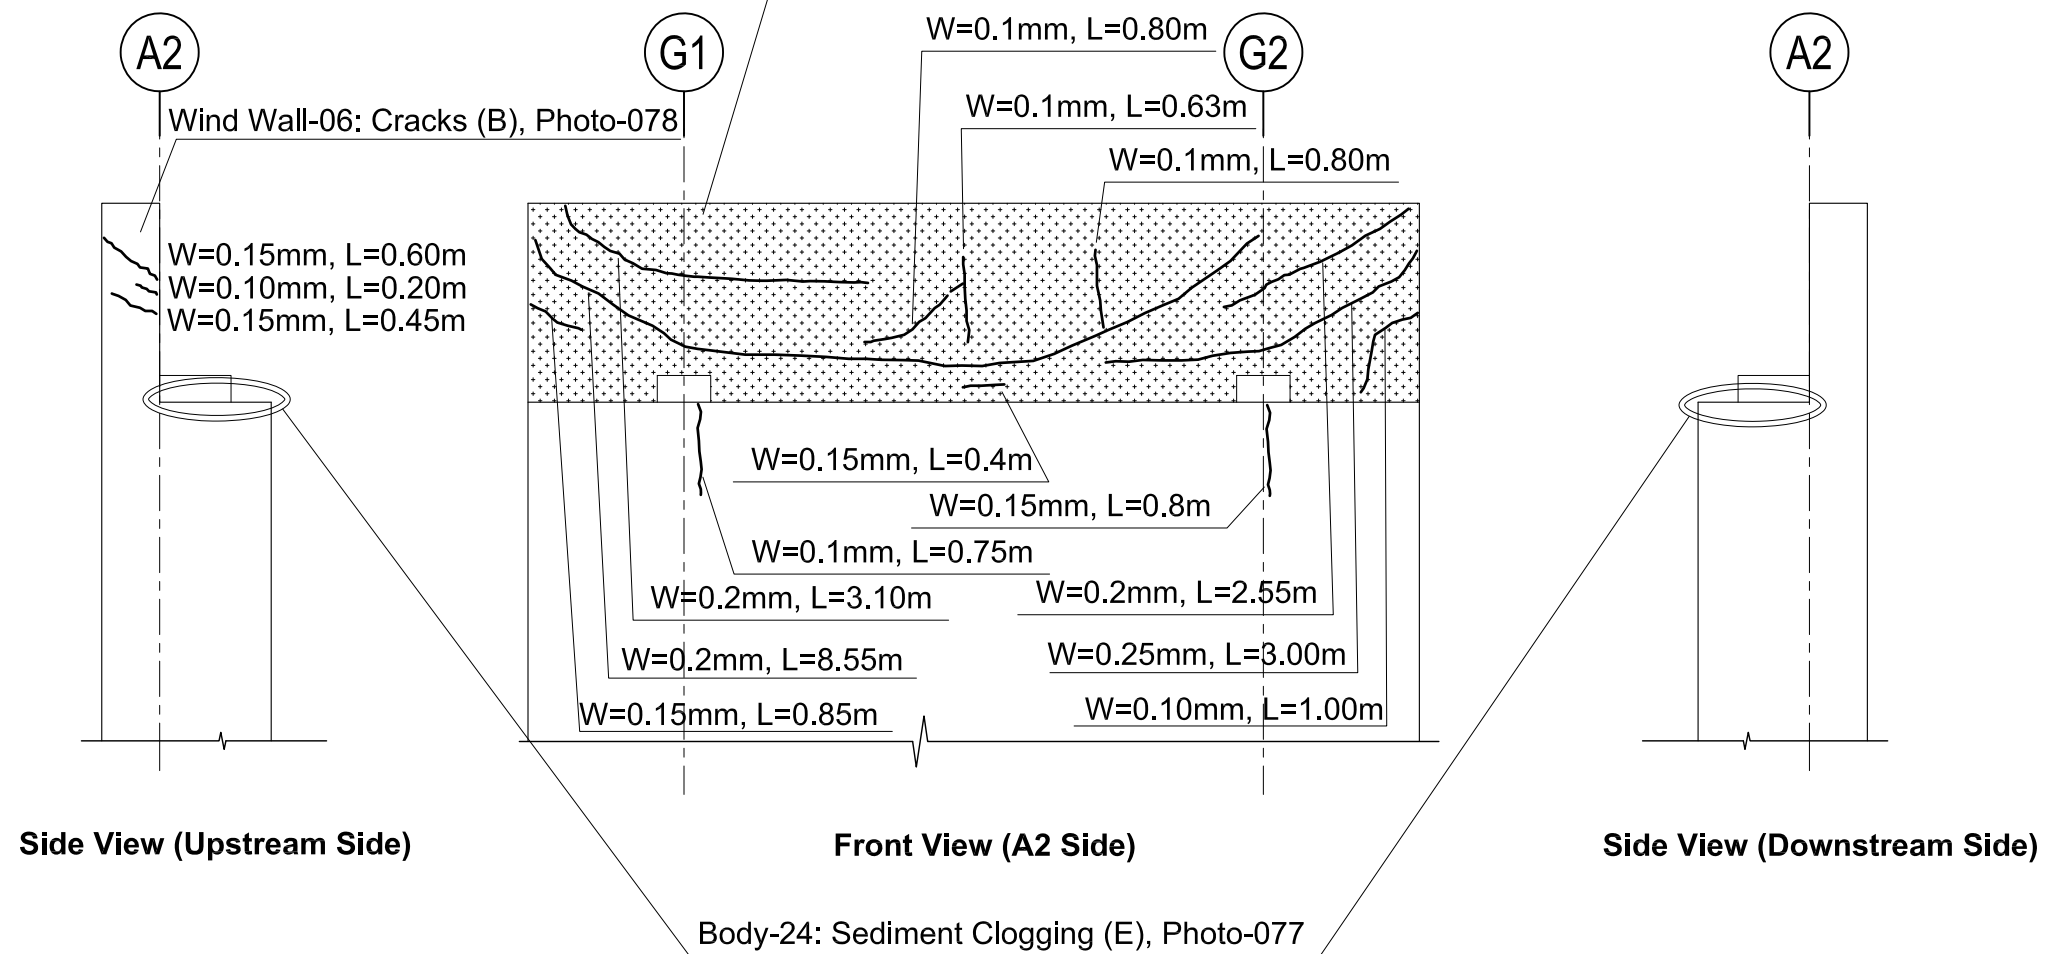
Abutment A2 Damage Drawings

Bearing Body-01: Corrosion (C), Photo-069
 Bearing Body-05: Degradation of Anticorrosion Performance (C), Photo-070
 Bearing Body-17: Others (E), Rubber is damaged, Photo-071

Bearing Body-01: Corrosion (C), Photo-072
 Bearing Body-05: Degradation of Anticorrosion Performance (C), Photo-073
 Bearing Body-17: Others (E), Rubber is damaged, Photo-074
 Bearing Anchor Bolt-03: Loose/Drop-off (E), Photo-075

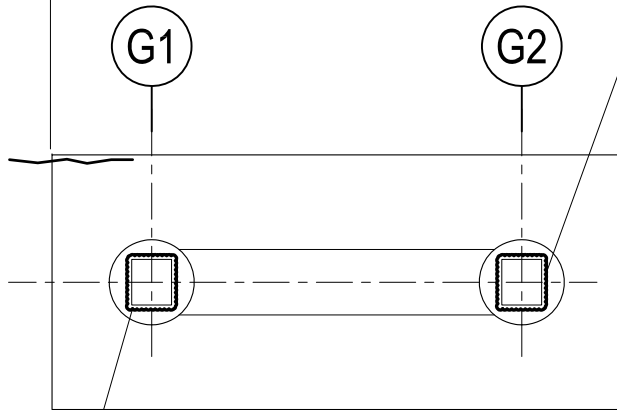
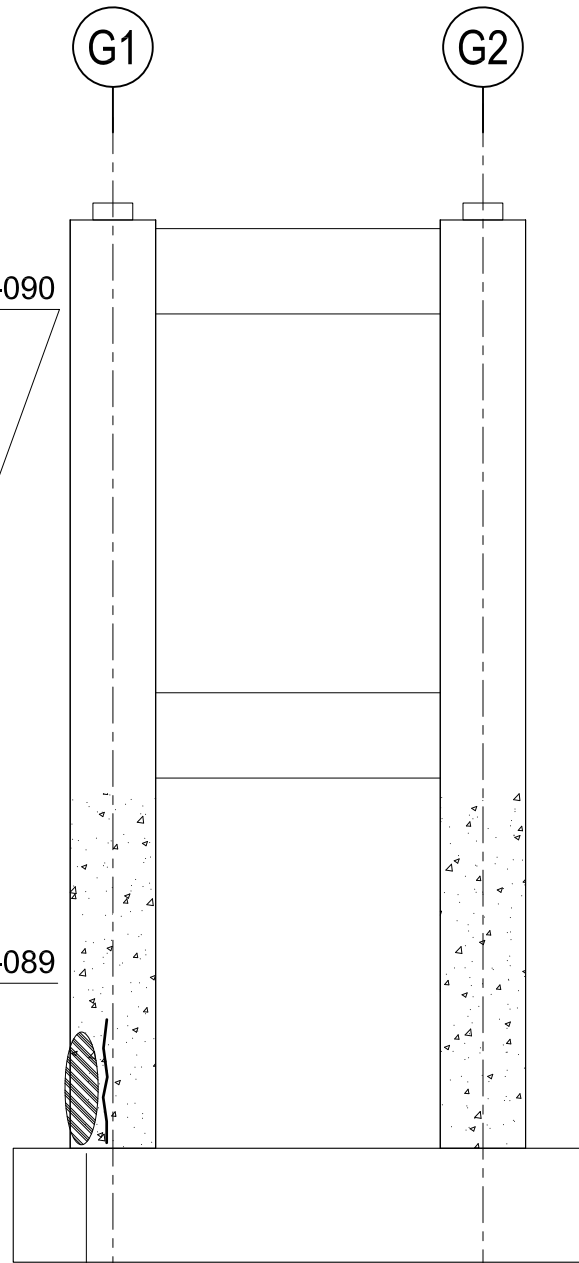
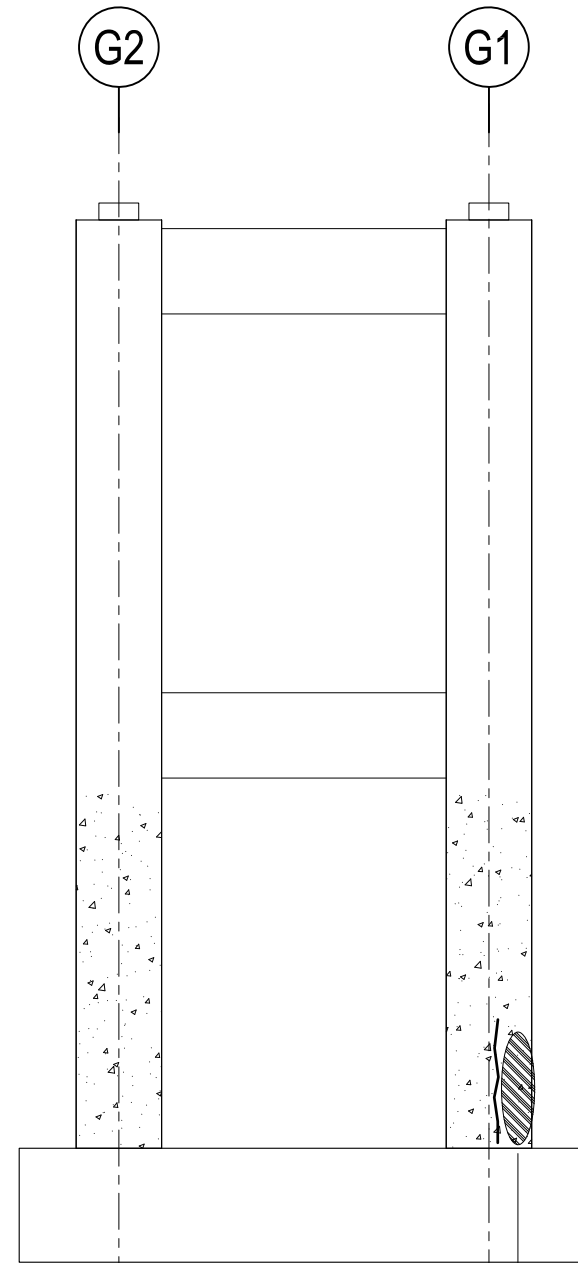
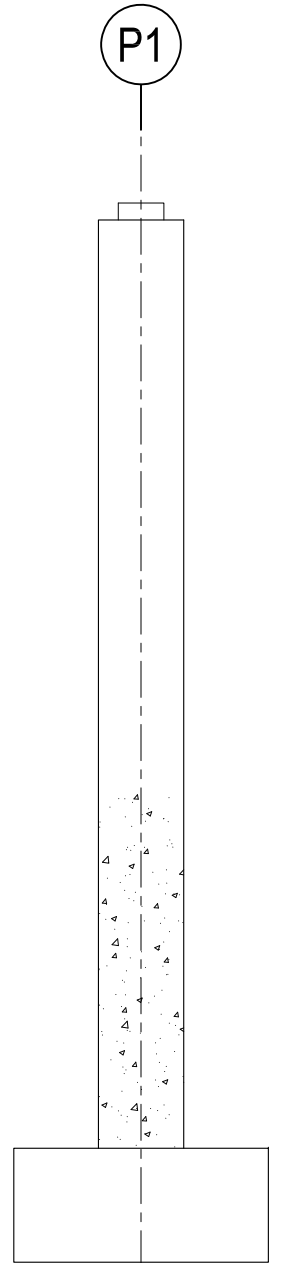
Pier P1 Damage Drawings

Foundation-06: Cracks (E),
W=0.65mm L=0.1m, Photo-087

Bearing Body-01: Corrosion (C), Photo-090
Bearing Body-05: Degradation of
Anticorrosion Performance (C),

Bearing Body-01: Corrosion (C), Photo-089
Bearing Body-05: Degradation of
Anticorrosion Performance (C),

Pier-06: Cracks (C), W=0.2mm L=0.7m, Photo-085

Pier-07: Peeling, Exposure of rebar (C), Area = 4200 cm², No rust fluid

Pier-26: Scouring (C), Photo-088

Pier-06: Cracks (E), W=0.5mm L=2.1m, Photo-086

Pier-07: Peeling, Exposure of rebar (C), Area = 4300 cm², No rust fluid

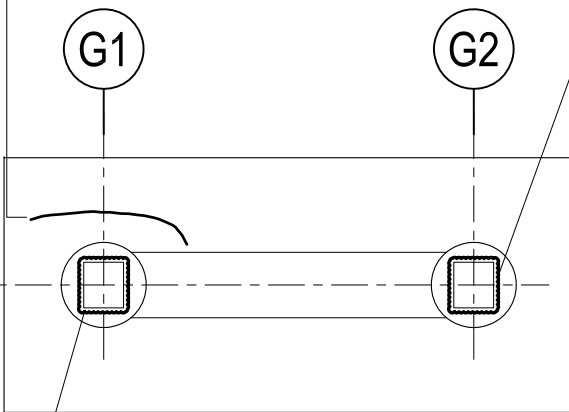
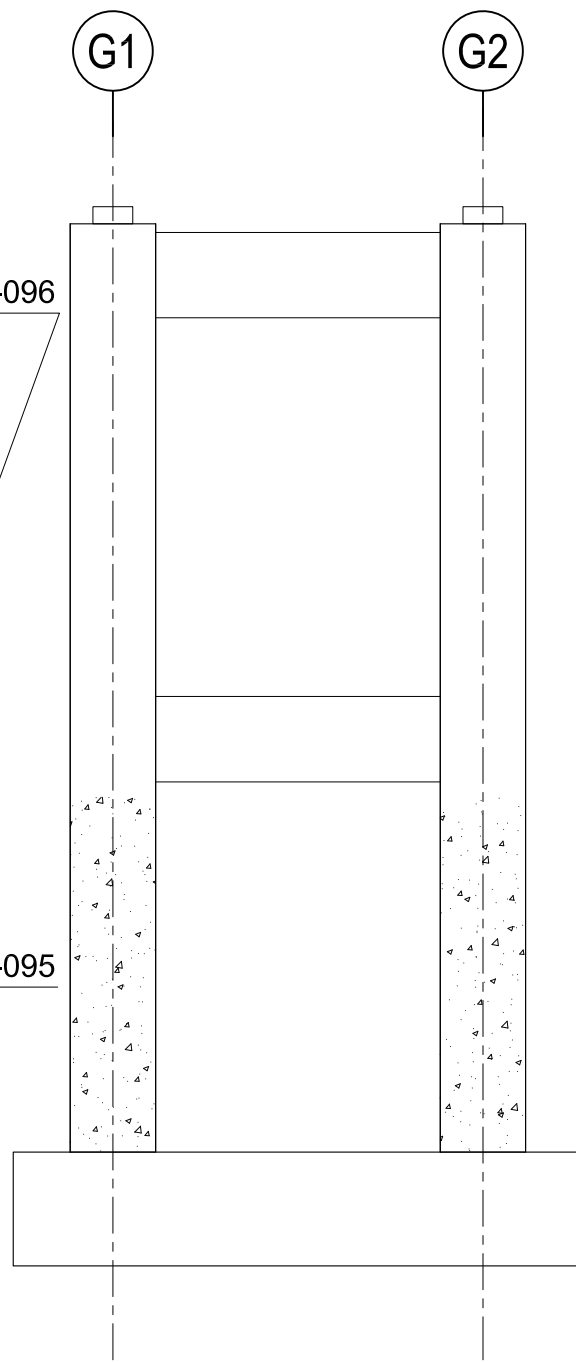
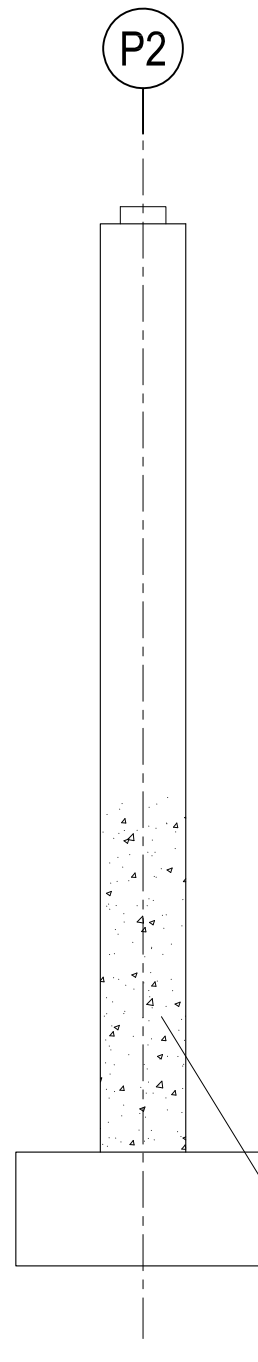
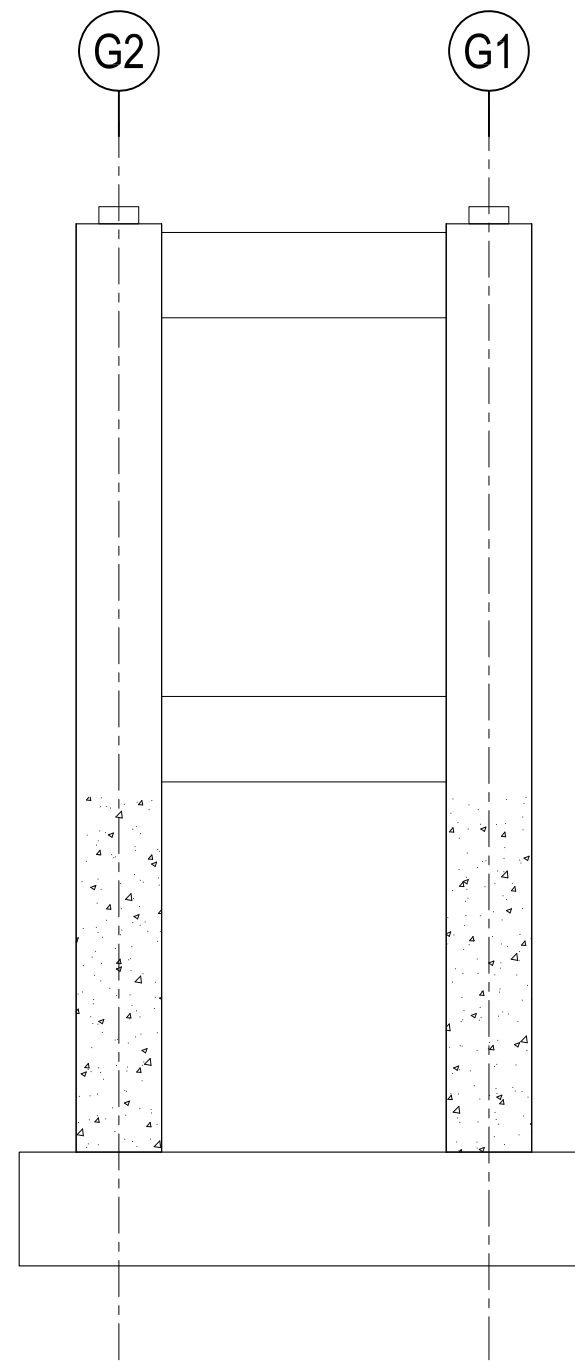
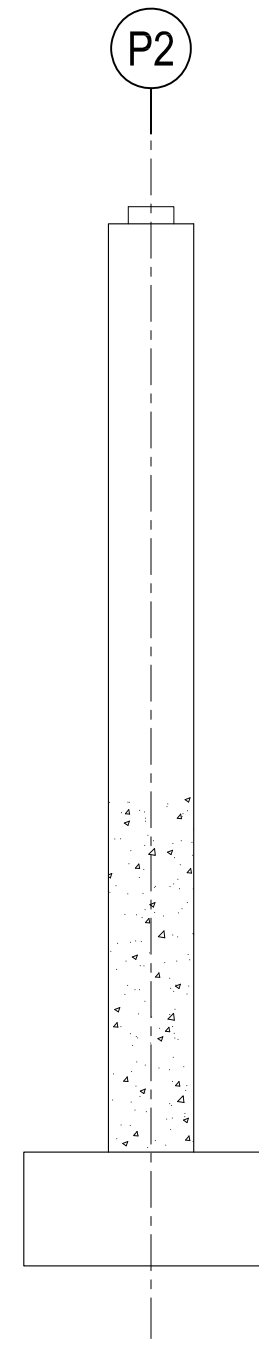
Pier P2 Damage Drawings

Foundation-06: Cracks (D),
W=0.35mm L=2.1m, Photo-091

Bearing Body-01: Corrosion (C), Photo-096
Bearing Body-05: Degradation of
Anticorrosion Performance (C),

Bearing Body-01: Corrosion (C), Photo-095
Bearing Body-05: Degradation of
Anticorrosion Performance (C),

Pier-26: Scouring (C), Photo-092-094
