Damage Photo Data

Inspection date	22-02-22
Road No.	13S	Bridge location (Chainage)	540 Km + 200 m
Road name	NR No.13 South	Bridge location (Province)	Savannakhet
Bridge ID/No.	Unknown	Coordinates (Latitude)	16° 00' 10.17"
Bridge name	Xe Bangnouan	Coordinates (Longitudu)	105° 28' 45.19"

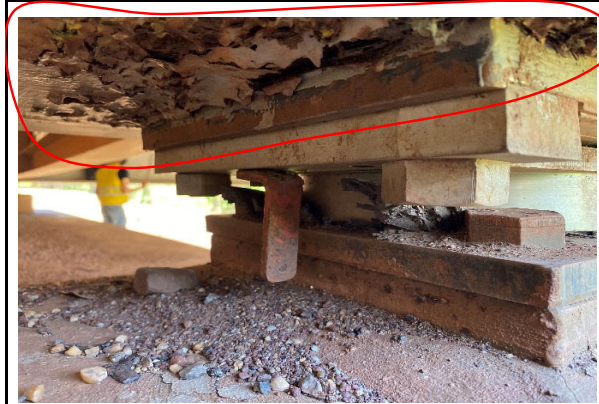
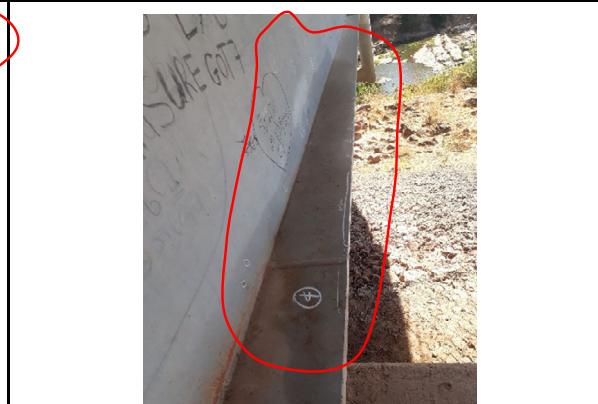
Photo No.	007	Component	Superstructure	Photo No.	008	Component	Superstructure
Element name	Main structure (Girder)			Element name	Main structure (Girder)		
Damage type	01	Damage grade	B	Damage type	01	Damage grade	B

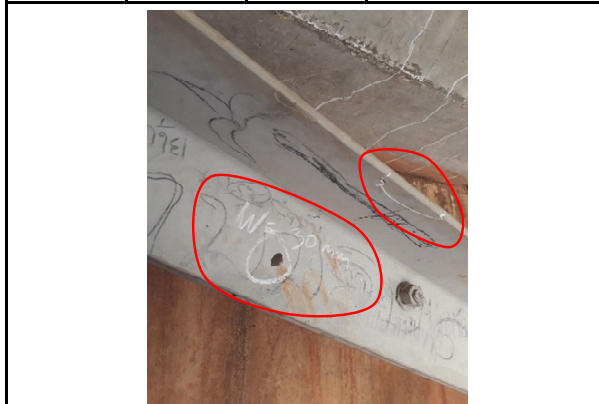
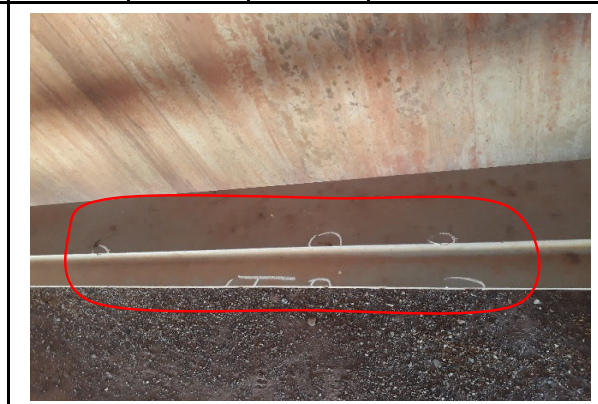
Photo No.	009	Component	Superstructure	Photo No.	010	Component	Superstructure
Element name	Others (Vertical Bracing)			Element name	Others (Vertical Bracing)		
Damage type	01	Damage grade	B	Damage type	01	Damage grade	B

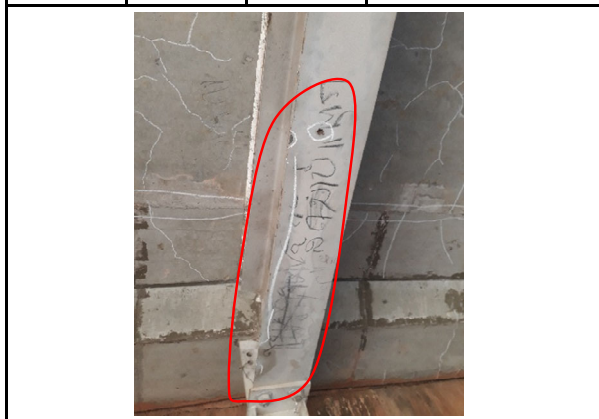
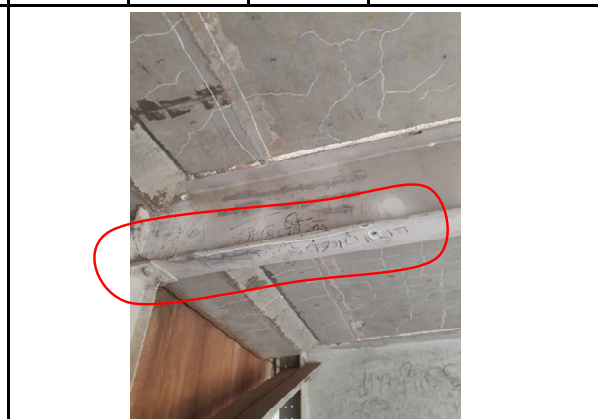
Photo No.	011	Component	Superstructure	Photo No.	012	Component	Superstructure
Element name	Others (Sub Girder)			Element name	Others (Sub Girder)		
Damage type	01	Damage grade	B	Damage type	01	Damage grade	B

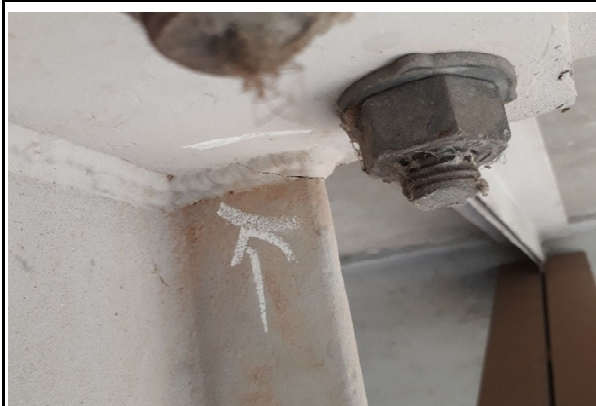
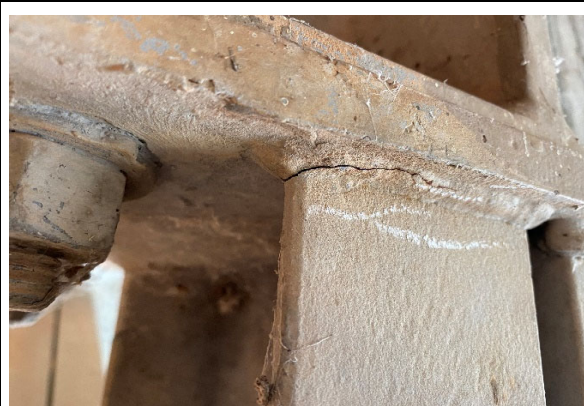
Photo No.	025	Component	Superstructure	Photo No.	026	Component	Superstructure
Element name	Others (Vertical Bracing)			Element name	Others (Vertical Bracing)		
Damage type	02	Damage grade	E	Damage type	02	Damage grade	E

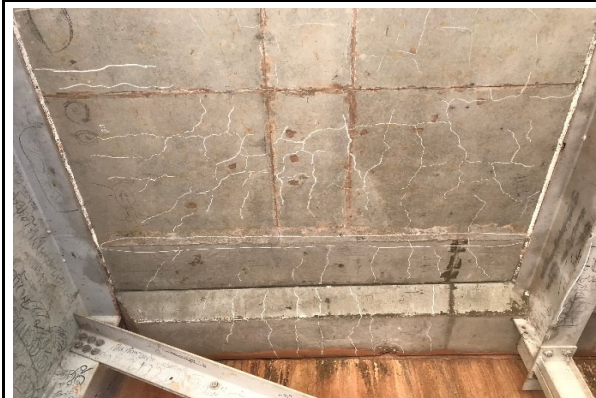
Photo No.	027	Component	Superstructure	Photo No.	028	Component	Superstructure
Element name	Deck			Element name	Deck		
Damage type	11	Damage grade	D	Damage type	11	Damage grade	D

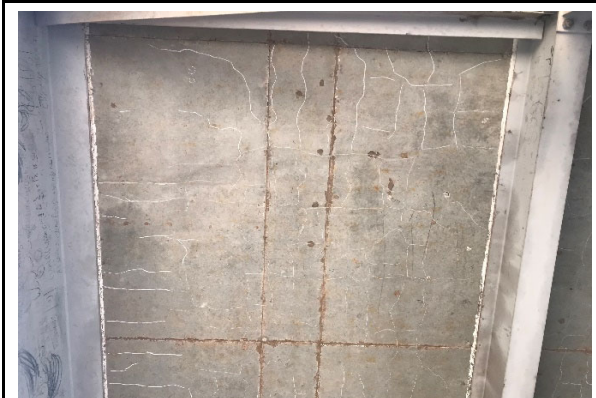
Photo No.	029	Component	Superstructure	Photo No.	030	Component	Superstructure
Element name	Deck			Element name	Deck		
Damage type	11	Damage grade	D	Damage type	11	Damage grade	D

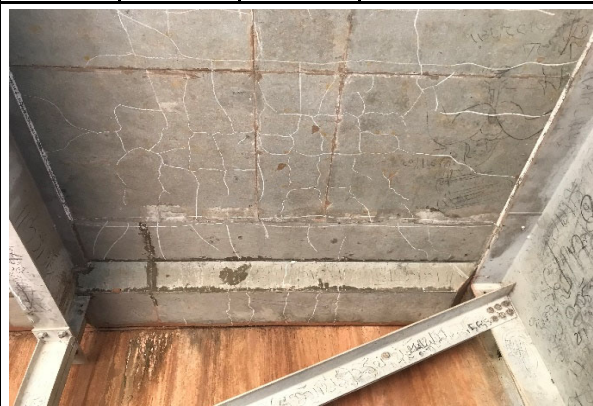
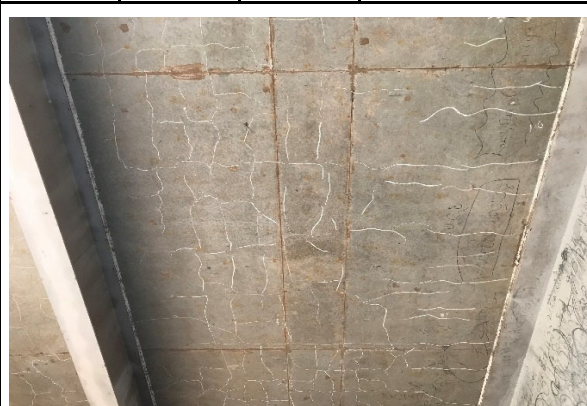
Photo No.	031	Component	Superstructure	Photo No.	032	Component	Superstructure
Element name	Deck			Element name	Deck		
Damage type	11	Damage grade	D	Damage type	11	Damage grade	D

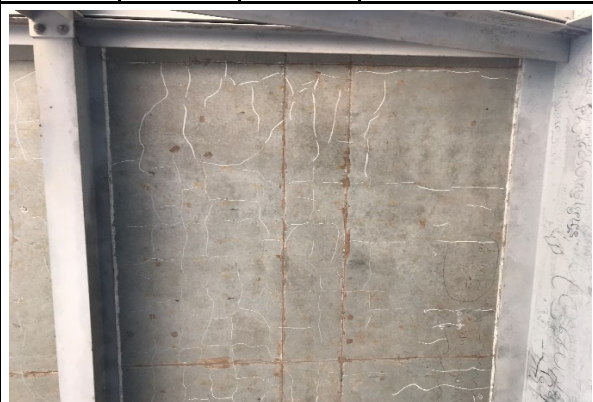
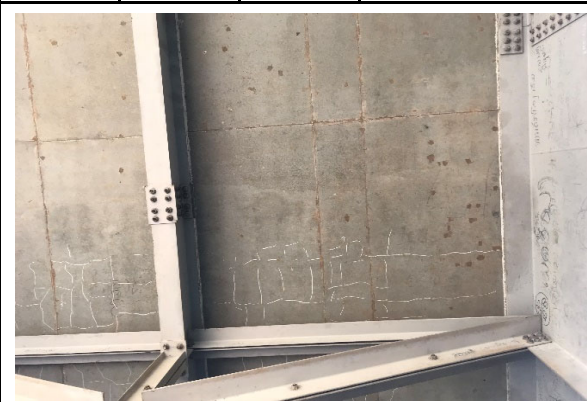
Photo No.	033	Component	Superstructure	Photo No.	034	Component	Superstructure
Element name	Deck			Element name	Deck		
Damage type	11	Damage grade	D	Damage type	11	Damage grade	D

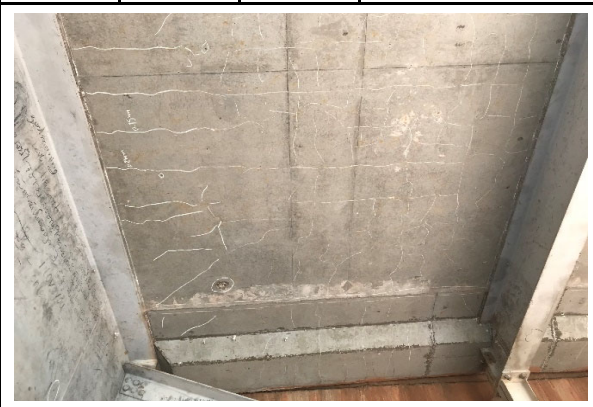
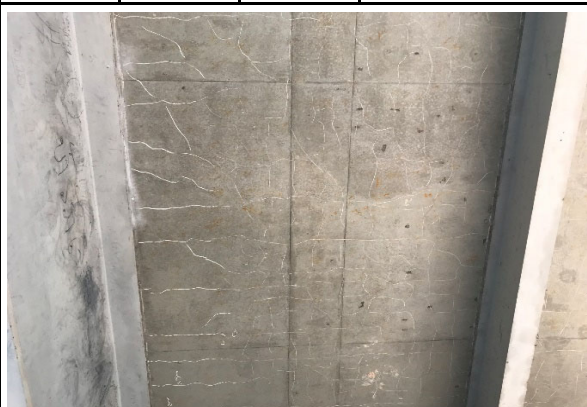
Photo No.	035	Component	Superstructure	Photo No.	036	Component	Superstructure
Element name	Deck			Element name	Deck		
Damage type	11	Damage grade	D	Damage type	11	Damage grade	D

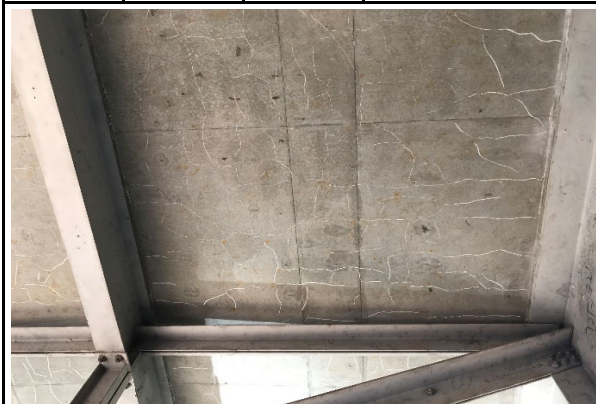
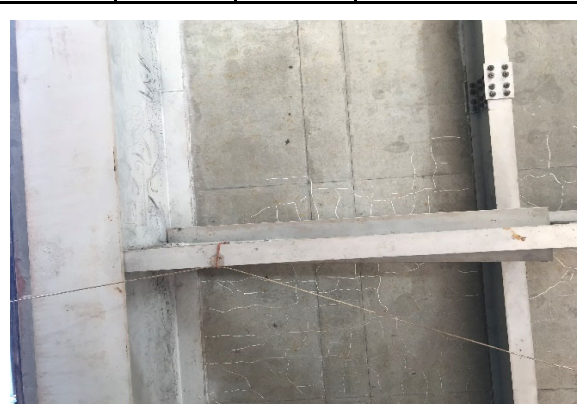
Photo No.	037	Component	Superstructure	Photo No.	038	Component	Superstructure
Element name	Deck			Element name	Deck		
Damage type	11	Damage grade	D	Damage type	11	Damage grade	D

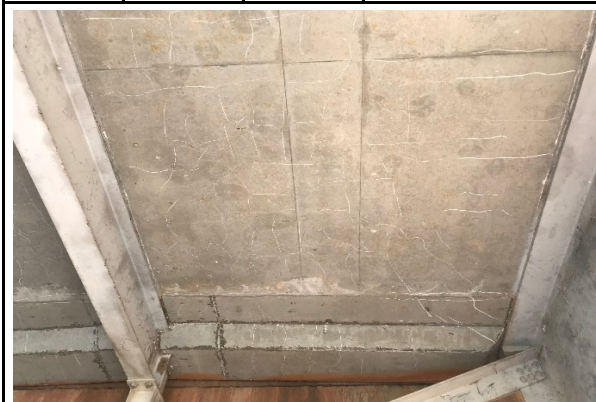
Photo No.	039	Component	Superstructure	Photo No.	040	Component	Superstructure
Element name	Deck			Element name	Deck		
Damage type	11	Damage grade	D	Damage type	11	Damage grade	D

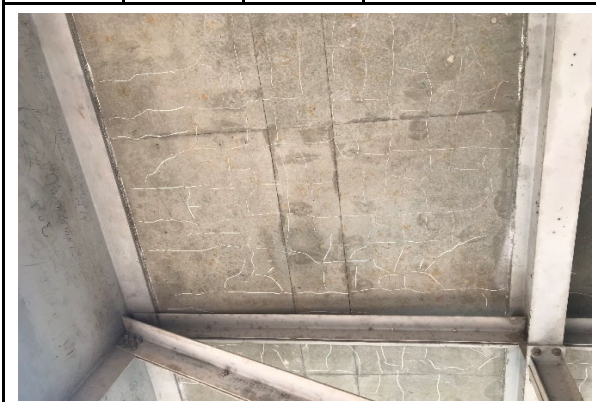
Photo No.	041	Component	Superstructure	Photo No.	042	Component	Superstructure
Element name	Deck			Element name	Deck		
Damage type	11	Damage grade	D	Damage type	11	Damage grade	D

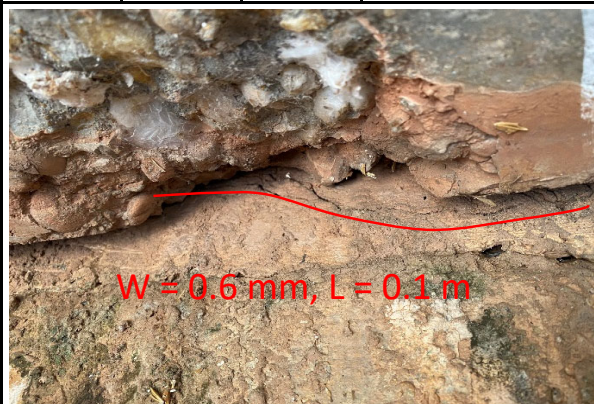
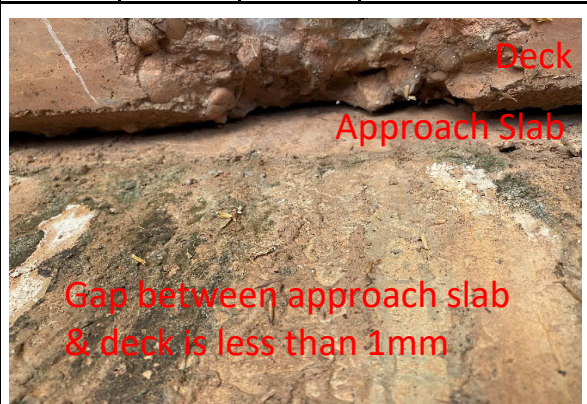
Photo No.	043	Component	Substructure	Photo No.	044	Component	Superstructure
Element name	Approach Slab			Element name	Deck		
Damage type	11	Damage grade	E	Damage type	13	Damage grade	C

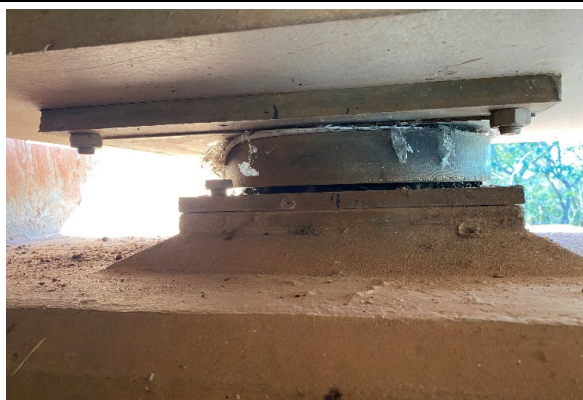
Photo No.	073	Component	Bearing	Photo No.	074	Component	Bearing
Element name	Bearing Body			Element name	Bearing Body		
Damage type	05	Damage grade	C	Damage type	17	Damage grade	E

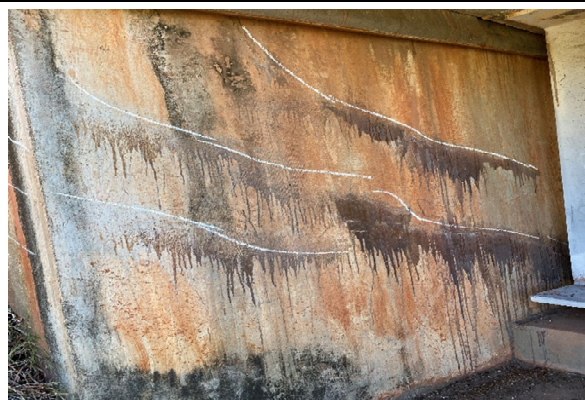
Photo No.	079	Component	Substructure	Photo No.	080	Component	Substructure
Element name Abutment A2, Parapet Wall				Element name Abutment A2, Parapet Wall			
Damage type	06	Damage grade	D	Damage type	06	Damage grade	D

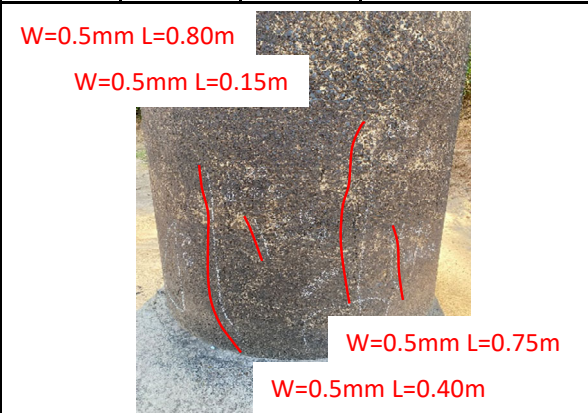
Photo No.	085	Component	Substructure	Photo No.	086	Component	Substructure
Element name	Pier, P1			Element name	Pier, P1		
Damage type	06	Damage grade	C	Damage type	06	Damage grade	E

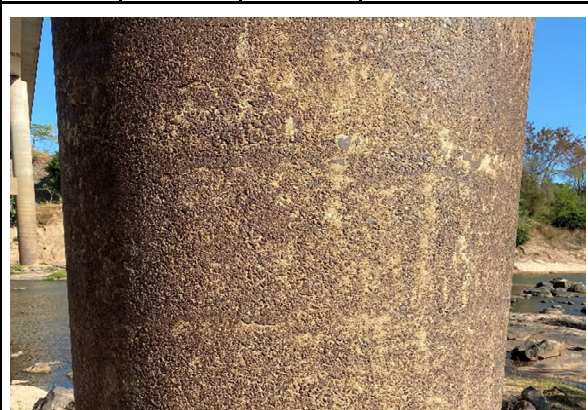
Photo No.	087	Component	Substructure	Photo No.	088	Component	Substructure
Element name	Foundation, P1			Element name	Pier, P1		
Damage type	06	Damage grade	E	Damage type	26	Damage grade	C

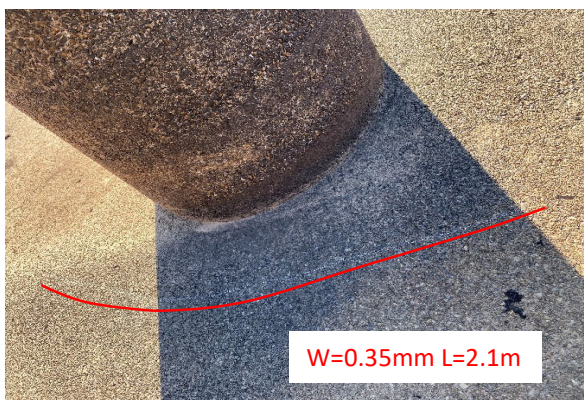
Photo No.	091	Component	Substructure	Photo No.	092	Component	Substructure
Element name	Foundation, P2			Element name	Pier, P2		
Damage type	06	Damage grade	D	Damage type	26	Damage grade	C

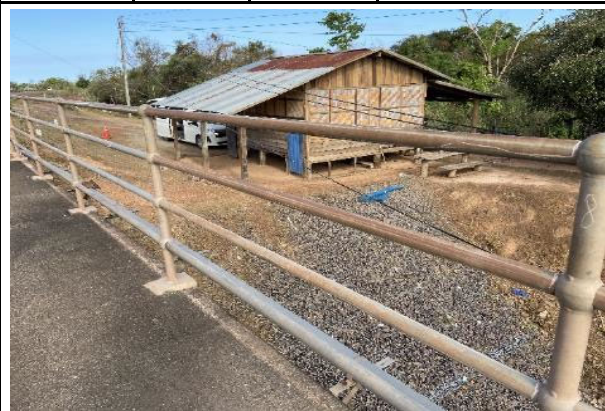
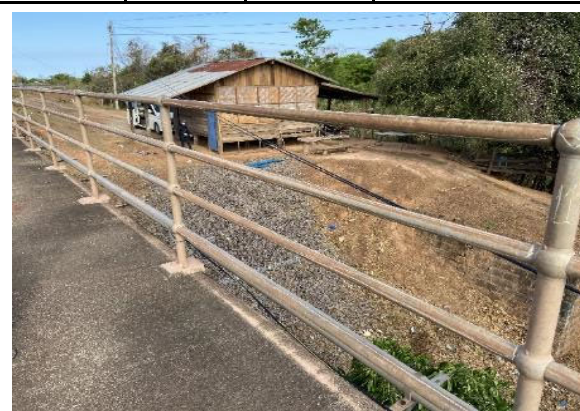
Photo No.	097	Component	On the road	Photo No.	098	Component	On the road
Element name	Railling			Element name	Railling		
Damage type	01	Damage grade	C	Damage type	01	Damage grade	C

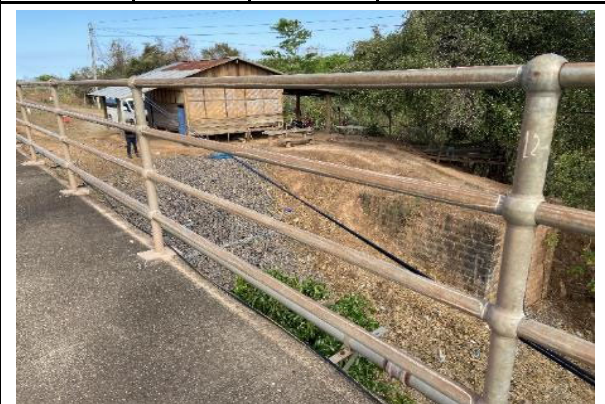
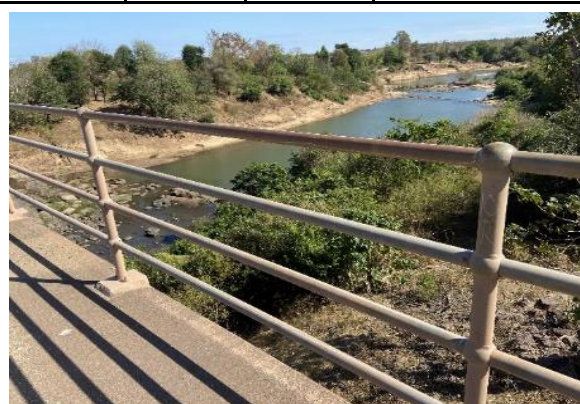
Photo No.	099	Component	On the road	Photo No.	100	Component	On the road
Element name	Railling			Element name	Railling		
Damage type	01	Damage grade	C	Damage type	01	Damage grade	C

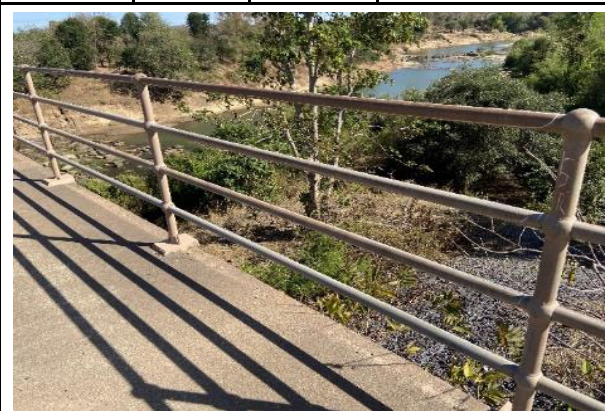
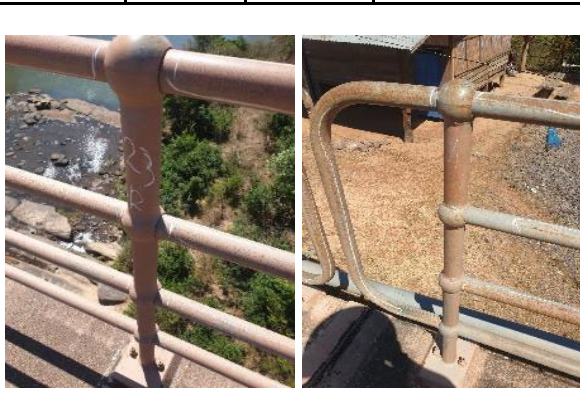
Photo No.	101	Component	On the road	Photo No.	102	Component	On the road
Element name	Railling			Element name	Railling		
Damage type	01	Damage grade	C	Damage type	01	Damage grade	C

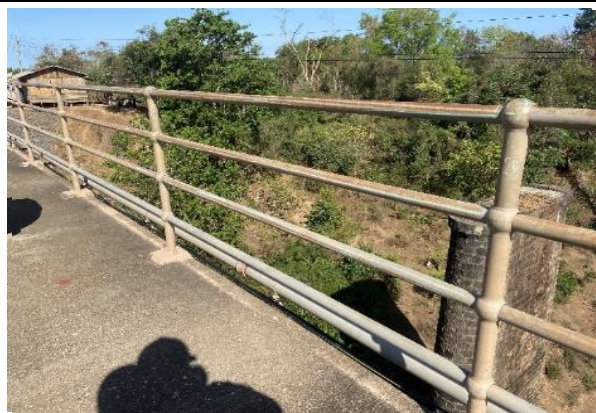
Photo No.	103	Component	On the road	Photo No.	104	Component	On the road
Element name	Railling			Element name	Railling		
Damage type	01	Damage grade	C	Damage type	01	Damage grade	C

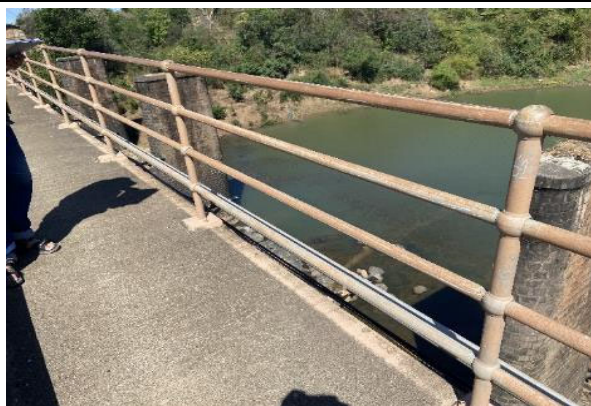
Photo No.	109	Component	On the road	Photo No.	110	Component	On the road
Element name	Railling			Element name	Railling		
Damage type	01	Damage grade	C	Damage type	01	Damage grade	C

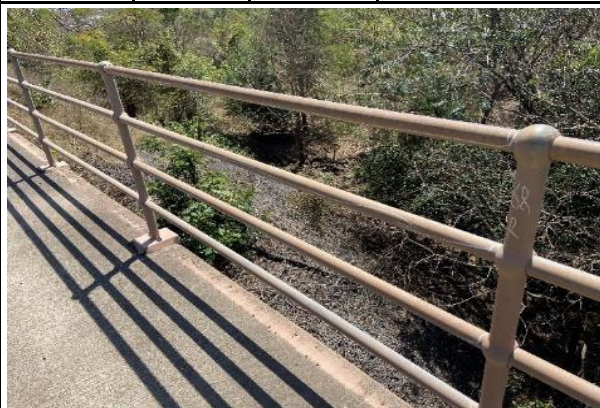
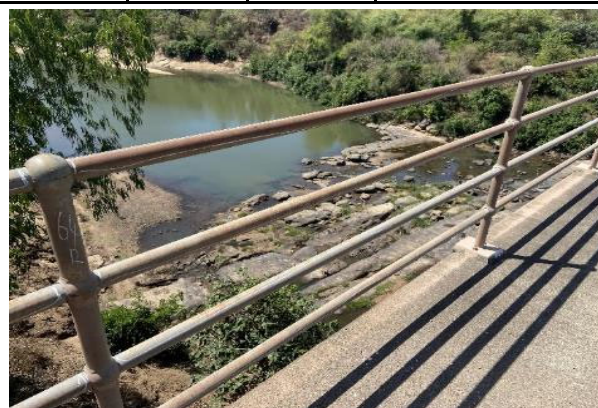
Photo No.	111	Component	On the road	Photo No.	112	Component	On the road
Element name	Railling			Element name	Railling		
Damage type	01	Damage grade	C	Damage type	01	Damage grade	C

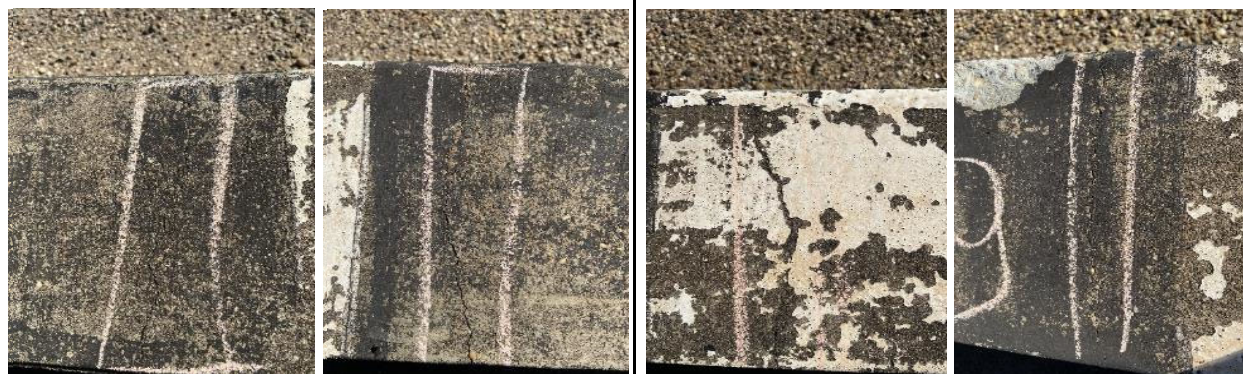
Photo No.	115	Component	On the road	Photo No.	116	Component	On the road
Element name	Wheel Guard			Element name	Wheel Guard		
Damage type	06	Damage grade	E	Damage type	06	Damage grade	E

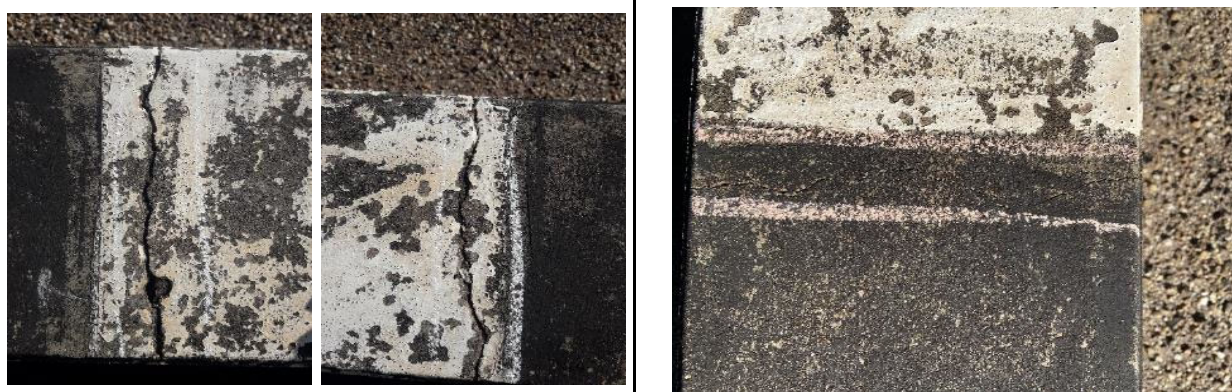
Photo No.	117	Component	On the road	Photo No.	118	Component	On the road
Element name	Wheel Guard			Element name	Wheel Guard		
Damage type	06	Damage grade	E	Damage type	06	Damage grade	E

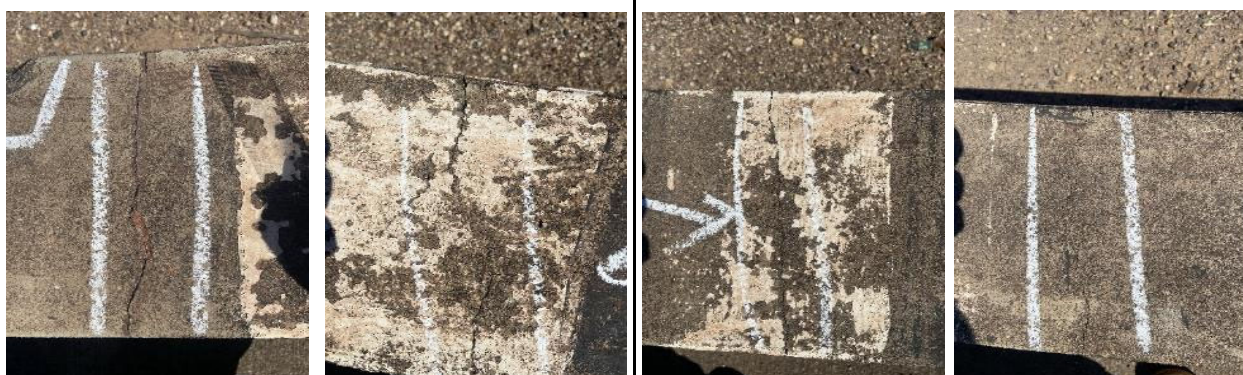
Photo No.	119	Component	On the road	Photo No.	120	Component	On the road
Element name	Wheel Guard			Element name	Wheel Guard		
Damage type	06	Damage grade	E	Damage type	06	Damage grade	E

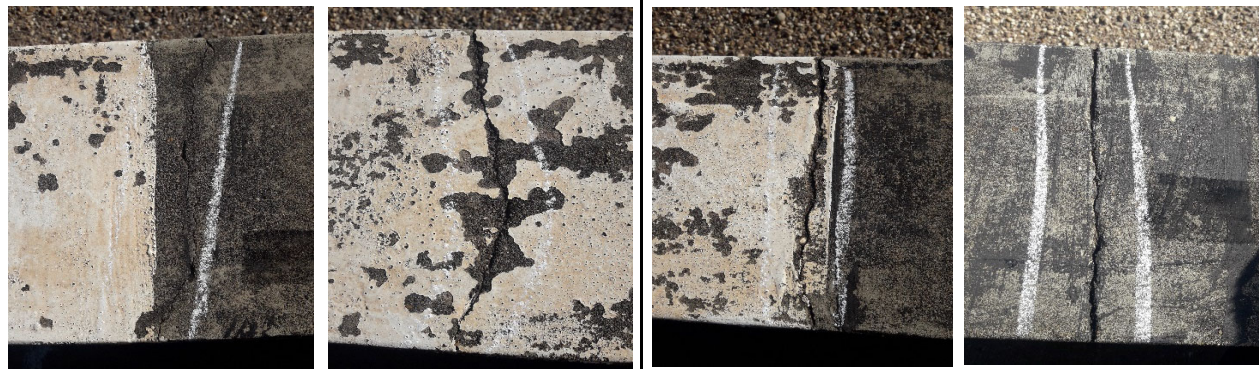
Photo No.	121	Component	On the road	Photo No.	122	Component	On the road
Element name	Wheel Guard			Element name	Wheel Guard		
Damage type	06	Damage grade	E	Damage type	06	Damage grade	E

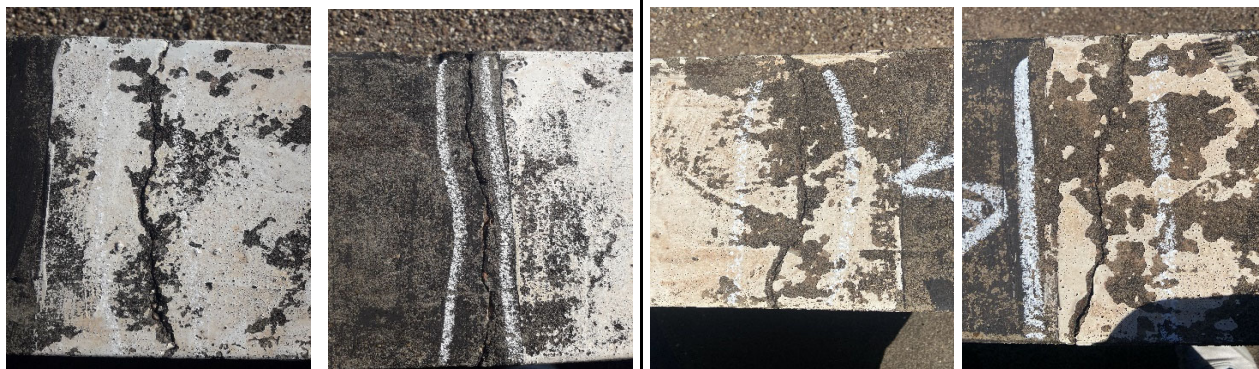
Photo No.	123	Component	On the road	Photo No.	124	Component	On the road
Element name	Wheel Guard			Element name	Wheel Guard		
Damage type	06	Damage grade	E	Damage type	06	Damage grade	E

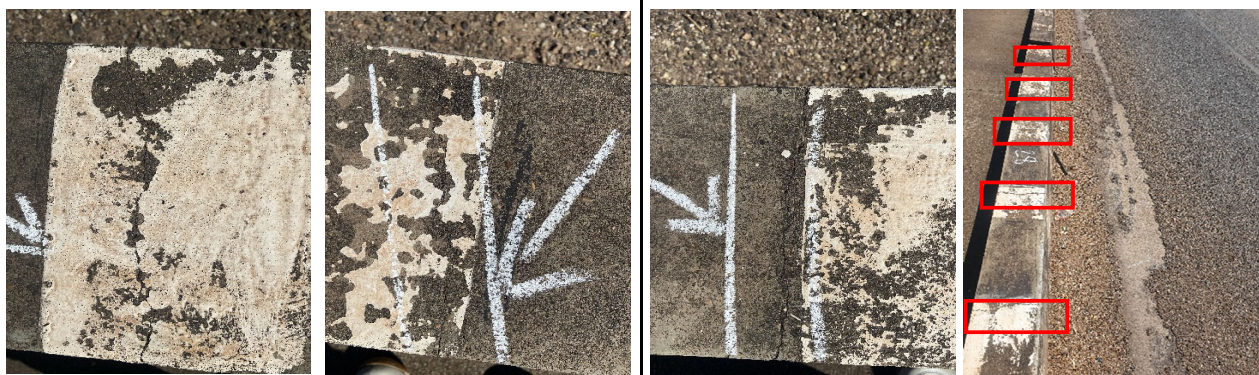
Photo No.	125	Component	On the road	Photo No.	126	Component	On the road
Element name	Wheel Guard			Element name	Wheel Guard		
Damage type	06	Damage grade	E	Damage type	06	Damage grade	E

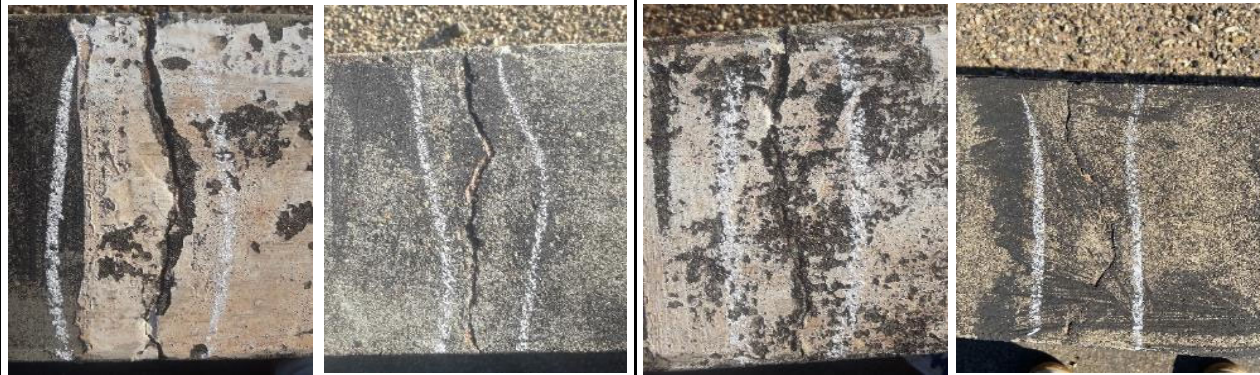
Photo No.	127	Component	On the road	Photo No.	128	Component	On the road
Element name	Wheel Guard			Element name	Wheel Guard		
Damage type	06	Damage grade	E	Damage type	06	Damage grade	E

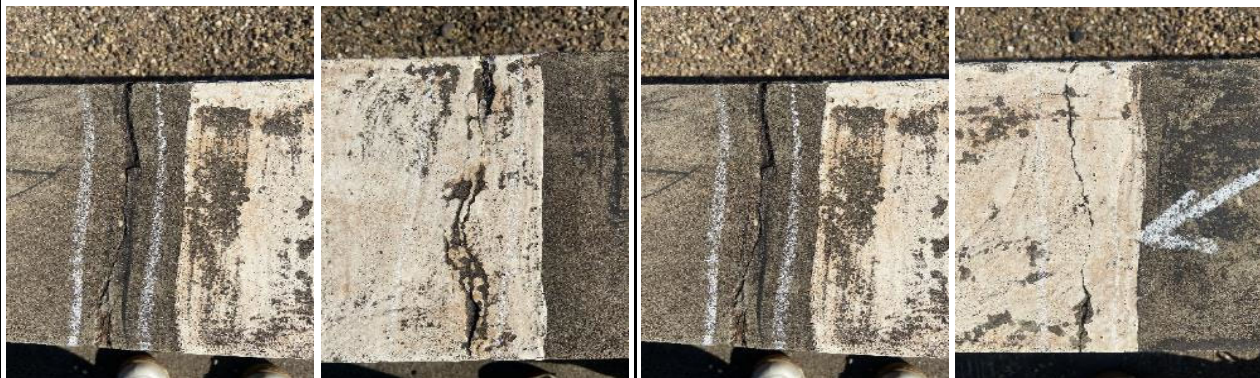
Photo No.	129	Component	On the road	Photo No.	130	Component	On the road
Element name	Wheel Guard			Element name	Wheel Guard		
Damage type	06	Damage grade	E	Damage type	06	Damage grade	E

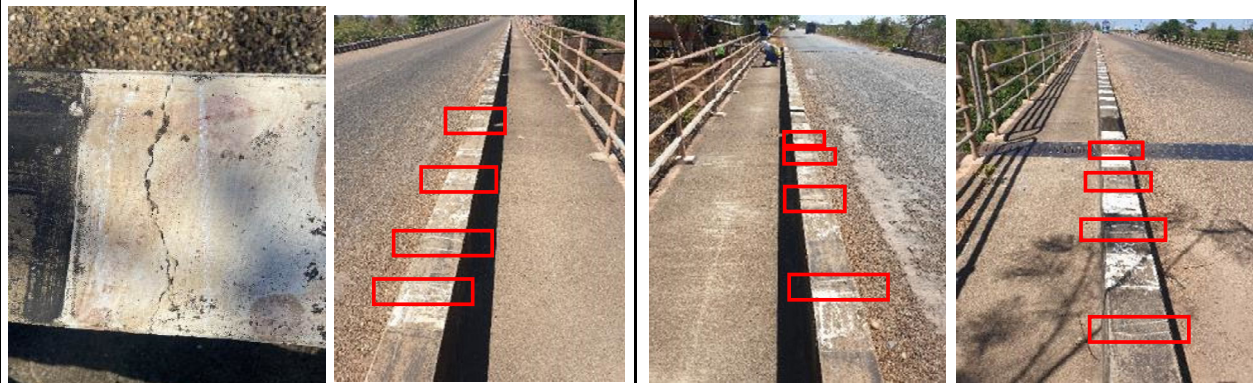
Photo No.	131	Component	On the road	Photo No.	132	Component	On the road
Element name	Wheel Guard			Element name	Wheel Guard		
Damage type	06	Damage grade	E	Damage type	06	Damage grade	E

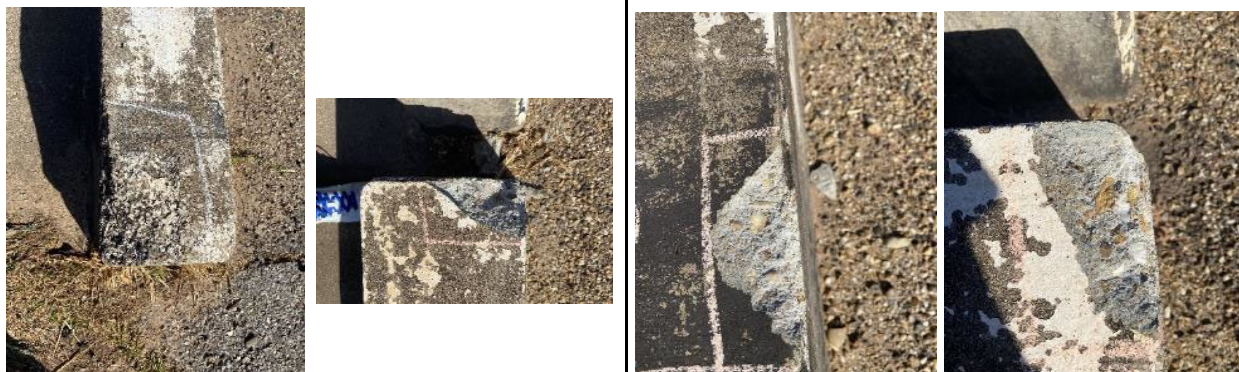
Photo No.	133	Component	On the road	Photo No.	134	Component	On the road
Element name	Wheel Guard			Element name	Wheel Guard		
Damage type	07	Damage grade	C	Damage type	07	Damage grade	C

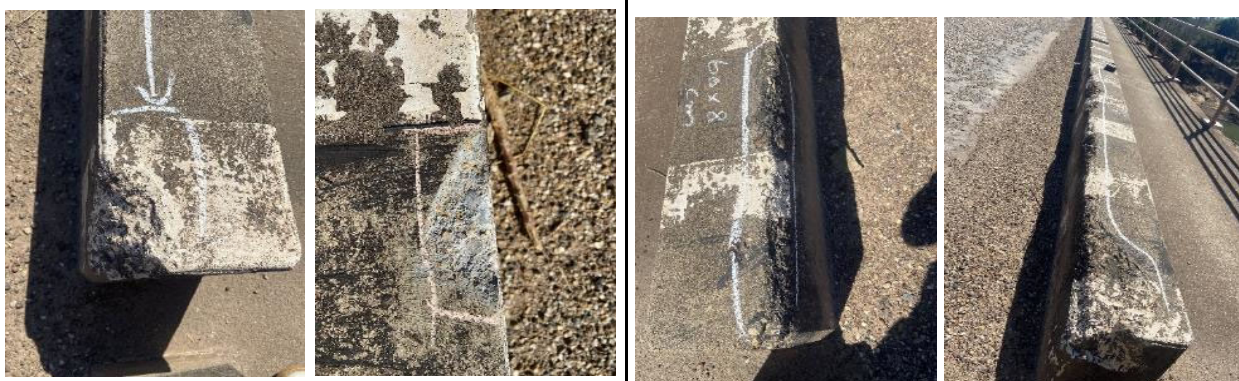
Photo No.	135	Component	On the road	Photo No.	136	Component	On the road
Element name	Wheel Guard			Element name	Wheel Guard		
Damage type	07	Damage grade	C	Damage type	07	Damage grade	C

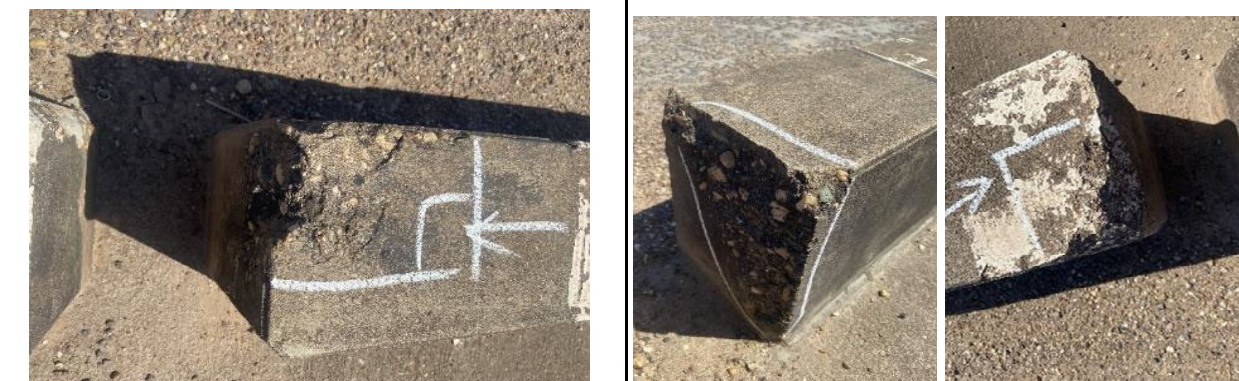
Photo No.	137	Component	On the road	Photo No.	138	Component	On the road
Element name	Wheel Guard			Element name	Wheel Guard		
Damage type	07	Damage grade	C	Damage type	07	Damage grade	C

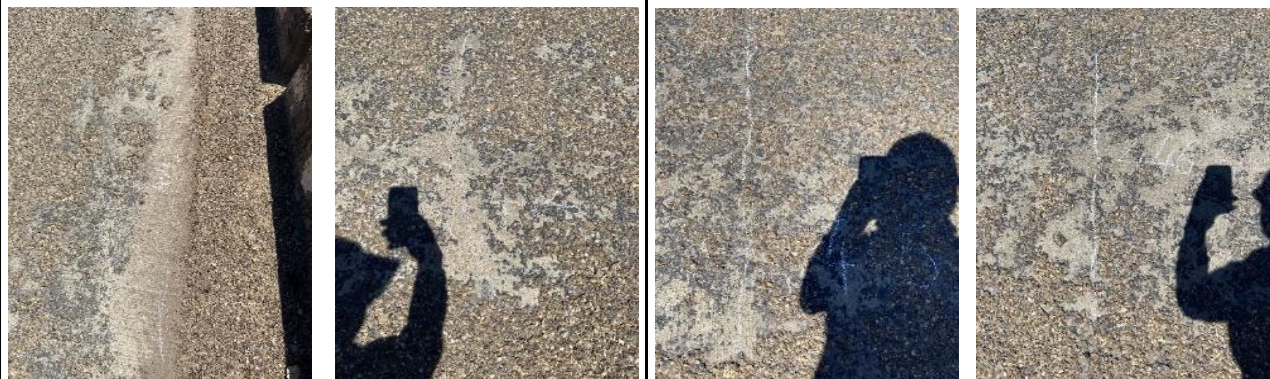
Photo No.	145	Component	Superstructure	Photo No.	146	Component	Superstructure
Element name	Deck			Element name	Deck		
Damage type	11	Damage grade	E	Damage type	11	Damage grade	E

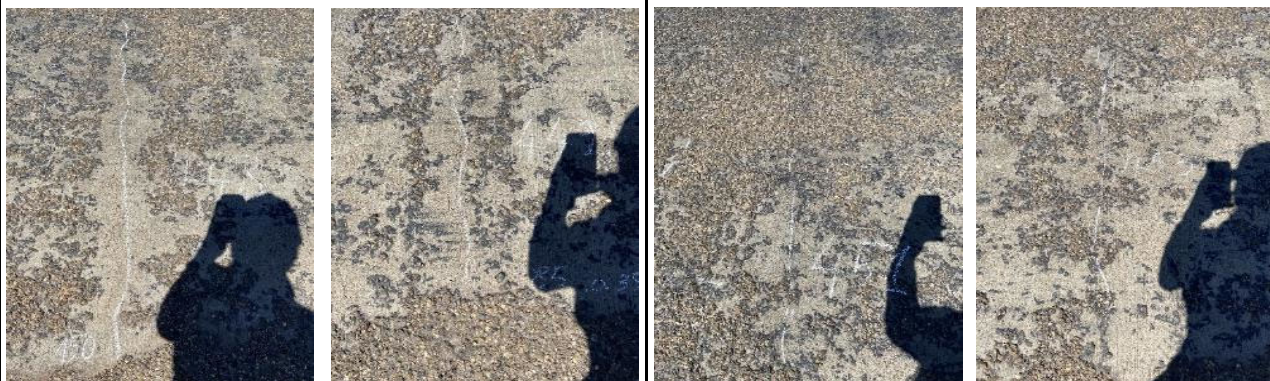
Photo No.	147	Component	Superstructure	Photo No.	148	Component	Superstructure
Element name	Deck			Element name	Deck		
Damage type	11	Damage grade	E	Damage type	11	Damage grade	E

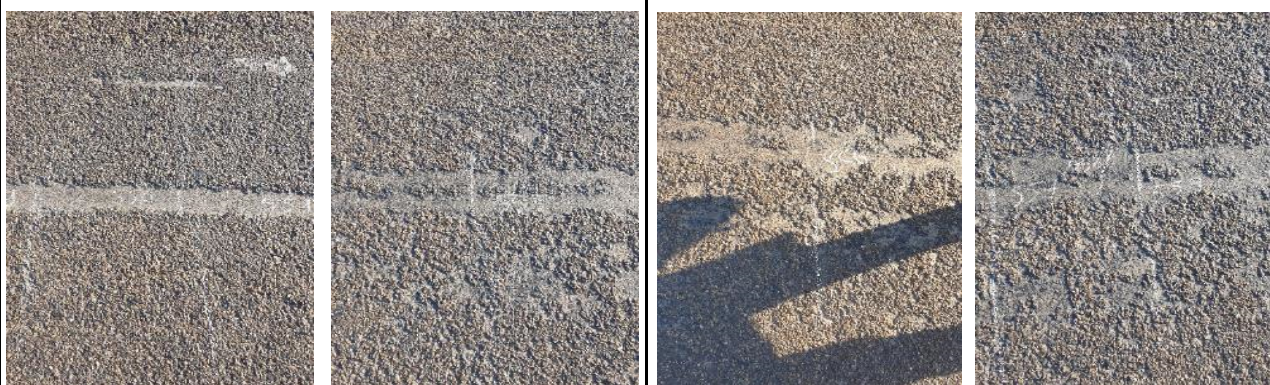
Photo No.	149	Component	Superstructure	Photo No.	150	Component	Superstructure
Element name	Deck			Element name	Deck		
Damage type	11	Damage grade	E	Damage type	11	Damage grade	E

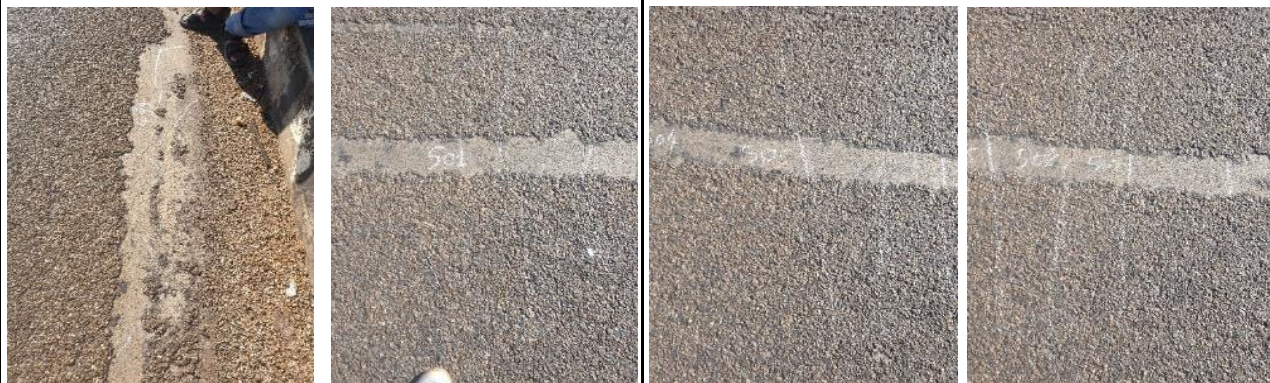
Photo No.	151	Component	Superstructure	Photo No.	152	Component	Superstructure
Element name	Deck			Element name	Deck		
Damage type	11	Damage grade	E	Damage type	11	Damage grade	E

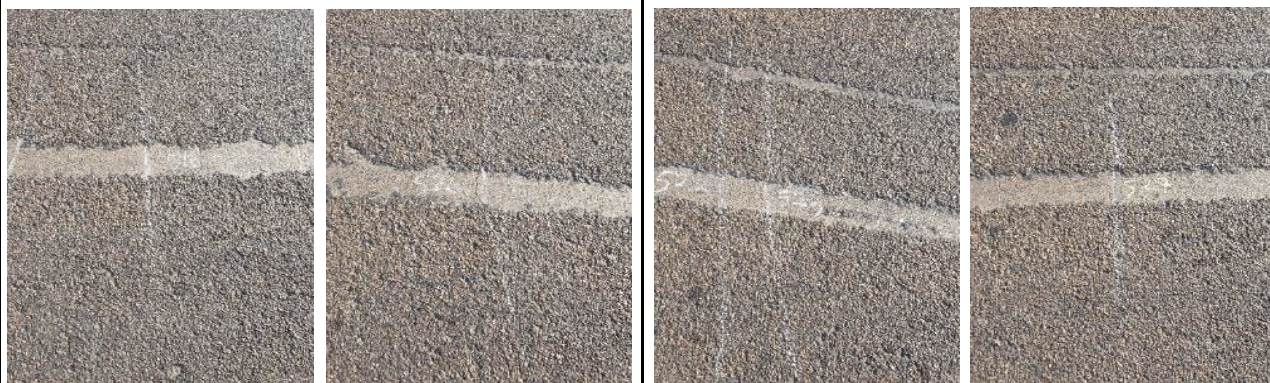
Photo No.	153	Component	Superstructure	Photo No.	154	Component	Superstructure
Element name	Deck			Element name	Deck		
Damage type	11	Damage grade	E	Damage type	11	Damage grade	E

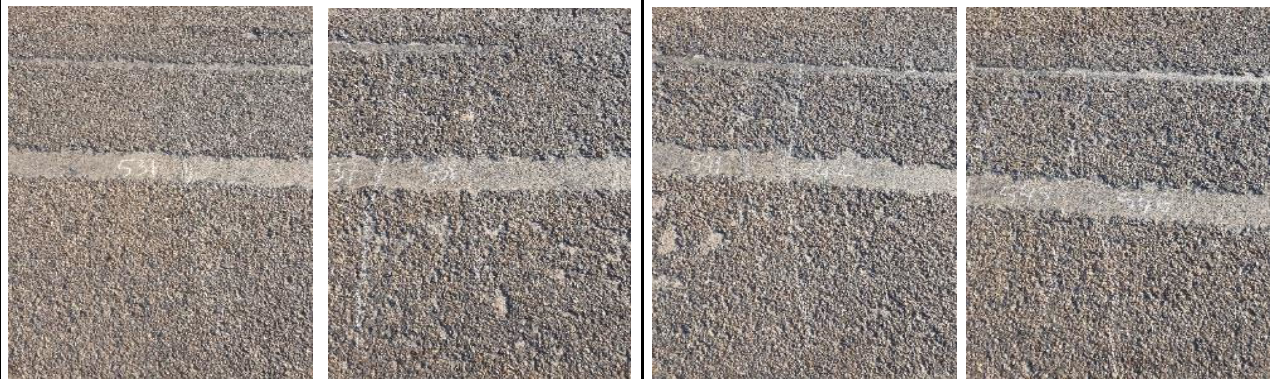
Photo No.	155	Component	Superstructure	Photo No.	156	Component	Superstructure
Element name	Deck			Element name	Deck		
Damage type	11	Damage grade	E	Damage type	11	Damage grade	E

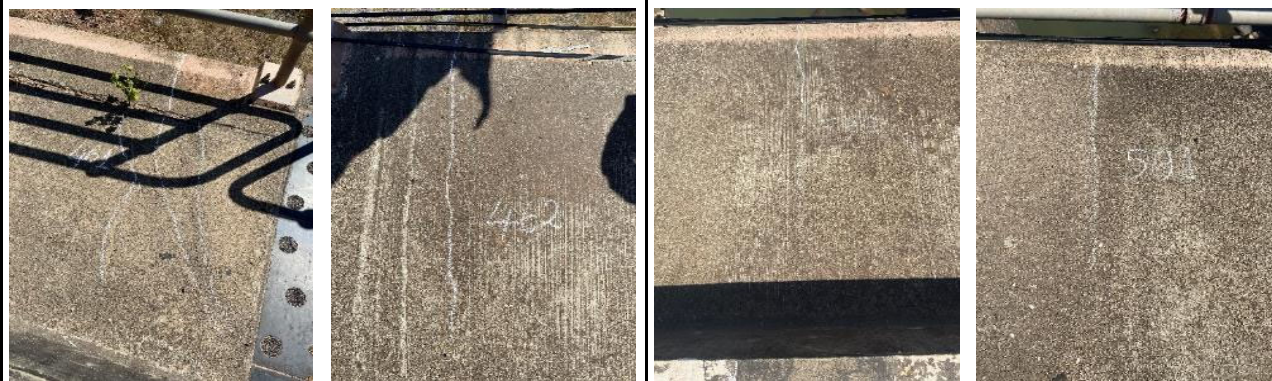
Photo No.	157	Component	Walkway	Photo No.	158	Component	Walkway
Element name	Slab			Element name	Slab		
Damage type	11	Damage grade	E	Damage type	11	Damage grade	E

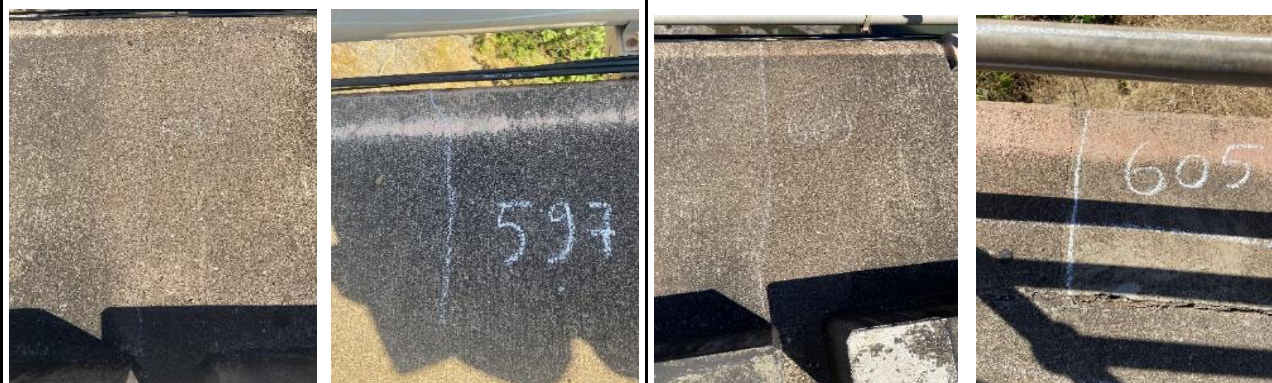
Photo No.	159	Component	Walkway	Photo No.	160	Component	Walkway
Element name	Slab			Element name	Slab		
Damage type	11	Damage grade	E	Damage type	11	Damage grade	E

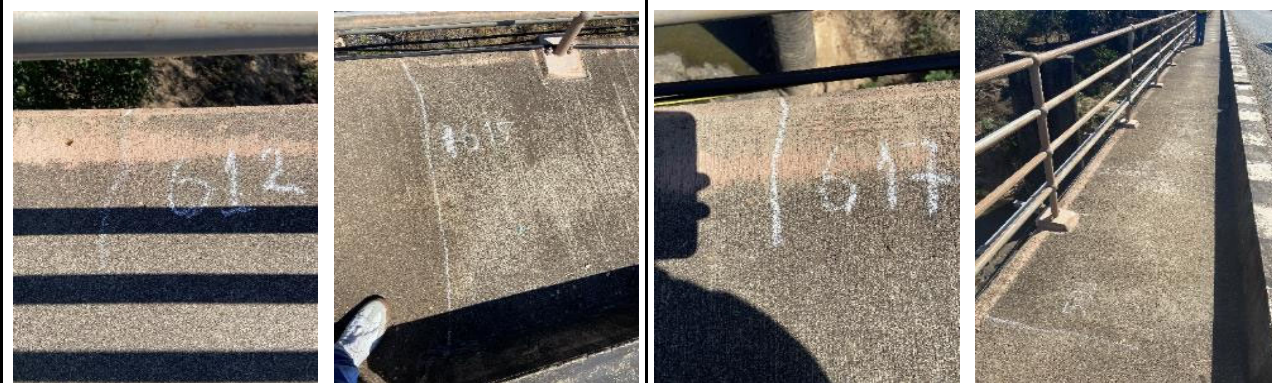
Photo No.	161	Component	Walkway	Photo No.	162	Component	Walkway
Element name	Slab			Element name	Slab		
Damage type	11	Damage grade	E	Damage type	11	Damage grade	E

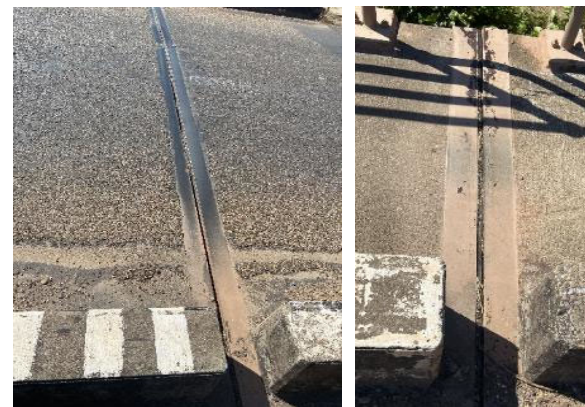
Photo No.	163	Component	Road surface	Photo No.	164	Component	Road surface
Element name	Expansion Joint			Element name	Expansion Joint		
Damage type	14	Damage grade	E	Damage type	14	Damage grade	E

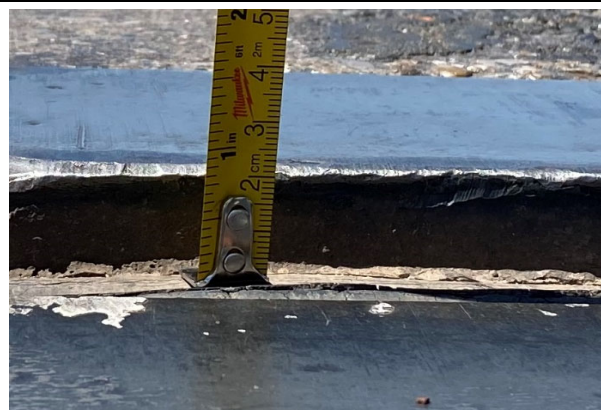
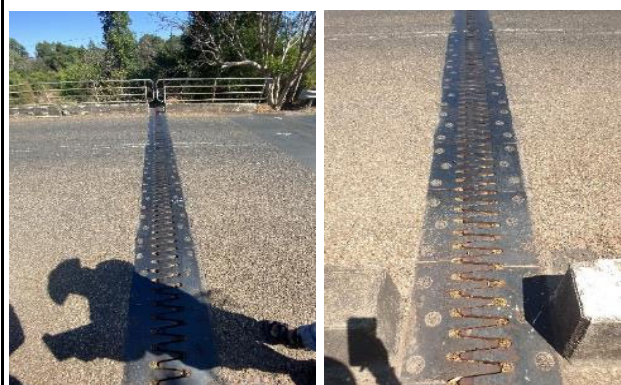
Photo No.	165	Component	Road surface	Photo No.	166	Component	Road surface
Element name	Expansion Joint			Element name	Expansion Joint		
Damage type	14	Damage grade	E	Damage type	14	Damage grade	C

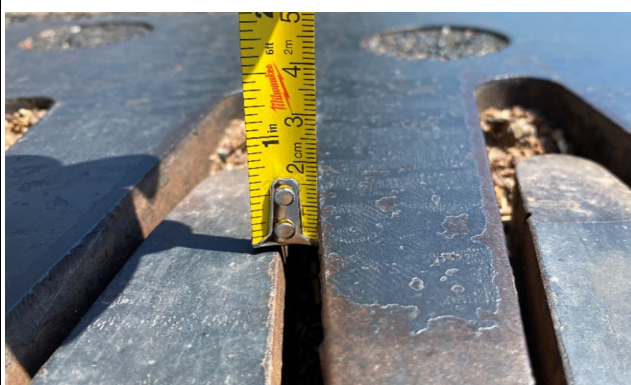
Photo No.	167	Component	Road surface	Photo No.	168	Component	Road surface
Element name	Expansion Joint			Element name	Expansion Joint		
Damage type	14	Damage grade	C	Damage type	14	Damage grade	C

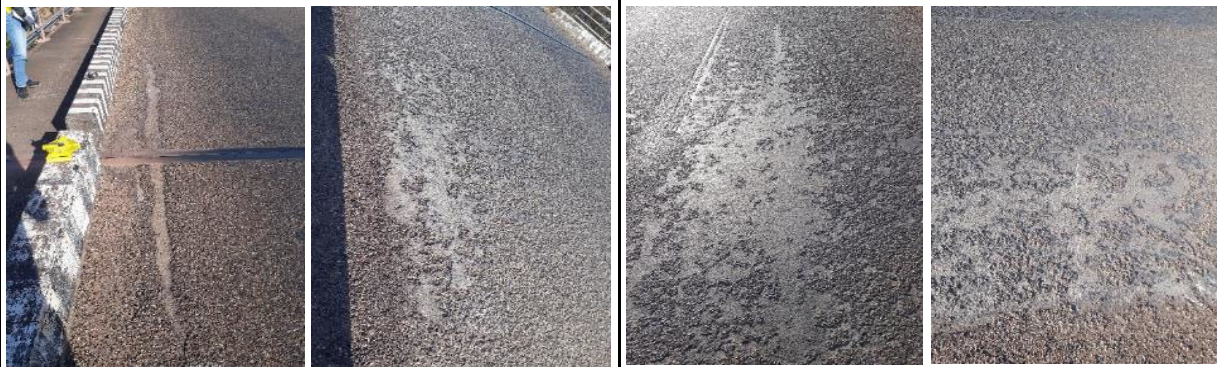
Photo No.	169	Component	Road surface	Photo No.	170	Component	Road surface
Element name	Pavement			Element name	Pavement		
Damage type	14	Damage grade	C	Damage type	14	Damage grade	C
