Damage Photo Data

Inspection date	22-02-22
Road No.	13S	Bridge location (Chainage)	540 Km + 200 m
Road name	NR No.13 South	Bridge location (Province)	Savannakhet
Bridge ID/No.	Unknown	Coordinates (Latitude)	16° 00' 10.17"
Bridge name	Xe Bangnouan	Coordinates (Longitudu)	105° 28' 45.19"

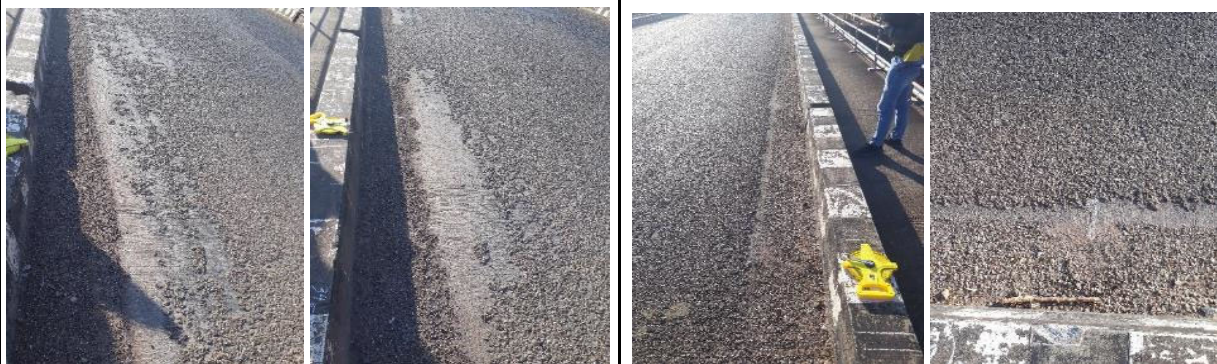
Photo No.	171	Component	Road surface	Photo No.	172	Component	Road surface
Element name	Pavement			Element name	Pavement		
Damage type	14	Damage grade	C	Damage type	14	Damage grade	C

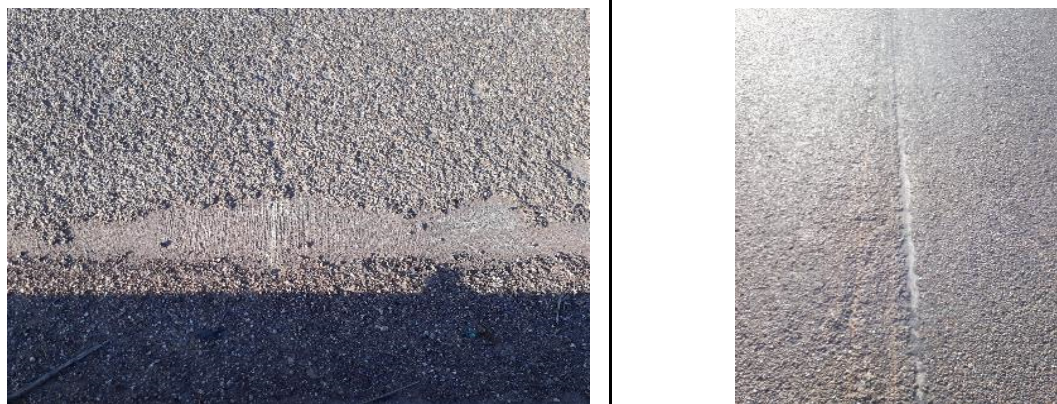
Photo No.	173	Component	Road surface	Photo No.	174	Component	Road surface
Element name	Pavement			Element name	Pavement		
Damage type	14	Damage grade	C	Damage type	14	Damage grade	C

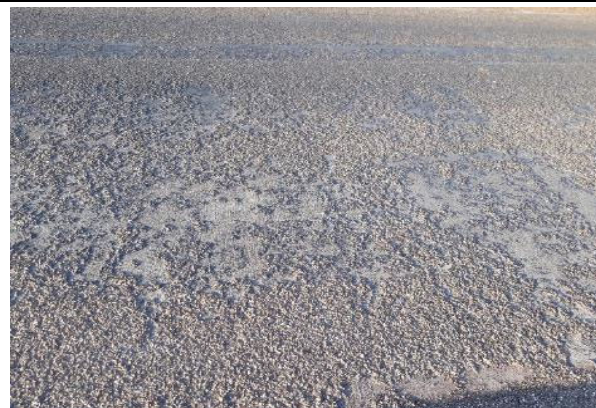
Photo No.	183	Component	Road surface	Photo No.	184	Component	Road surface
Element name	Pavement			Element name	Pavement		
Damage type	14	Damage grade	C	Damage type	14	Damage grade	C

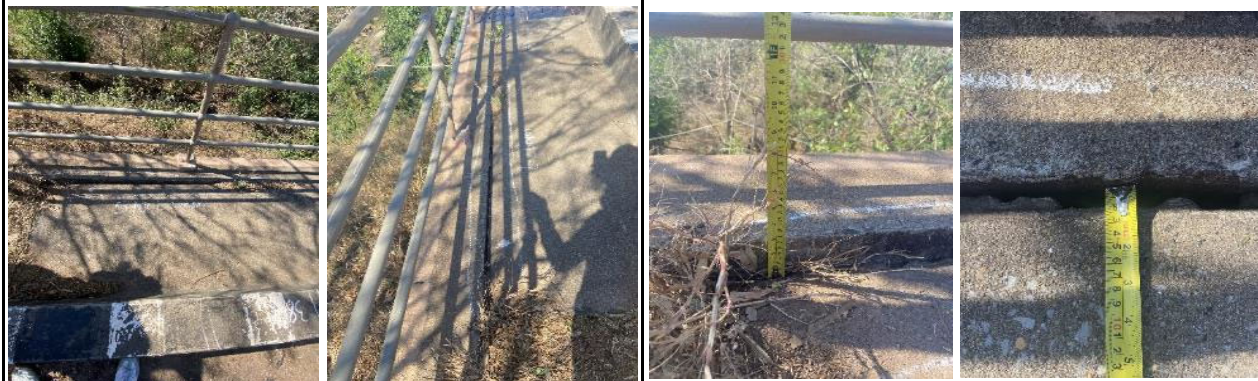
Photo No.	193	Component	Others	Photo No.	194	Component	Others
Element name	Approach Slab			Element name	Approach Slab		
Damage type	17	Damage grade	E	Damage type	17	Damage grade	E

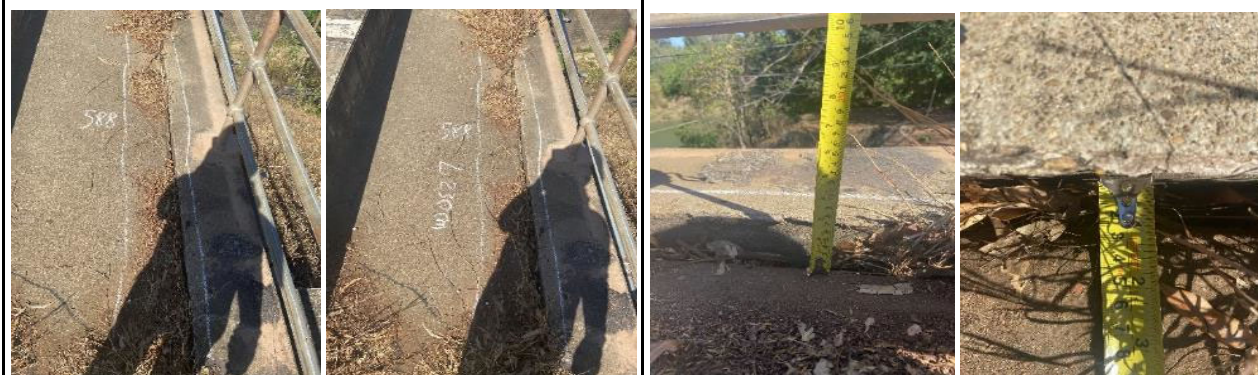
Photo No.	195	Component	Others	Photo No.	196	Component	Others
Element name	Approach Slab			Element name	Approach Slab		
Damage type	17	Damage grade	E	Damage type	17	Damage grade	E

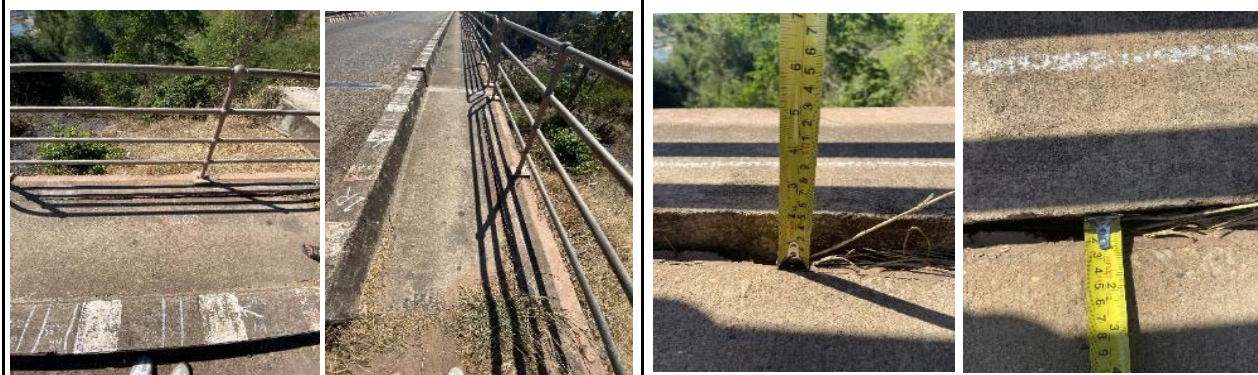
Photo No.	197	Component	Others	Photo No.	198	Component	Others
Element name	Approach Slab			Element name	Approach Slab		
Damage type	17	Damage grade	E	Damage type	17	Damage grade	E

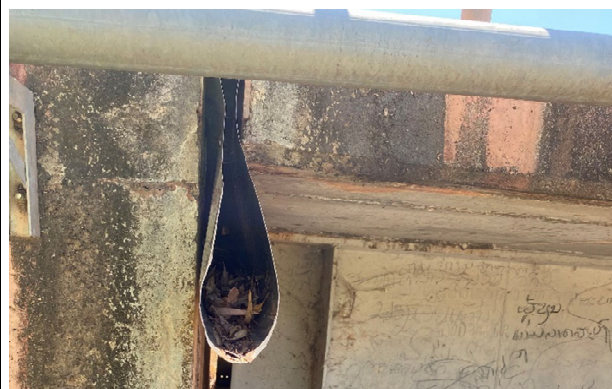
Photo No.	201	Component	Others	Photo No.	202	Component	Road surface
Element name	Approach Slab			Element name	Expansion Joint		
Damage type	17	Damage grade	E	Damage type	24	Damage grade	E
