**NR 13 NORTH IMPROVEMENT AND MAINTENANCE PROJECT**  
**(SIKEUTH JUNCTION – PHONHONG)**

**PART III**  
**REPORT ON PAVEMENT INVESTIGATION**

**PROJECT CODE : SD-262-17**

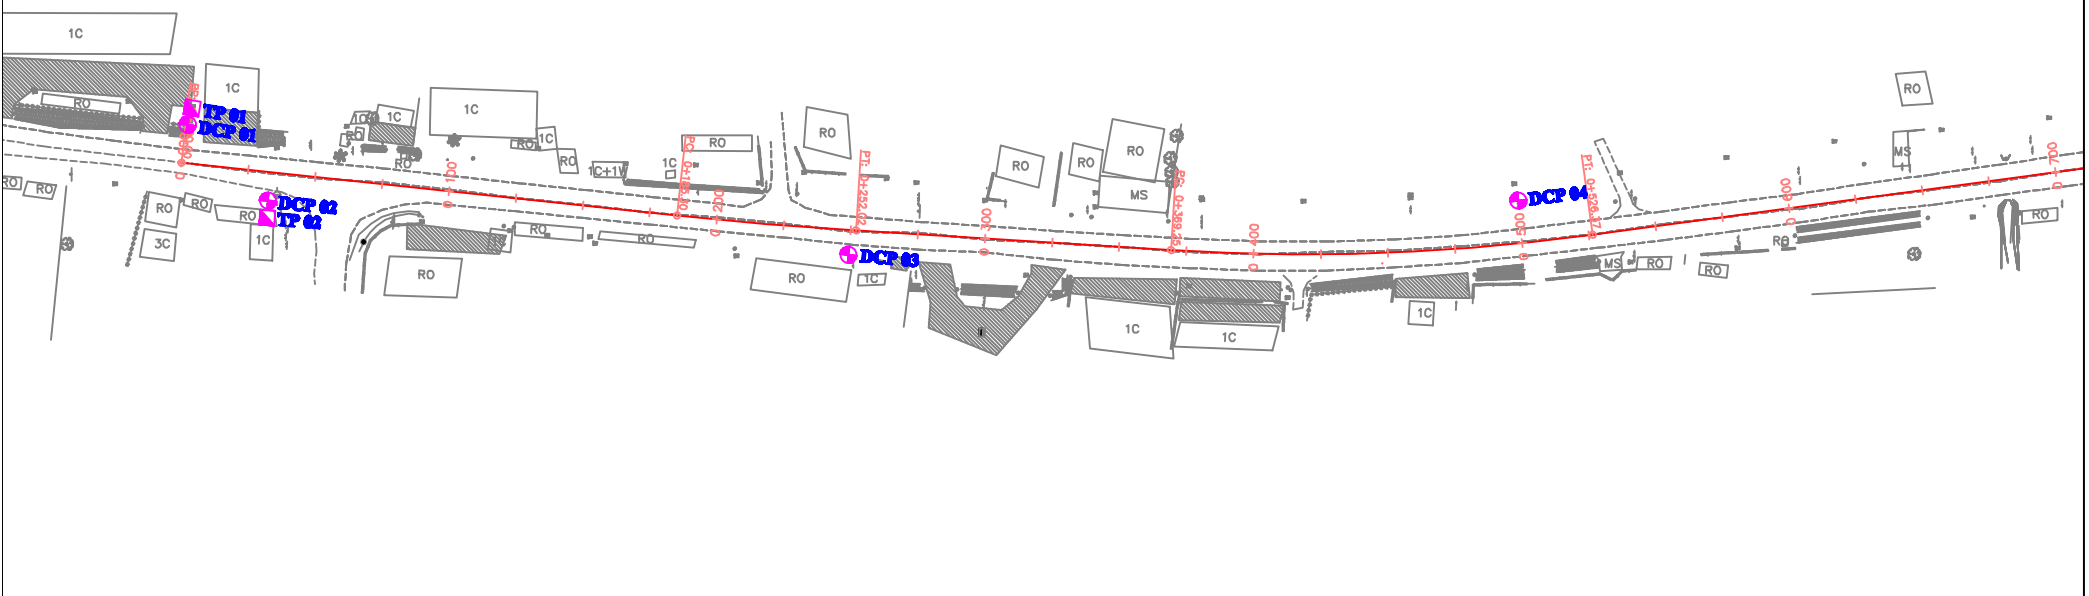
**Figure 2.1 Location Plan of Test Pit Log and DCP Test**

**LOCATION PLAN OF TEST PIT LOG AND DCP TEST**  
**ROAD No. 13 NORTH IMPROVEMENT AND MAINTENANCE PROJECT**  
**SECTION: SIKEUTH JUNCTION - PHONHONG ( 58 KM )**

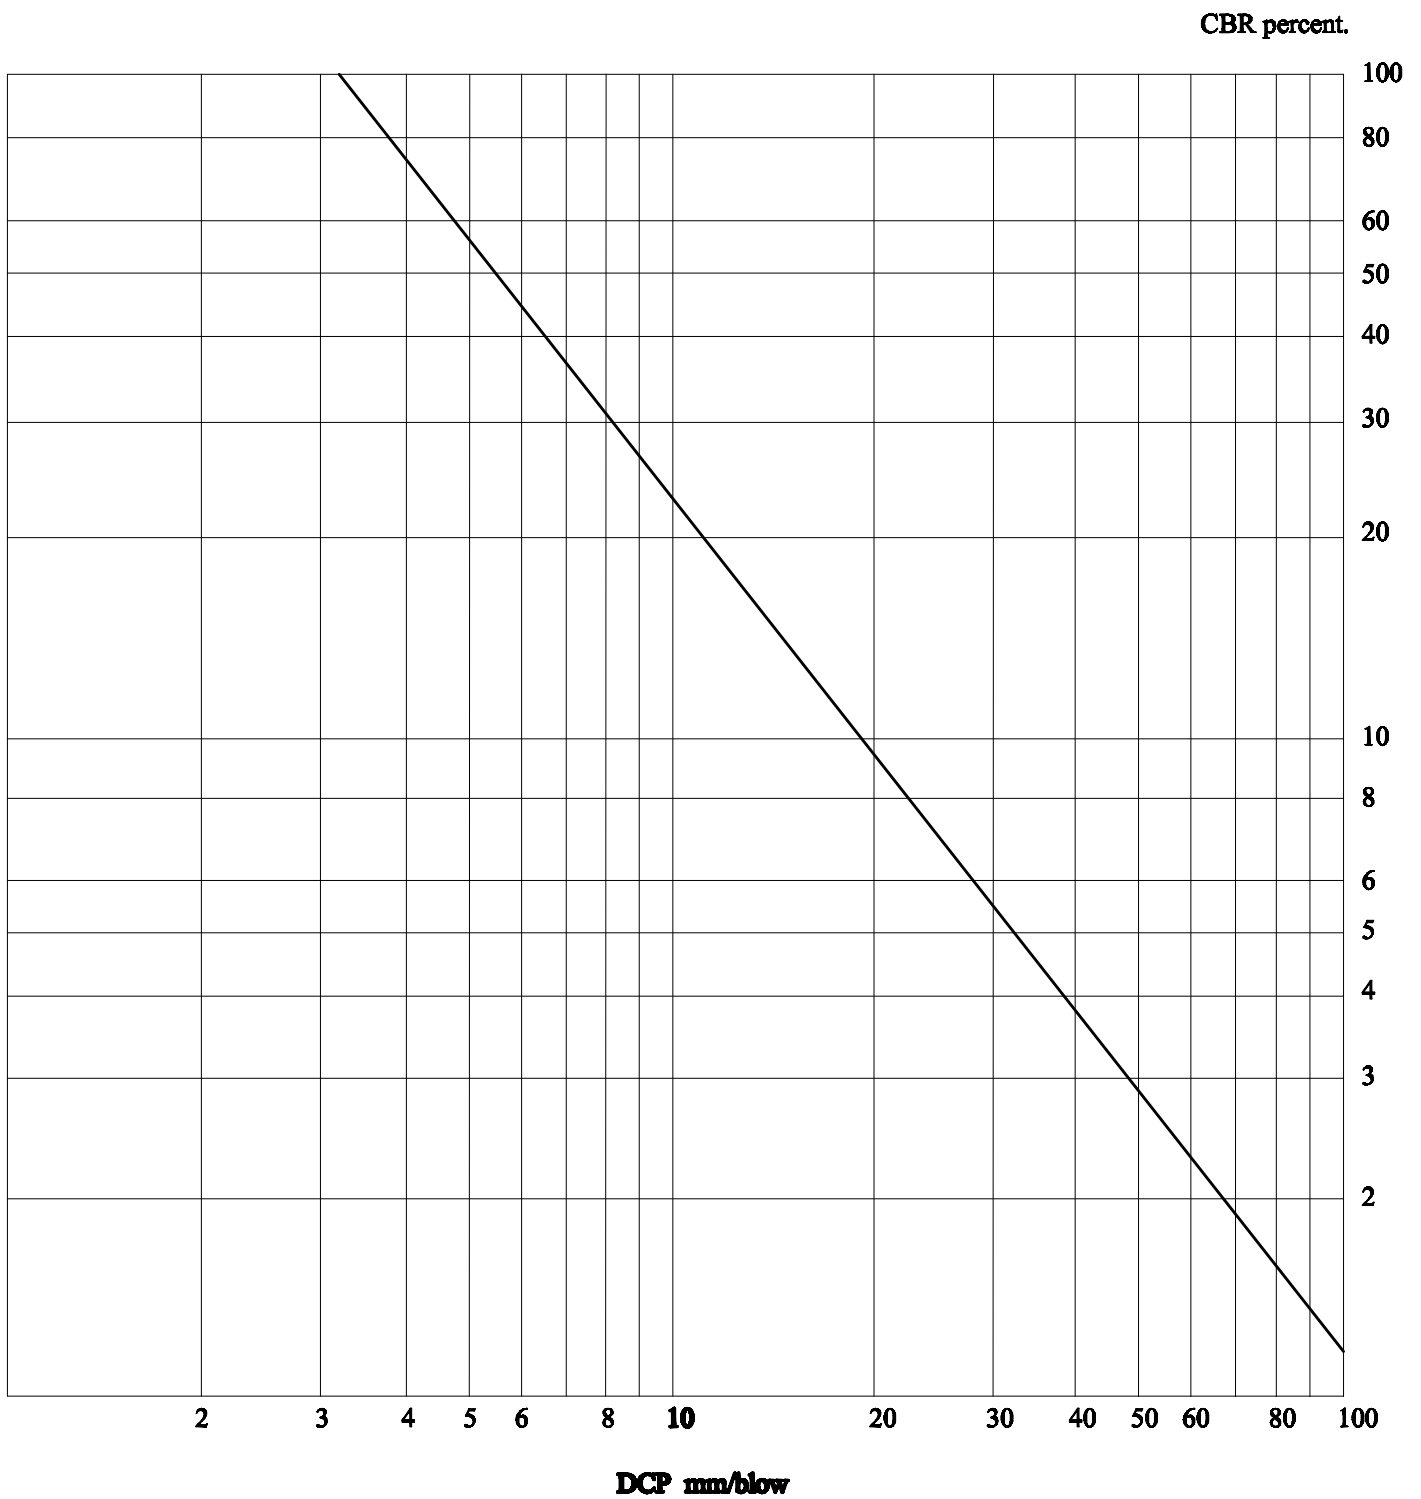
**Figure 3 DCP-CBR Relationship Chart**

**DCP - CBR RELATIONSHIP CHART**  
**( Kleyn and Van Heerden 60° cone )**

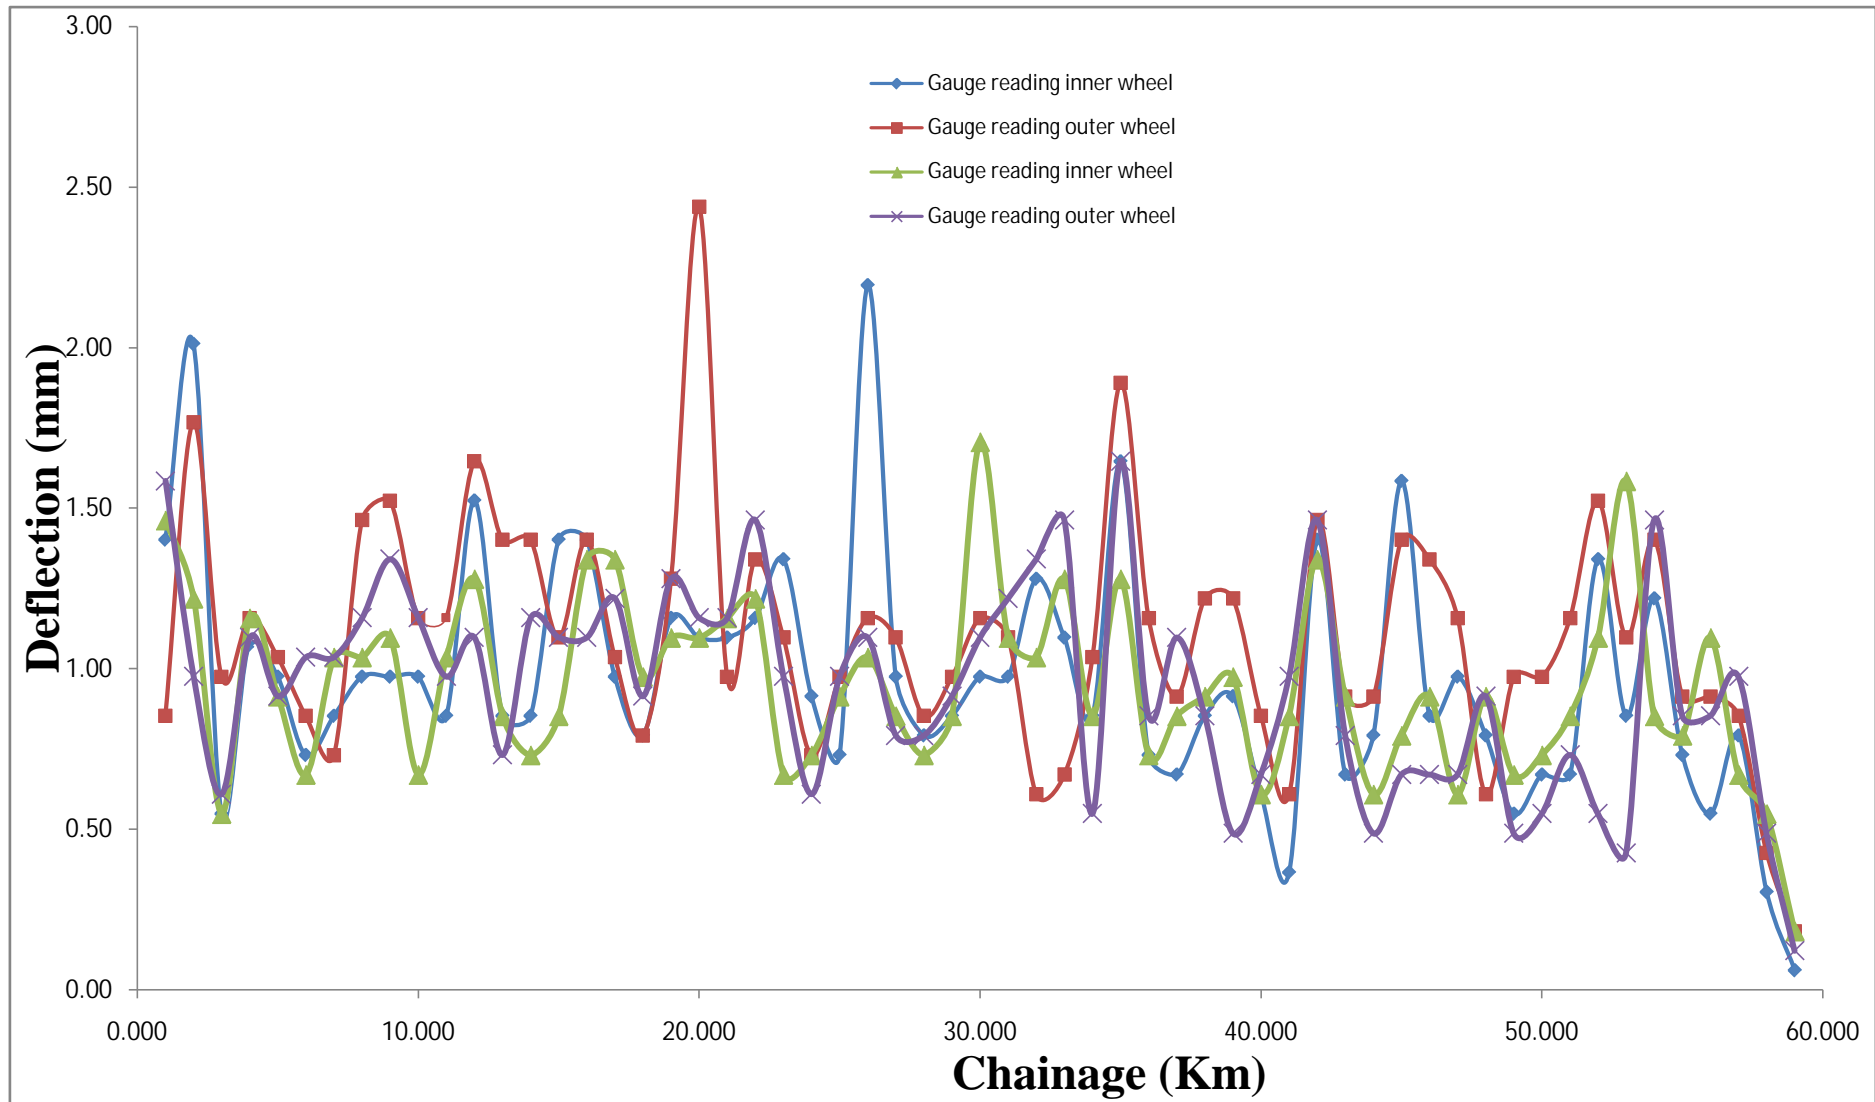
Figure C- 1 Benkelman Beam Test Results

# Benkelman Beam Test Results

Benkelman Beam deflection measurement of existing pavement has taken on both sides of the road. Measure axle load of loaded truck and adjust the load until axle load meets the requirement of 11 tones, then record; adjust type pressure to 80 psi (5,6 kg/cm<sup>2</sup>). Stop the truck at the test location and record all required data on form. If there is any loose material on the pavement it should be swept clear before finally positioning the truck. Prepare the Benkelman Beam equipment. Check dial gauge moves freely and smoothly. Place beam in position behind truck with beam tip exactly under axle between the two tires. Secure Beam Lock in unlocked position. Switch on vibrator if fitted, or tap beam lightly between pivot

point and dial gauge for example with a pencil. Zero the dial gauge fine scale. Move truck very slowly forward (The speed of the truck is about 2 to 3 Kilometers per hours) Read and record the dial gauge reading as before. The truck shall be driven in the traffic lane at about the same distance from the lane edge as the general truck traffic and in the same direction as the general traffic. Pavement distress was also noted and recorded during the Benkelman Beam testing. Individual rebound reading staggered at zero (0), Maximum and final spacing along both the inner and outer wheel path as well as pavement condition comments are provided on Benkelman Beam data test.
