The Project for Capacity Development on Bridge Maintenance and Management in Laos JICA-BMM

Nam Mone Bridge and Xe Bangnouan Bridges Detailed Inspection Report

March 2022

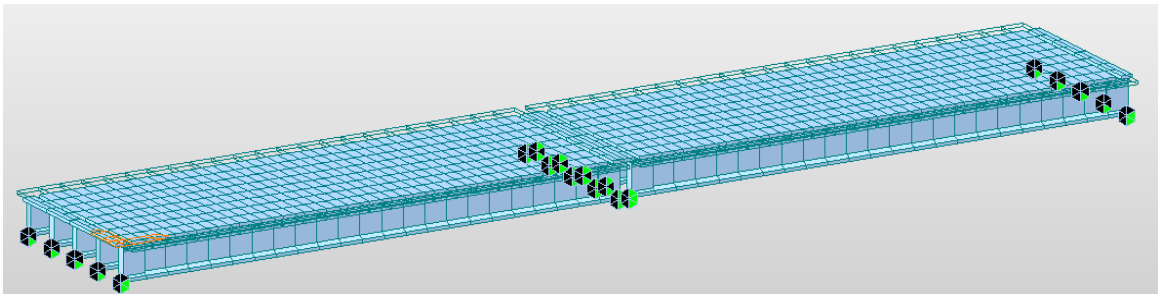
- From our detailed visual inspection, it is observed that the expansion joint gap between deck slabs, and between main girder end and abutment parapet wall is abnormally small.
- At the abutment ledges, there are mud that have congealed over the bearings and water stains indicating water leakage through the joint in the deck slab.
- From top view it is observed that both expansion joints have been paved over. Based on our results of the bridge simulation, an expansion joint gap should be at least 20 mm.

The above observations could have contributed to the bridge structural damages i.e bridge bearing might not function properly, leading to the case that girders and deck slab do not able to act as per the original design concept, and consequently the cracks appeared on the main girders and deck slab.

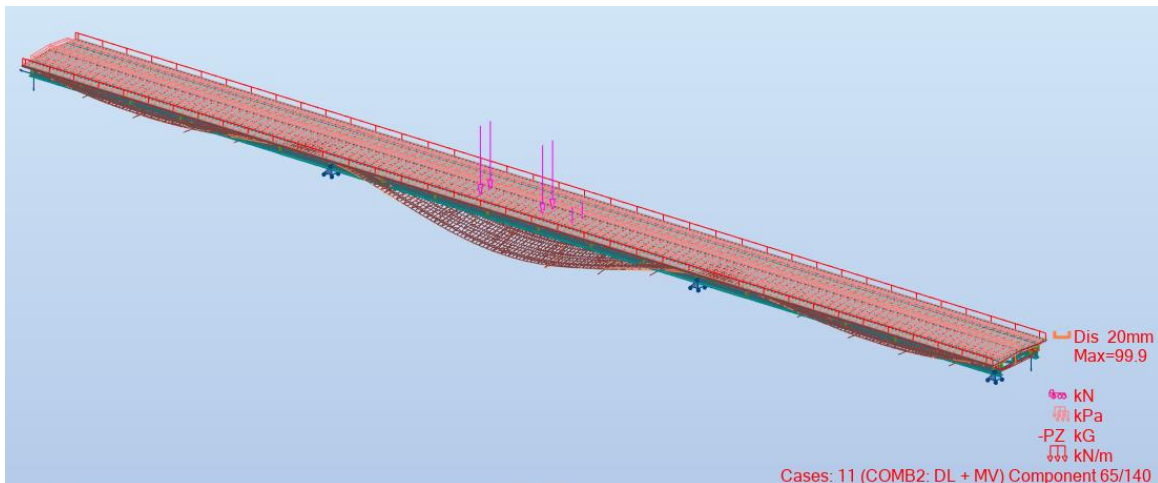
- There are many cracks on deck slab with grade E have been found, especially at span -2, where from bottom view the free lime is observed, suspecting that the cracks could go through the deck slab.

Based on our results of the bridge simulation, the steel bridge deflection is quite high up to the allowable. The crack could be occurred due to the dynamic moving loads. The deck slab reinforcement might be insufficient in order to resist the forces induced by the cyclic dynamic loads.

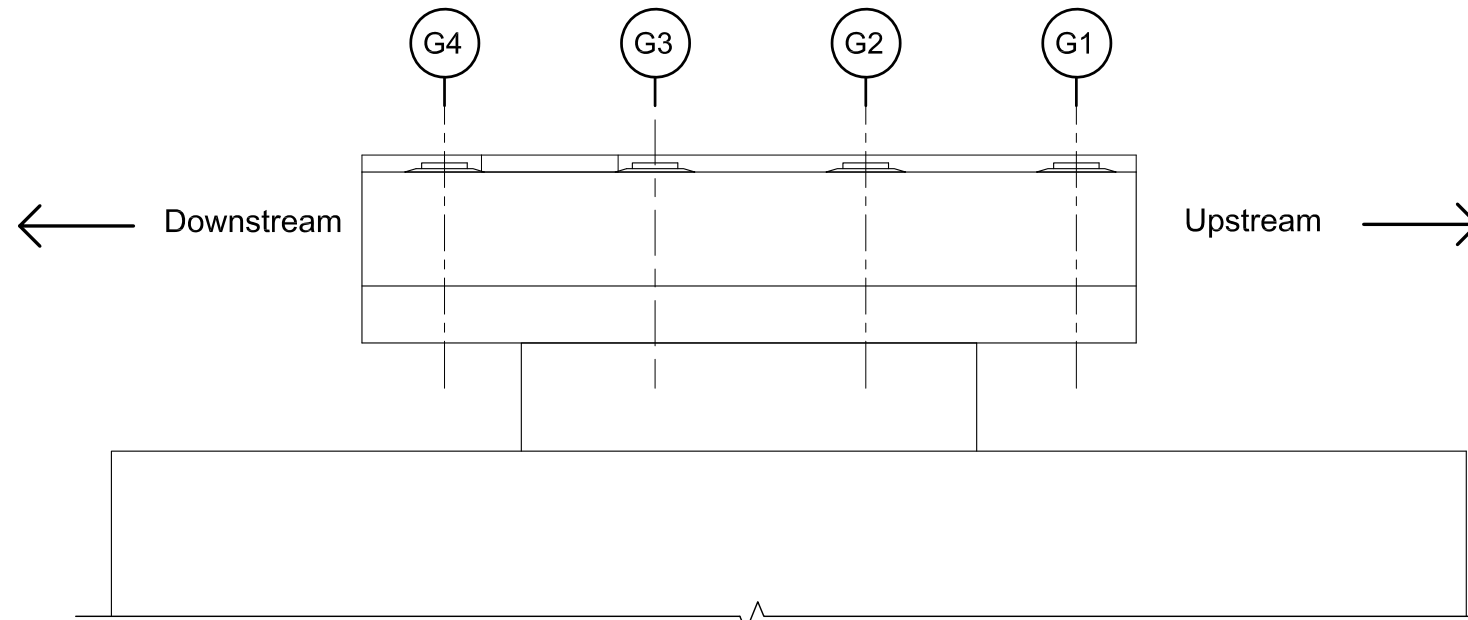
Pier P1 Damage Drawings

Stop Block-06: Cracks (E), $W=1.30\text{mm}$ $L=0.14\text{m}$, Photo-056
 Stop Block-07: Peeling, Exposure of rebar (C), Area = 250 cm^2 , No rust fluid, Photo-057

Photo No.	055	Component	Substructure	Photo No.	056	Component	Substructure
Element name	Abutment A1			Element name	Stop block at pier P1		
Damage type	24	Damage grade	E	Damage type	06	Damage grade	E

Photo No.	057	Component	Substructure	Photo No.	058	Component	Substructure
Element name	Construction joint between stop block and P1 pier cap			Element name	Top surface of P1 pier cap		
Damage type	07	Damage grade	C	Damage type	24	Damage grade	E

2.1	Element: Body; Material: Reinforce Concrete			
2.1.1	06: Cracks			
2.1.1.1	width ≤ 0.2mm	m	0.00	None
2.1.1.2	0.2mm < width < 1.0mm	m	0.00	None
2.1.1.3	width ≥ 1.0mm	m	0.14	
	Photo-056			On stop block at pier P1

2.1.2	07: Peeling/Exposure of Rebar	m ²	0.025	
	Photo-057			On stop block at pier P1
2.1.3	08: Leaching/Free lime	m ²	0.00	None
2.2	Element: Foundation; Material: Reinforce Concrete

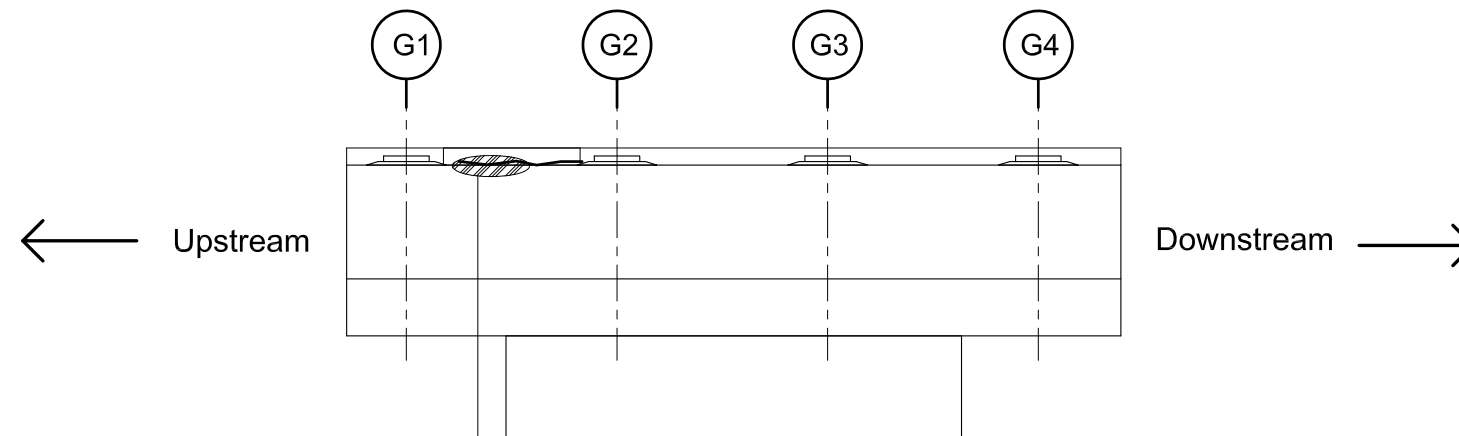
Side View (Upstream Side)

Stop Block-06: Cracks (E), $W=1.30\text{mm}$ $L=0.14\text{m}$, Photo-056
 Stop Block-07: Peeling, Exposure of rebar (C), Area = 250 cm^2 , No rust fluid, Photo-057

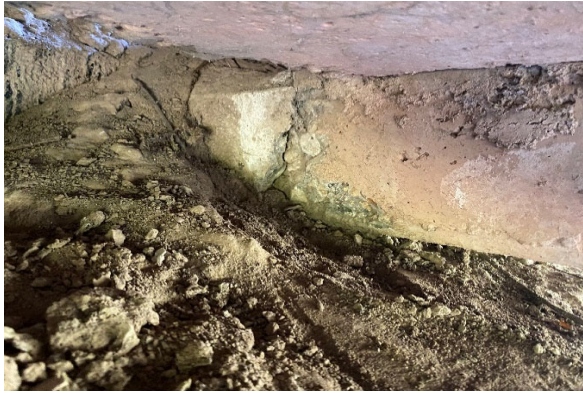
Photo No.	001	Component	Superstructure	Photo No.	002	Component	Superstructure
Element name	Main structure (Girder)			Element name	Main structure (Girder)		
Damage type	07	Damage grade	C	Damage type	07	Damage grade	C

1.2.2	07: Peeling/Exposure of Rebar	m ²	0.128	
	Photo-001	m ²	0.0293	
	Photo-002	m ²	0.0193	
	Photo-006	m ²	0.0195	
	Photo-009	m ²	0.06	
1.2.3	08: Leaching/Free lime	m ²	0.00	None
2	Component: Substructure

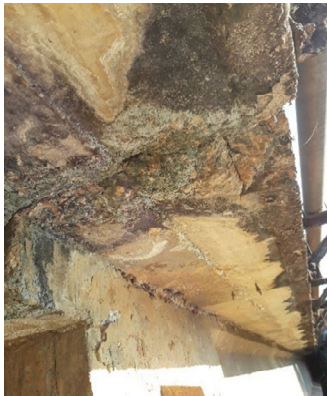
Photo No.	003	Component	Superstructure	Photo No.	004	Component	Superstructure
Element name	Deck			Element name	Deck		
Damage type	07	Damage grade	C	Damage type	07	Damage grade	C

Item	Type of damages	Unit	Quantity	Remark
1	Component: Superstructure			
1.1	Element: Deck; Material: Reinforce Concrete			
1.1.1	07: Peeling/Exposure of Rebar	m ²	5.0113	
	Photo-003	m ²	0.1125	
	Photo-004	m ²	0.1125	
	Photo-005	m ²	0.4063	
	Photo-007	m ²	0.1125	
	Photo-008	m ²	0.1500	
	Photo-010	m ²	0.3375	
	Peeling at area between each pre-cast slab	m ²	3.78

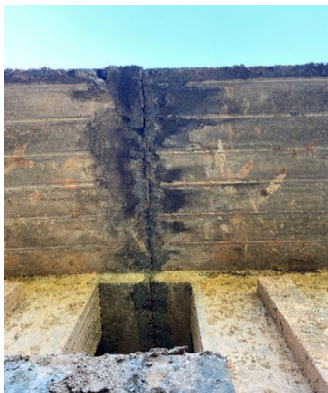
Photo No.	005	Component	Superstructure	Photo No.	006	Component	Superstructure
Element name	Deck			Element name	Main structure (Girder)		
Damage type	07	Damage grade	C	Damage type	07	Damage grade	C

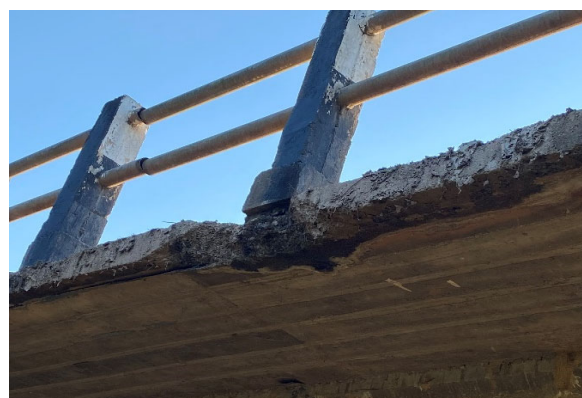
Photo No.	007	Component	Superstructure	Photo No.	008	Component	Superstructure
Element name	Deck			Element name	Deck		
Damage type	07	Damage grade	C	Damage type	07	Damage grade	C

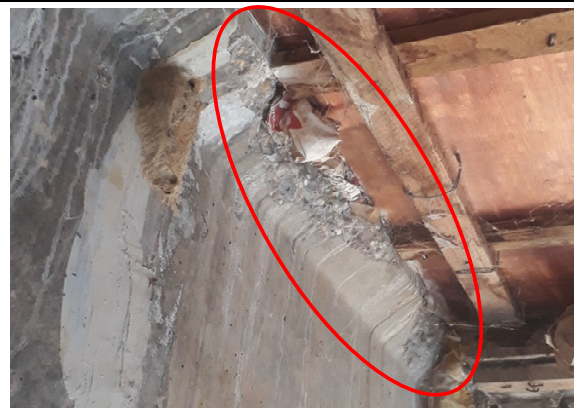
Photo No.	009	Component	Superstructure	Photo No.	010	Component	Superstructure
Element name	Main structure (Girder)			Element name	Deck		
Damage type	07	Damage grade	C	Damage type	07	Damage grade	C

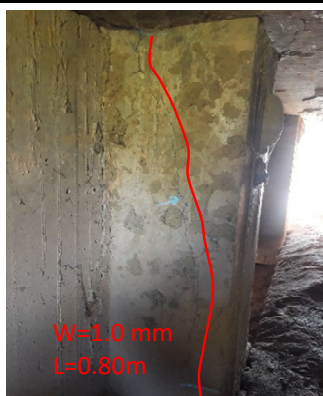
Photo No.	011	Component	Superstructure	Photo No.	012	Component	Superstructure
Element name	Main structure (Girder)			Element name	Main structure (Girder)		
Damage type	06	Damage grade	D	Damage type	06	Damage grade	D

1.2.1.2	0.2mm < width < 1.0mm	m	0.23	
	Photo-013, W=0.25mm	m	0.23	
1.2.1.3	width ≥ 1.0mm	m	2.08	
	Photo-011, W=1.00mm	m	0.80	
	Photo-012, W=1.00mm	m	0.88	
	Photo-051, W=1.40mm	m	0.40

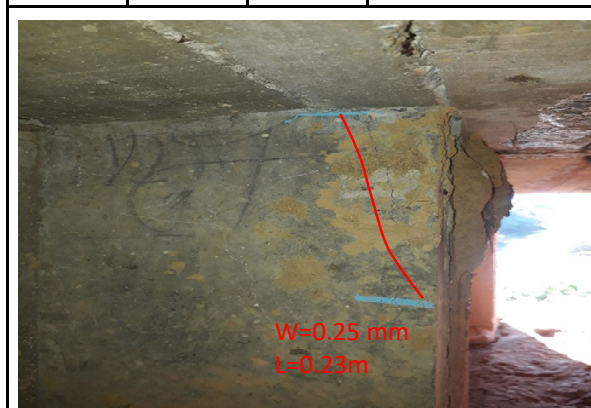
Photo No.	013	Component	Superstructure	Photo No.	014	Component	Superstructure
Element name	Main structure (Girder)			Element name	Main structure (Girder)		
Damage type	06	Damage grade	D	Damage type	06	Damage grade	C

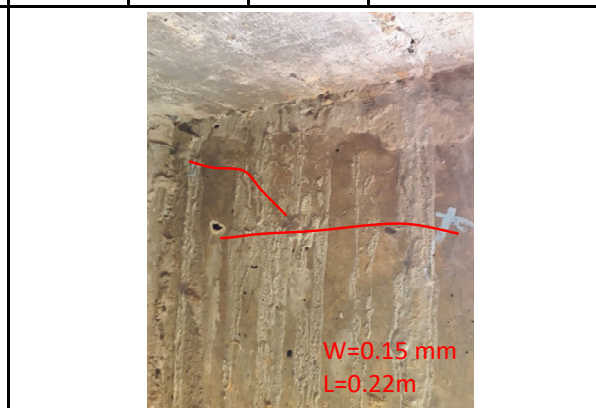
1.1.3.3	width ≥ 1.0mm	m	0.00	None
1.2	Element: Girder; Material: Post-tensioned concrete			
1.2.1	06: Cracks			
1.2.1.1	width ≤ 0.2mm	m	0.58	
	Photo-014, W=0.15mm	m	0.22	
	Photo-015, W=0.15mm	m	0.08	
	Photo-016, W=0.15mm	m	0.20	
	Photo-017, W=0.10mm	m	0.05	
	Photo-018, W=0.20mm	m	0.03

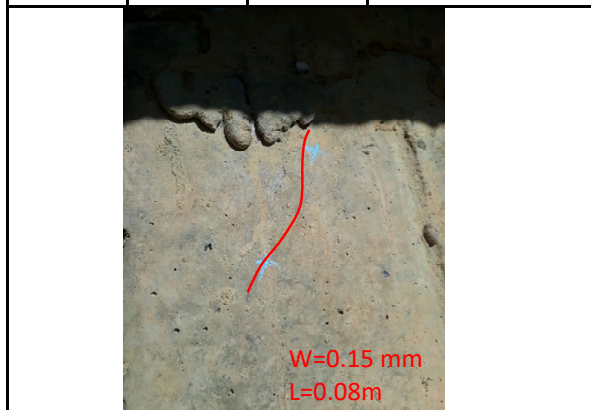
Photo No.	015	Component	Superstructure	Photo No.	016	Component	Superstructure
Element name	Main structure (Girder)			Element name	Main structure (Girder)		
Damage type	06	Damage grade	C	Damage type	06	Damage grade	C

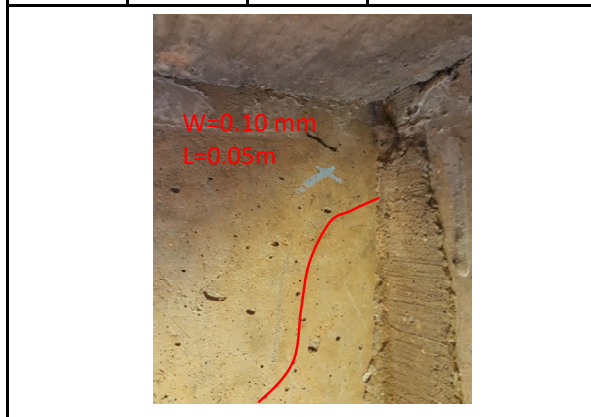
Photo No.	017	Component	Superstructure	Photo No.	018	Component	Superstructure
Element name	Main structure (Girder)			Element name	Main structure (Girder)		
Damage type	06	Damage grade	C	Damage type	06	Damage grade	D

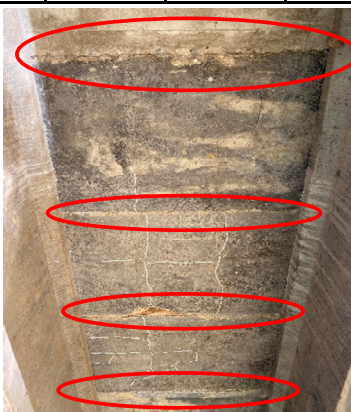
*Note1: Deck RC pre-cast slab-07: Peeling/Exposure of Rebar. The damage grade C is generally observed at the joint between each pre-cast slab, but grade D cracks can be observed locally. Photo-021

Photo No.	021	Component	Superstructure	Photo No.	022	Component	Superstructure
Element name	Deck			Element name	Deck		
Damage type	07	Damage grade	D	Damage type	11	Damage grade	C

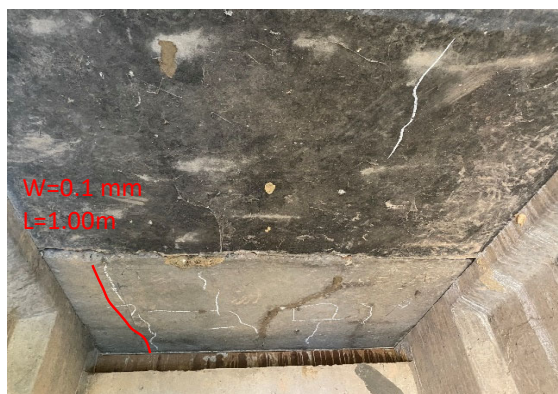
1.1.2	08: Leaching/Free lime	m ²	0.00	None
1.1.3	11: Cracks on Slab			
1.1.3.1	width ≤ 0.2mm	m	137.80	
	Photo-022, W=0.10mm	m	3.3	Span 1
	Photo-023, W=0.10-0.15mm	m	10.7	Span 1
	Photo-024, W=0.10-0.20mm	m	3.40	Span 1
	Photo-025, W=0.15mm	m	0.70	Span 1
	Photo-026, W=0.10mm	m	1.65	Span 1
	Photo-027, W=0.10mm	m	0.50	Span 1
	Photo-028, W=0.15mm	m	2.25	Span 1
	Photo-029, W=0.20mm	m	0.55	Span 1
	Photo-030, W=0.10-0.20mm	m	4.15	Span 1
	Photo-031, W=0.10mm	m	1.35	Span 1
	Photo-032, W=0.20mm	m	0.40	Span 1
	Photo-033, W=0.10-0.20mm	m	1.55	Span 1
	Photo-034, W=0.20mm	m	1.20	Span 2
	Photo-035, W=0.20mm	m	0.30	Span 2
	Photo-036, W=0.20mm	m	1.00	Span 2
	Photo-037, W=0.20mm	m	2.00	Span 2
	Photo-038, W=0.15-0.20mm	m	3.25	Span 2
	Photo-039, W=0.10mm	m	1.00	Span 2
	Photo-040, W=0.15-0.20mm	m	7.70	Span 2
	Photo-041, W=0.20mm	m	1.05	Span 2
	Photo-042, W=0.20mm	m	1.05	Span 2
	Photo-043, W=0.20mm	m	2.80	Span 2
	Photo-044, W=0.20mm	m	0.85	Span 2

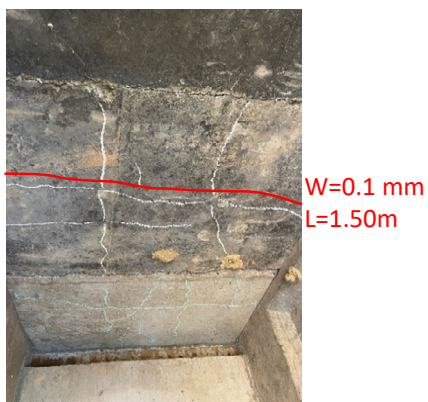
Photo No.	023	Component	Superstructure	Photo No.	024	Component	Superstructure
Element name	Deck			Element name	Deck		
Damage type	11	Damage grade	C	Damage type	11	Damage grade	C

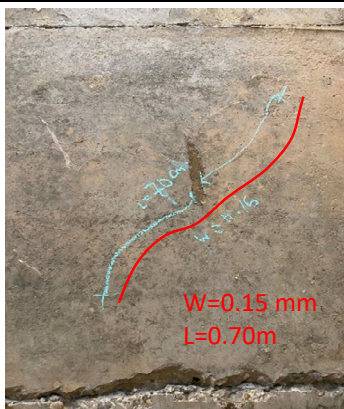
Photo No.	025	Component	Superstructure	Photo No.	026	Component	Superstructure
Element name	Deck			Element name	Deck		
Damage type	11	Damage grade	D	Damage type	11	Damage grade	C

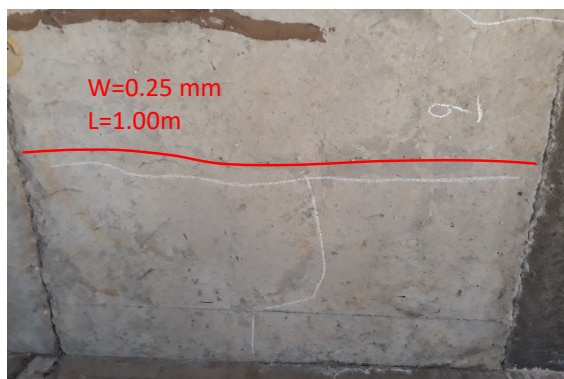
Photo No.	027	Component	Superstructure	Photo No.	028	Component	Superstructure
Element name	Deck			Element name	Deck		
Damage type	11	Damage grade	E	Damage type	11	Damage grade	D

1.1.3.2	0.2mm < width < 1.0mm	m	17.96	
	Photo-027, W=0.25mm	m	1.00	Span 1
	Photo-031, W=0.25mm	m	5.00	Span 1
	Photo-038, W=0.25mm	m	3.13	Span 2

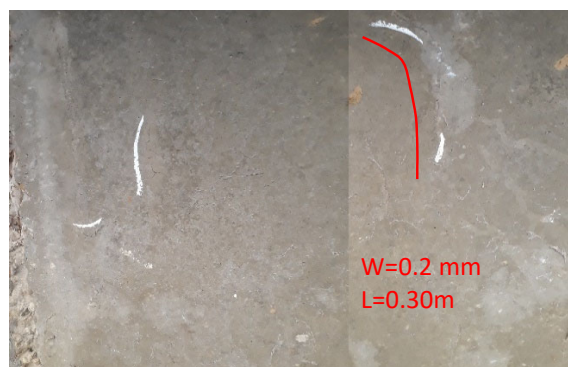
Photo No.	029	Component	Superstructure	Photo No.	030	Component	Superstructure
Element name	Deck			Element name	Deck		
Damage type	11	Damage grade	D	Damage type	11	Damage grade	D

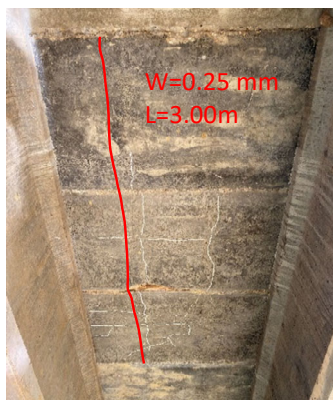
Photo No.	031	Component	Superstructure	Photo No.	032	Component	Superstructure
Element name	Deck			Element name	Deck		
Damage type	11	Damage grade	E	Damage type	11	Damage grade	D

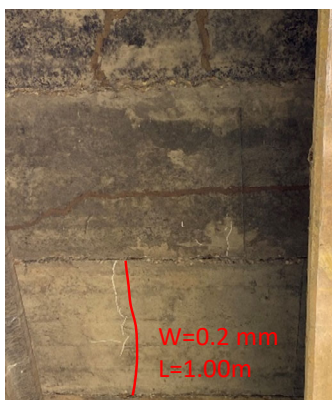
Photo No.	033	Component	Superstructure	Photo No.	034	Component	Superstructure
Element name	Deck			Element name	Deck		
Damage type	11	Damage grade	D	Damage type	11	Damage grade	D

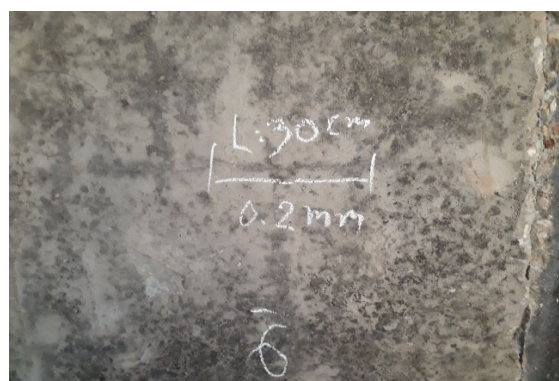
Photo No.	035	Component	Superstructure	Photo No.	036	Component	Superstructure
Element name	Deck			Element name	Deck		
Damage type	11	Damage grade	D	Damage type	11	Damage grade	D

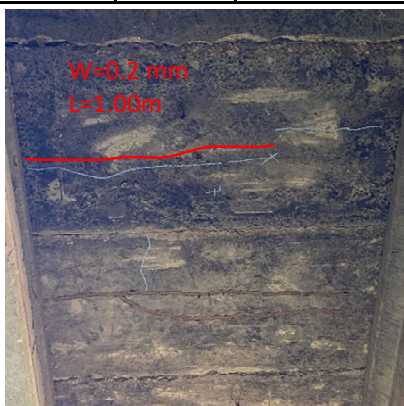
Photo No.	037	Component	Superstructure	Photo No.	038	Component	Superstructure
Element name	Deck			Element name	Deck		
Damage type	11	Damage grade	D	Damage type	11	Damage grade	E

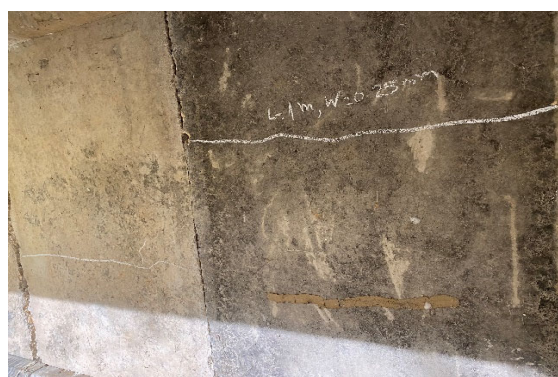
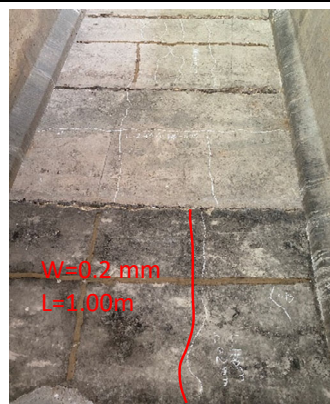
Photo No.	039	Component	Superstructure	Photo No.	040	Component	Superstructure
Element name	Deck			Element name	Deck		
Damage type	11	Damage grade	E	Damage type	11	Damage grade	D

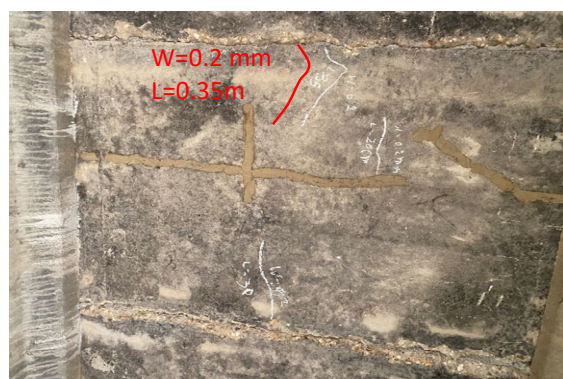
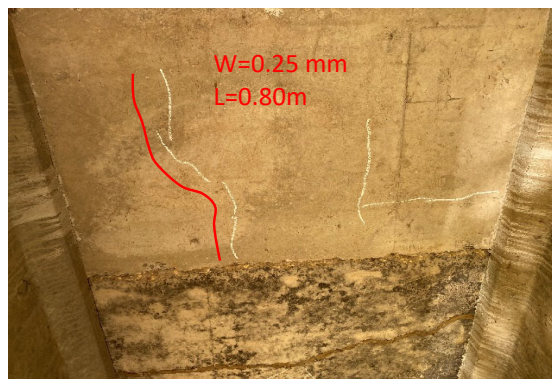
Photo No.	041	Component	Superstructure	Photo No.	042	Component	Superstructure
Element name	Deck			Element name	Deck		
Damage type	11	Damage grade	D	Damage type	11	Damage grade	E

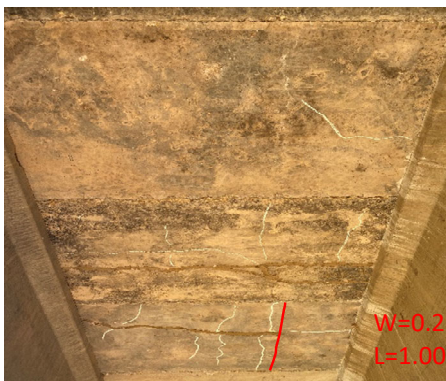
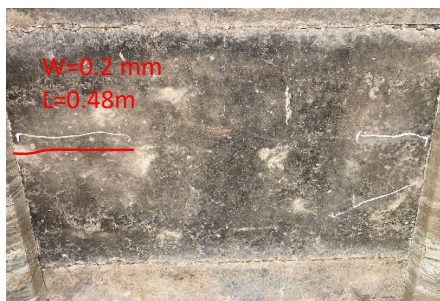
Photo No.	043	Component	Superstructure	Photo No.	044	Component	Superstructure
Element name	Deck			Element name	Deck		
Damage type	11	Damage grade	E	Damage type	11	Damage grade	D

Photo-045, W=0.20mm	m	0.90	Span 2
	Photo-046, W=0.15-0.20mm	m	6.35	Span 2
	Photo-047, W=0.10-0.20mm	m	1.10	Span 2
	Photo-048, W=0.10-0.20mm	m	4.15	Span 2
	Photo-049, W=0.15-0.20mm	m	2.00	Span 2
	Photo-050, W=0.10mm	m	1.70	Span 2
	Cracks on pre-cast slab No.4 to No.18	m	53.38	Span 1 assumed by multiplying a average cracks length in one precast slab by cracks unrecoded precast slab number.
	Cracks on pre-cast slab No.25 to No.33	m	15.52	Span 2 average cracks length in one precast slab = total crack length / cracks recoded precast slab number

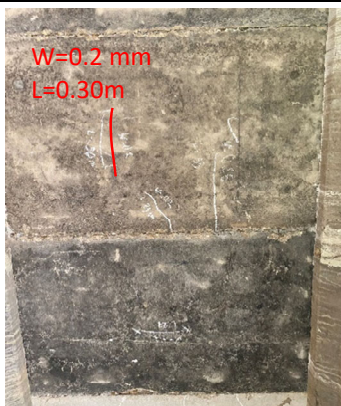
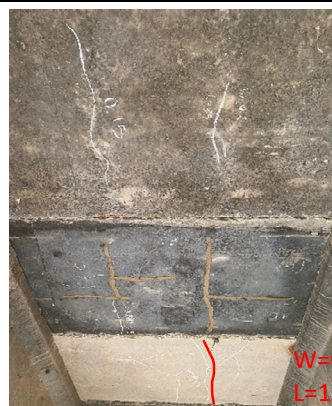
Photo No.	045	Component	Superstructure	Photo No.	046	Component	Superstructure
Element name	Deck			Element name	Deck		
Damage type	11	Damage grade	D	Damage type	11	Damage grade	D

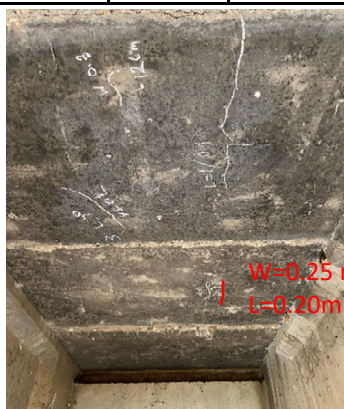
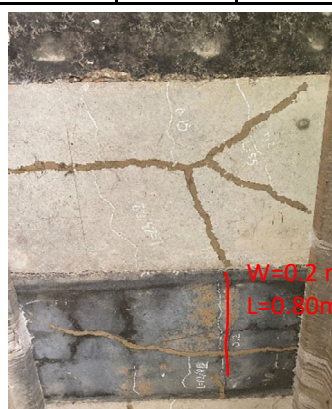
Photo No.	047	Component	Superstructure	Photo No.	048	Component	Superstructure
Element name	Deck			Element name	Deck		
Damage type	11	Damage grade	E	Damage type	11	Damage grade	D

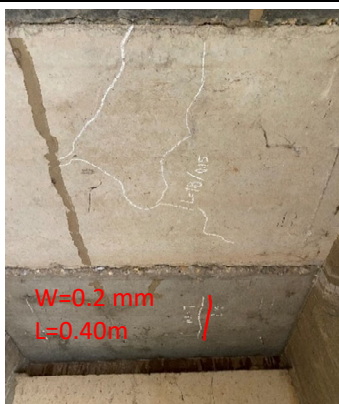
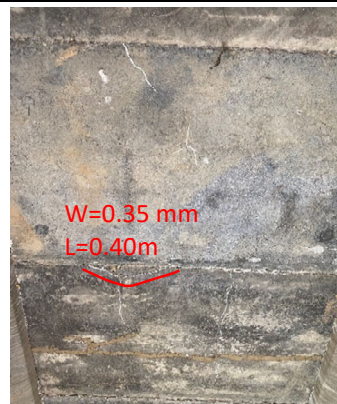
Photo No.	049	Component	Superstructure	Photo No.	050	Component	Superstructure
Element name	Deck			Element name	Deck		
Damage type	11	Damage grade	D	Damage type	11	Damage grade	E

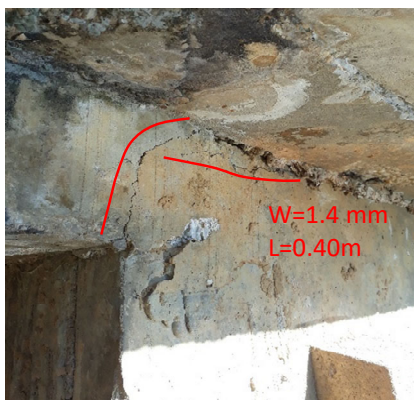
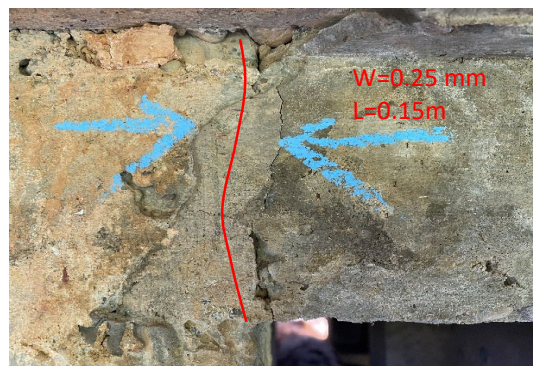
Photo No.	051	Component	Superstructure	Photo No.	052	Component	Superstructure
Element name	Main structure (Girder)			Element name	Deck		
Damage type	06	Damage grade	D	Damage type	11	Damage grade	E

Photo-039, W=0.25mm	m	1.00	Span 2
	Photo-042, W=0.25mm	m	0.80	Span 2
	Photo-043, W=0.25mm	m	4.41	Span 2
	Photo-044, W=0.25mm	m	0.40	Span 2
	Photo-045, W=0.25mm	m	0.55	Span 2
	Photo-047, W=0.25-0.30mm	m	0.37	Span 2
	Photo-050, W=0.25-0.35mm	m	1.00	Span 2
	Photo-052, W=0.25mm	m	0.15	Span 1
	Photo-053, W=0.25mm	m	0.15	Span 2

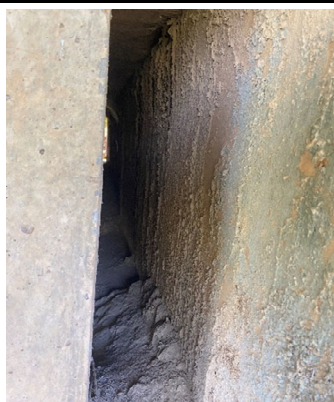
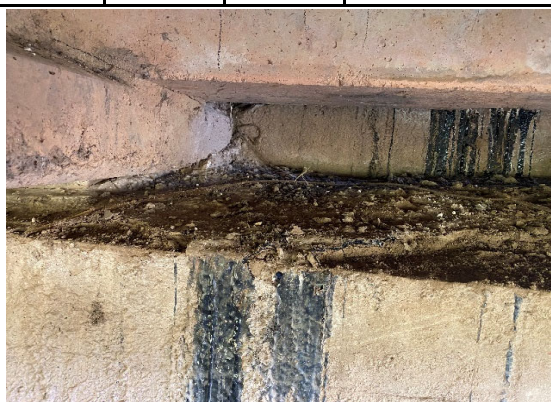
Photo No.	059	Component	Substructure	Photo No.	060	Component	Substructure
Element name	Abutment A2			Element name	Abutment A2		
Damage type	20	Damage grade	E	Damage type	24	Damage grade	E

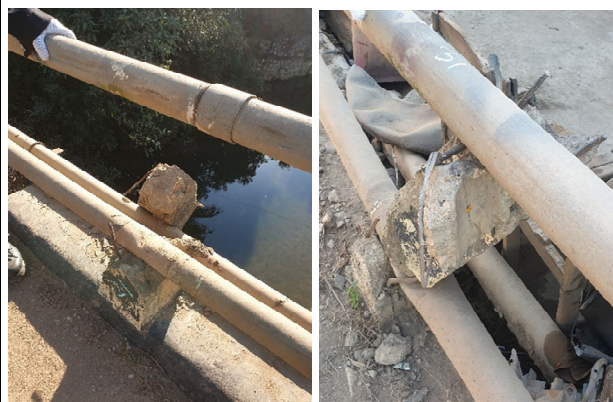
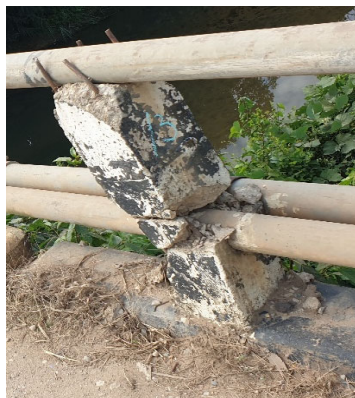
Photo No.	067	Component	On the road	Photo No.	68	Component	On the road
Element name Railling Column				Element name Railling Column			
Damage type	04	Damage grade	E	Damage type	04	Damage grade	E

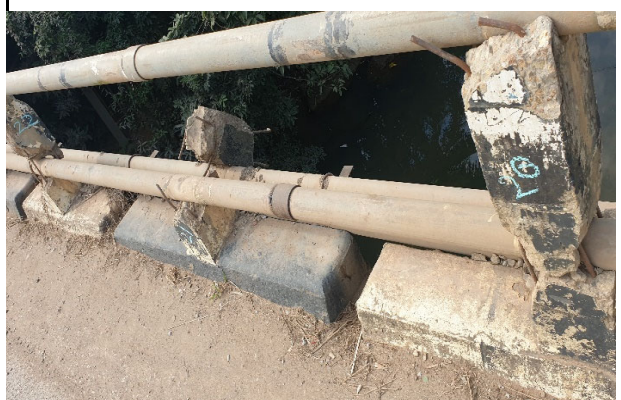
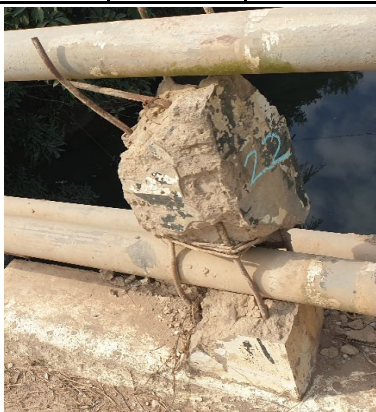
Photo No.	069	Component	On the road	Photo No.	070	Component	On the road
Element name Railling Column				Element name Railling Column			
Damage type	04	Damage grade	E	Damage type	04	Damage grade	E

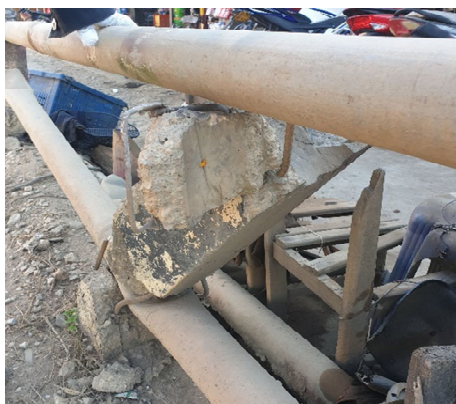
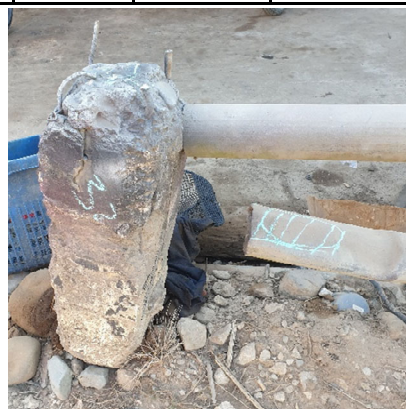
Photo No.	071	Component	On the road	Photo No.	072	Component	On the road
Element name Railling Column				Element name Railling Column			
Damage type	04	Damage grade	E	Damage type	04	Damage grade	E

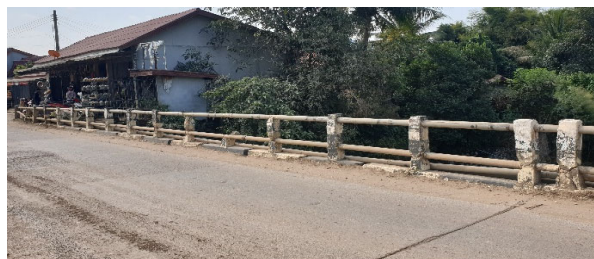
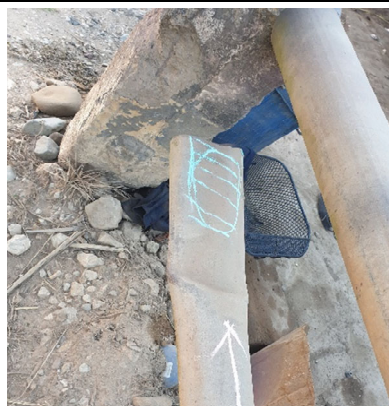
Photo No.	073	Component	On the road	Photo No.	074	Component	On the road
Element name	Railling			Element name	Railling		
Damage type	04	Damage grade	E	Damage type	04	Damage grade	E

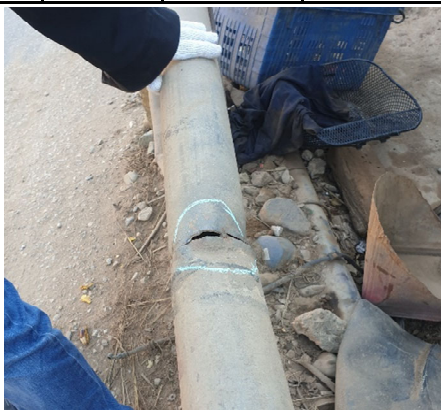
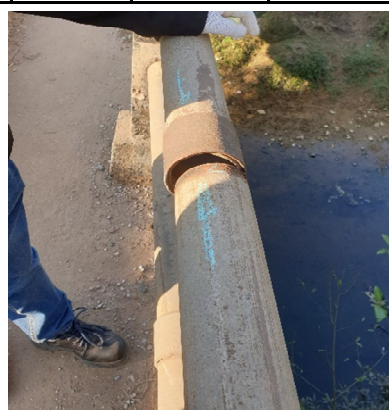
Photo No.	075	Component	On the road	Photo No.	076	Component	On the road
Element name	Railling			Element name	Railling		
Damage type	04	Damage grade	E	Damage type	04	Damage grade	E

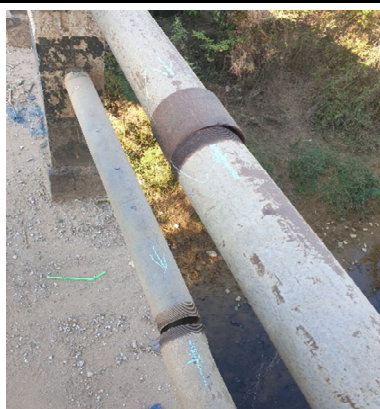
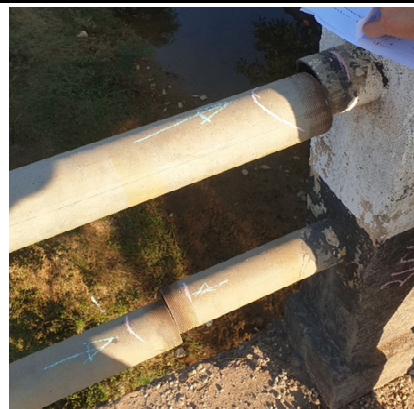
Photo No.	077	Component	On the road	Photo No.	078	Component	On the road
Element name	Railling			Element name	Railling		
Damage type	04	Damage grade	E	Damage type	04	Damage grade	E

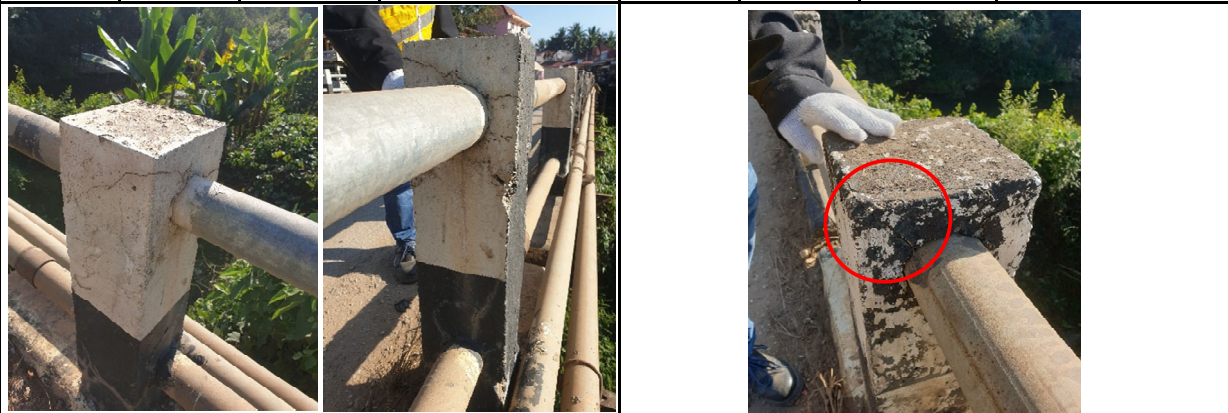
Photo No.	079	Component	On the road	Photo No.	080	Component	On the road
Element name Railling Column				Element name Railling Column			
Damage type	06	Damage grade	E	Damage type	06	Damage grade	E

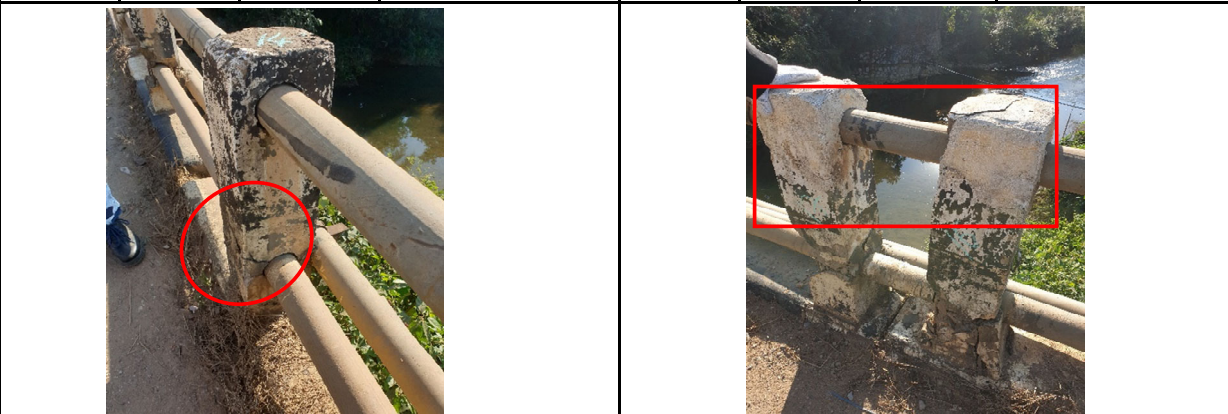
Photo No.	081	Component	On the road	Photo No.	082	Component	On the road
Element name Railling Column				Element name Railling Column			
Damage type	06	Damage grade	E	Damage type	06	Damage grade	E

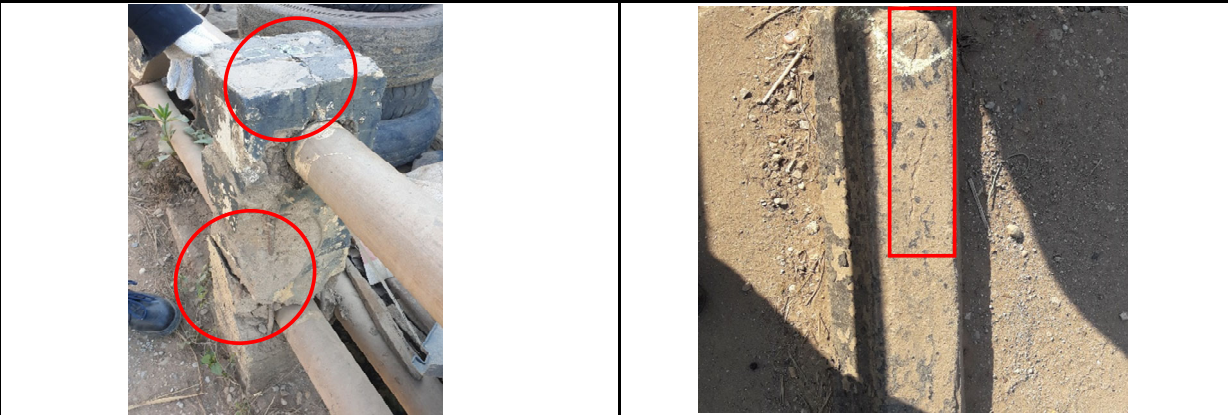
Photo No.	083	Component	On the road	Photo No.	084	Component	On the road
Element name Railling Column				Element name Wheel Guard			
Damage type	06	Damage grade	E	Damage type	06	Damage grade	E

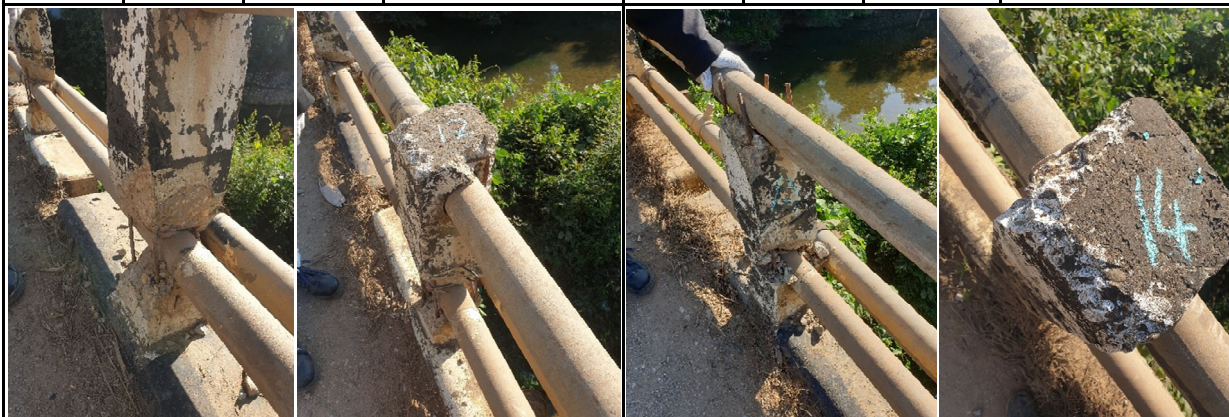
Photo No.	085	Component	On the road	Photo No.	086	Component	On the road
Element name Railling Column				Element name Railling Column			
Damage type	07	Damage grade	E	Damage type	07	Damage grade	E

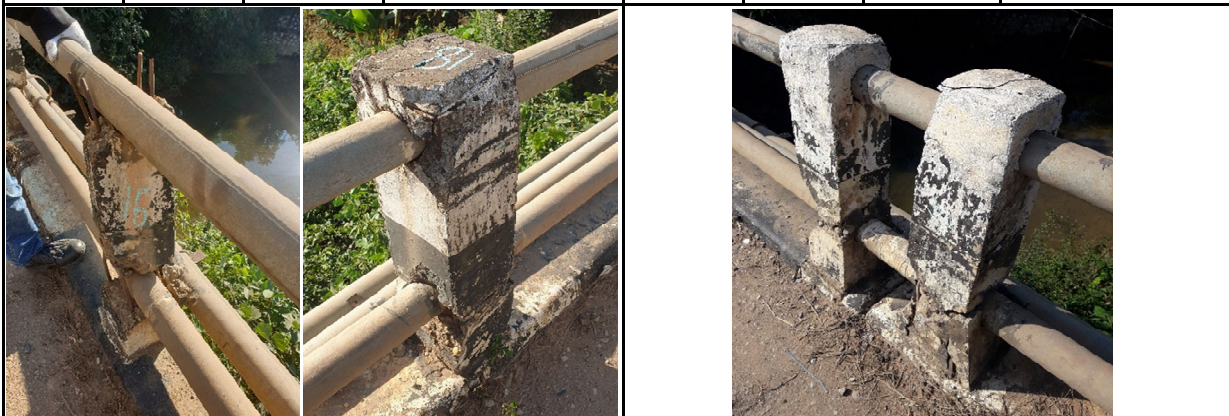
Photo No.	087	Component	On the road	Photo No.	088	Component	On the road
Element name Railling Column				Element name Railling Column			
Damage type	07	Damage grade	E	Damage type	07	Damage grade	E

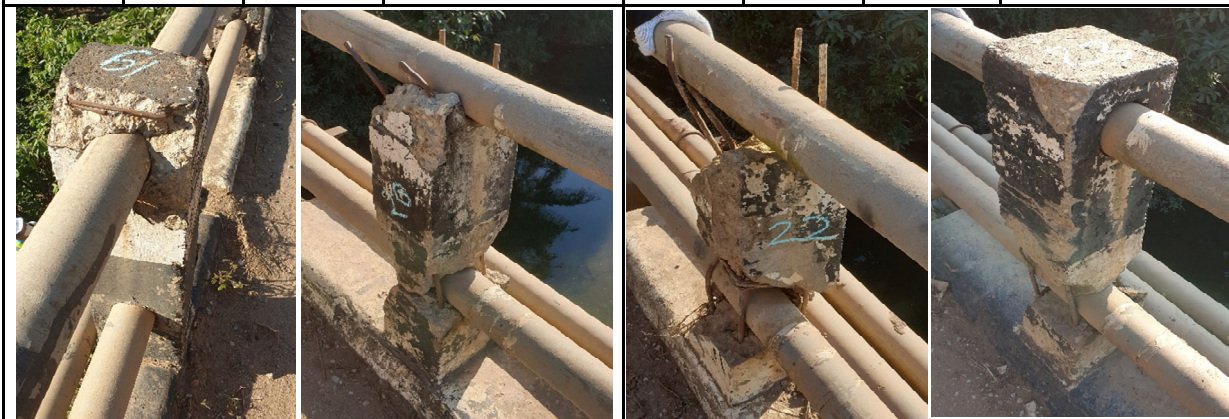
Photo No.	089	Component	On the road	Photo No.	090	Component	On the road
Element name Railling Column				Element name Railling Column			
Damage type	07	Damage grade	E	Damage type	07	Damage grade	E

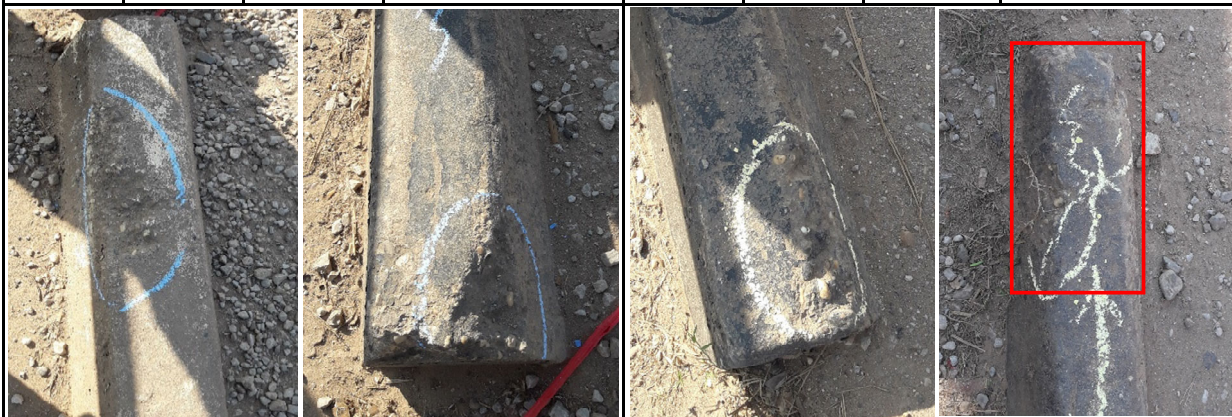
Photo No.	091	Component	On the road	Photo No.	092	Component	On the road
Element name	Wheel Guard			Element name	Wheel Guard		
Damage type	07	Damage grade	C	Damage type	07	Damage grade	C

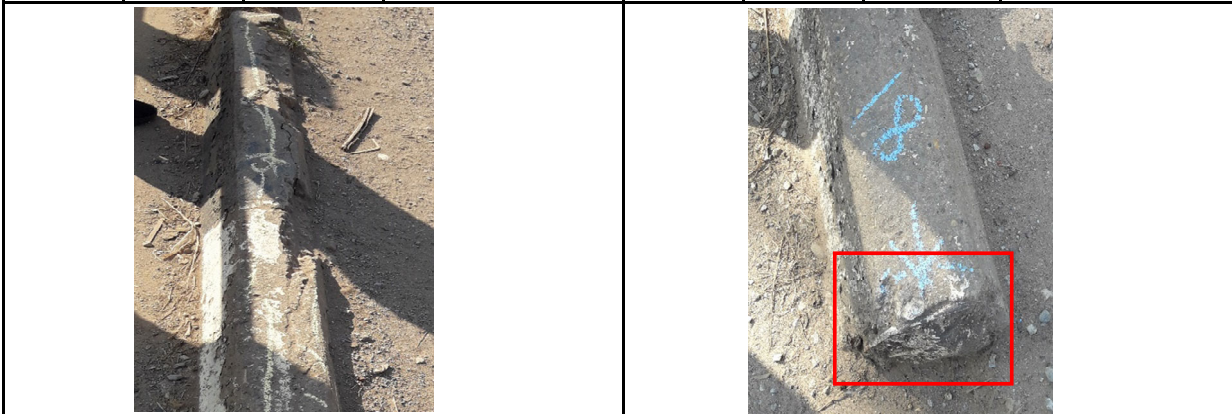
Photo No.	093	Component	On the road	Photo No.	094	Component	On the road
Element name	Wheel Guard			Element name	Wheel Guard		
Damage type	07	Damage grade	C	Damage type	07	Damage grade	C

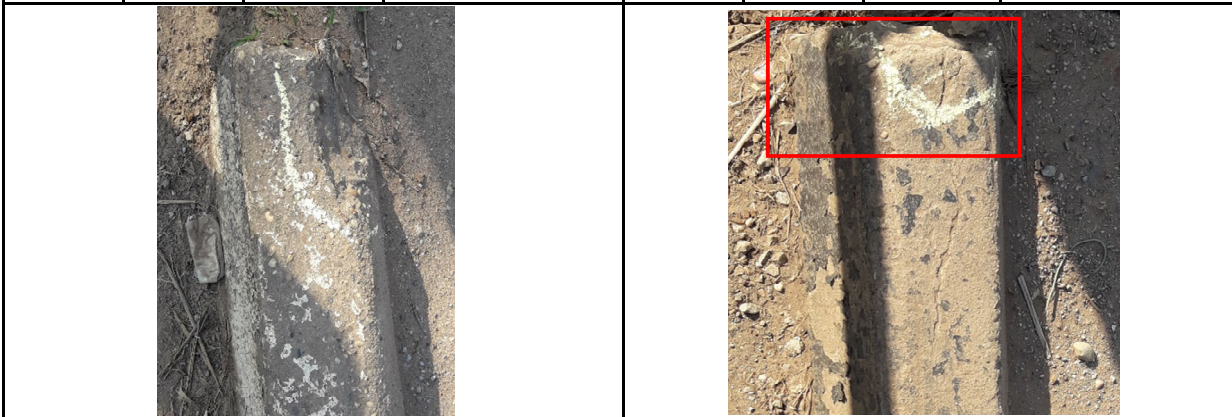
Photo No.	095	Component	On the road	Photo No.	096	Component	On the road
Element name	Wheel Guard			Element name	Wheel Guard		
Damage type	07	Damage grade	C	Damage type	07	Damage grade	C

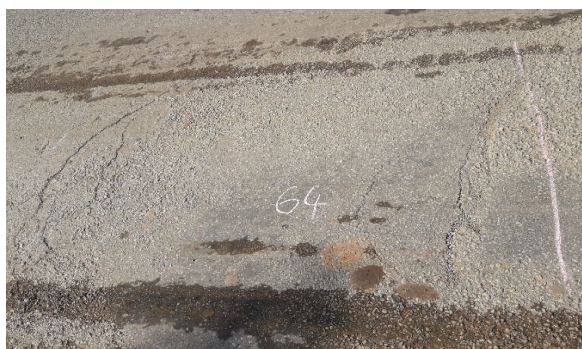
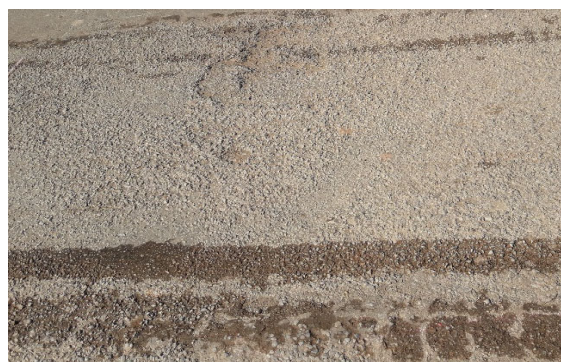
Photo No.	103	Component	Road surface	Photo No.	104	Component	Road surface
Element name	Pavement			Element name	Pavement		
Damage type	14	Damage grade	C	Damage type	14	Damage grade	C

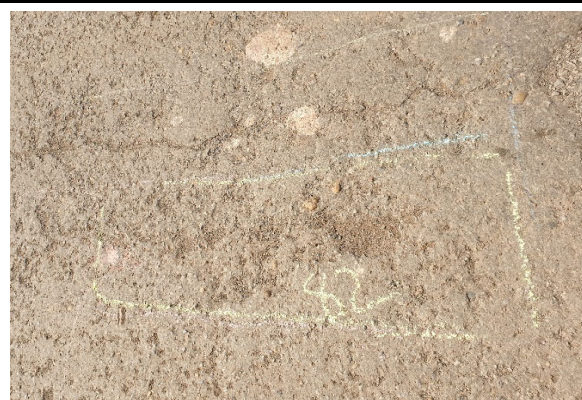
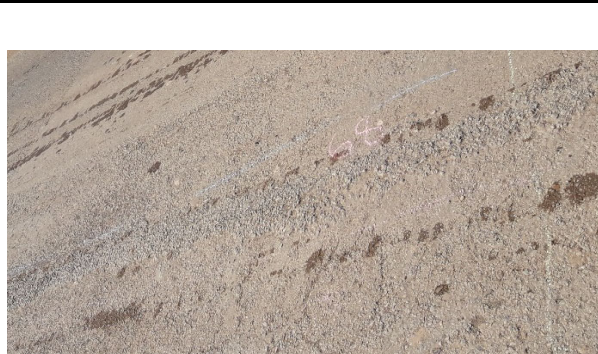
Photo No.	105	Component	Road surface	Photo No.	106	Component	Road surface
Element name	Pavement			Element name	Pavement		
Damage type	14	Damage grade	C	Damage type	14	Damage grade	C

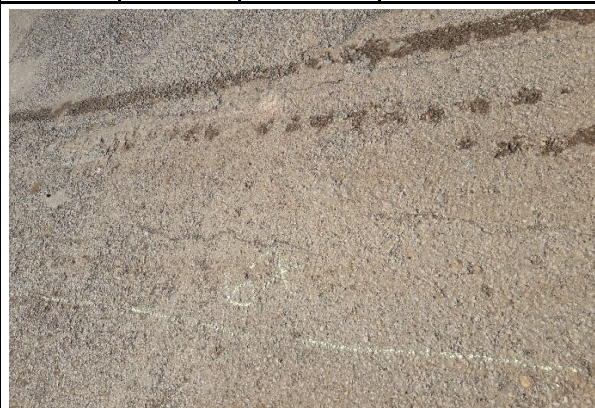
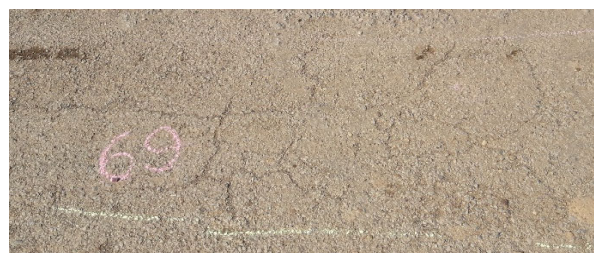
Photo No.	107	Component	Road surface	Photo No.	108	Component	Road surface
Element name	Pavement			Element name	Pavement		
Damage type	15	Damage grade	C	Damage type	15	Damage grade	C

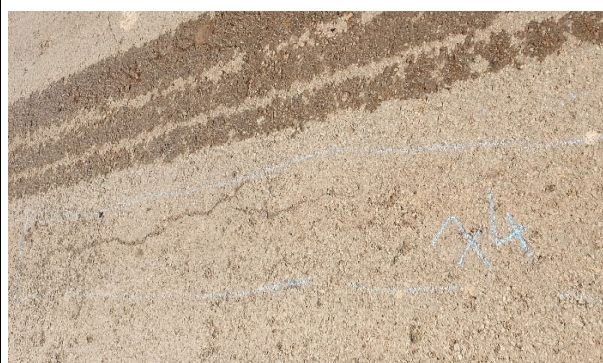
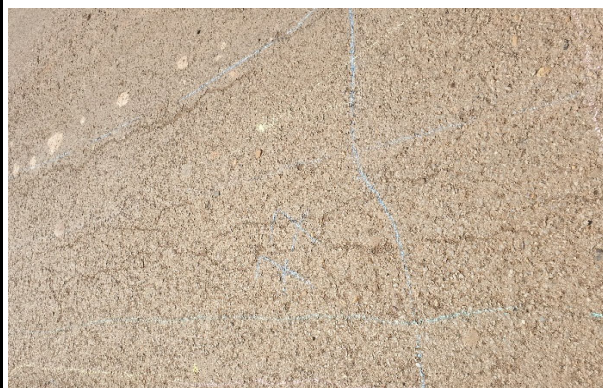
Photo No.	109	Component	Road surface	Photo No.	110	Component	Road surface
Element name	Pavement			Element name	Pavement		
Damage type	15	Damage grade	C	Damage type	15	Damage grade	C

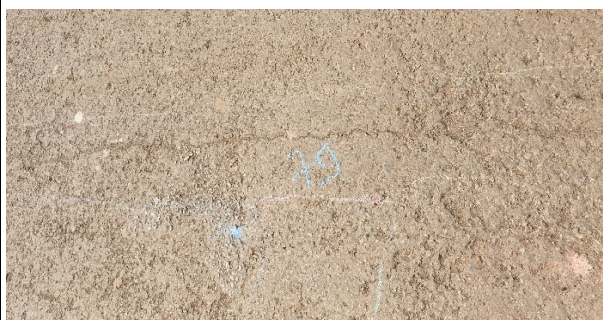
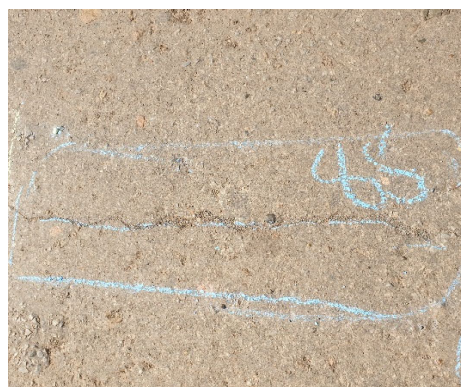
Photo No.	111	Component	Road surface	Photo No.	112	Component	Road surface
Element name	Pavement			Element name	Pavement		
Damage type	15	Damage grade	E	Damage type	15	Damage grade	E

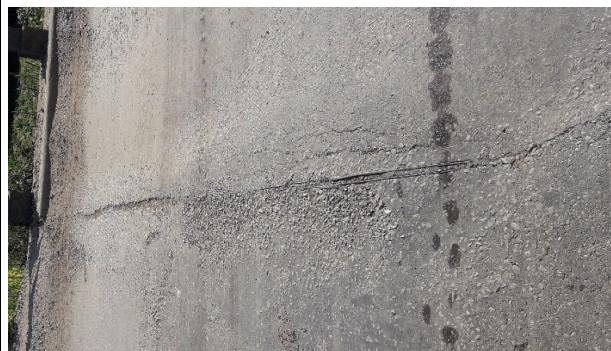
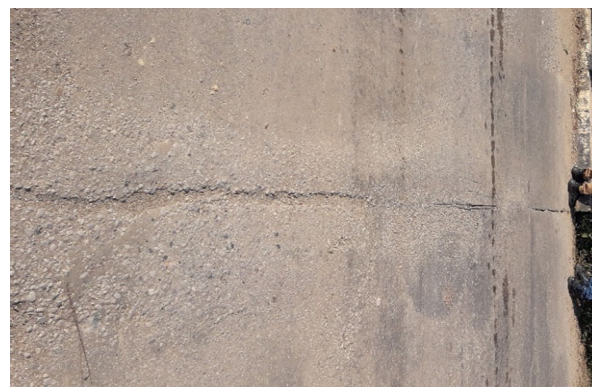
Photo No.	113	Component	Road surface	Photo No.	114	Component	Road surface
Element name	Expansion Joint			Element name	Expansion Joint		
Damage type	17	Damage grade	E	Damage type	17	Damage grade	E

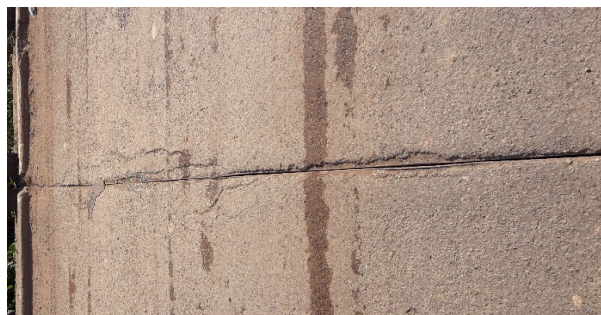
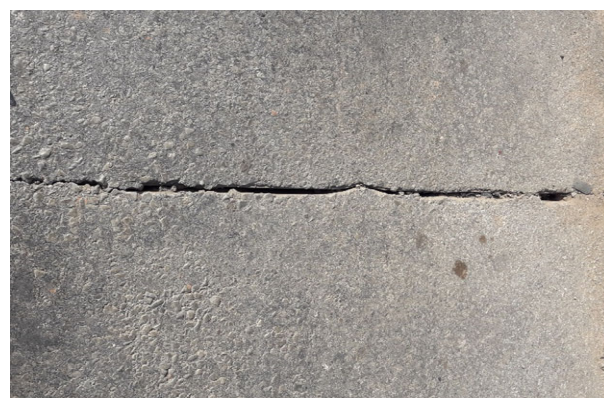
Photo No.	115	Component	Road surface	Photo No.	116	Component	Road surface
Element name	Expansion Joint			Element name	Expansion Joint		
Damage type	17	Damage grade	E	Damage type	17	Damage grade	E
