The Project for Capacity Development on Bridge Maintenance and Management in Laos JICA-BMM

Nam Mone Bridge and Xe Bangnouan Bridges Detailed Inspection Report

March 2022

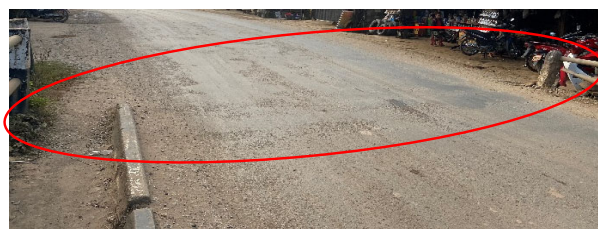
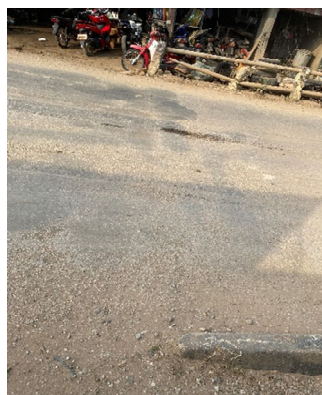
Photo No.	117	Component	Road surface	Photo No.	118	Component	Road surface
Element name	Expansion Joint			Element name	Expansion Joint		
Damage type	17	Damage grade	E	Damage type	17	Damage grade	E

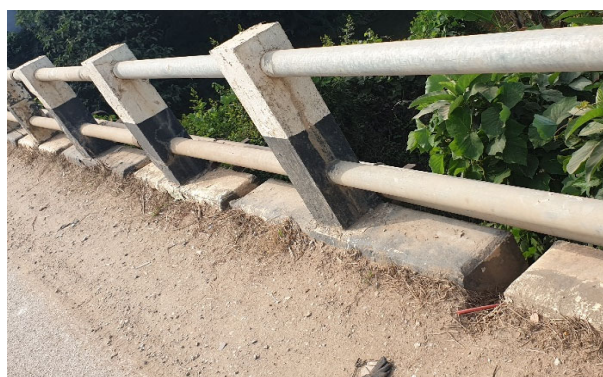
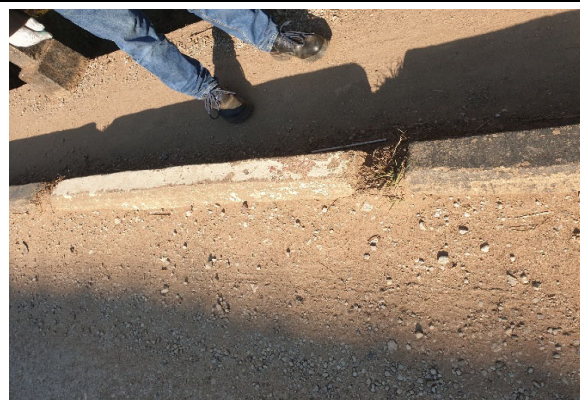
Photo No.	121	Component	Road surface	Photo No.	122	Component	Road surface
Element name	Sediment clogging (Drainage prblems)			Element name	Sediment clogging (Drainage prblems)		
Damage type	24	Damage grade	E	Damage type	24	Damage grade	E

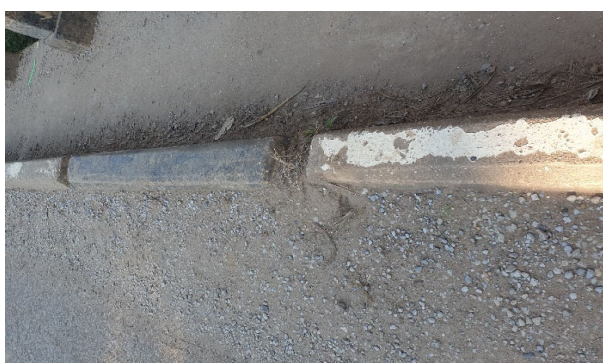
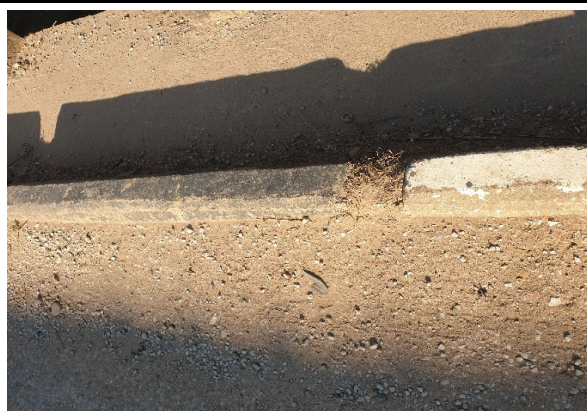
Photo No.	123	Component	Road surface	Photo No.	124	Component	Road surface
Element name	Sediment clogging (Drainage prblems)			Element name	Sediment clogging (Drainage prblems)		
Damage type	24	Damage grade	E	Damage type	24	Damage grade	E
