Damage Photo Data

Inspection date	22-02-22
Road No.	13S	Bridge location (Chainage)	540 Km + 200 m
Road name	NR No.13 South	Bridge location (Province)	Savannakhet
Bridge ID/No.	Unknown	Coordinates (Latitude)	16° 00' 10.17"
Bridge name	Xe Bangnouan	Coordinates (Longitudu)	105° 28' 45.19"

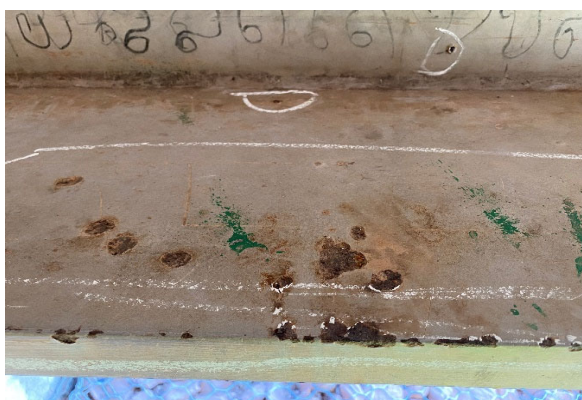
Photo No.	001	Component	Superstructure	Photo No.	002	Component	Superstructure
Element name	Main structure (Girder)			Element name	Main structure (Girder)		
Damage type	01	Damage grade	B	Damage type	01	Damage grade	B

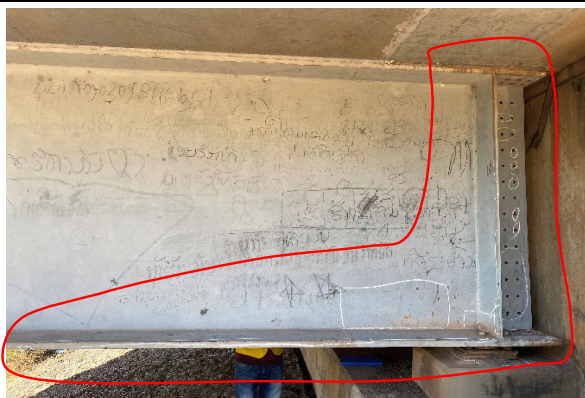
Photo No.	003	Component	Superstructure	Photo No.	004	Component	Superstructure
Element name	Main structure (Girder)			Element name	Main structure (Girder)		
Damage type	01	Damage grade	B	Damage type	01	Damage grade	B

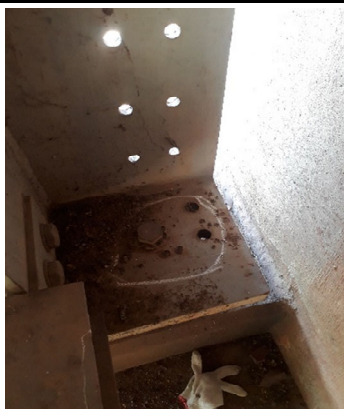
Photo No.	005	Component	Superstructure	Photo No.	006	Component	Superstructure
Element name	Main structure (Girder)			Element name	Main structure (Girder)		
Damage type	01	Damage grade	B	Damage type	01	Damage grade	B

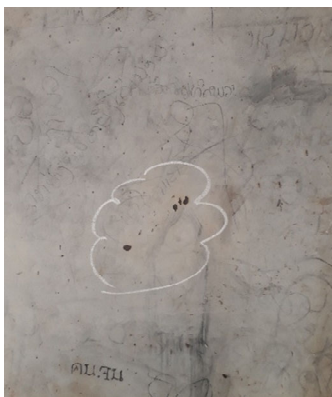
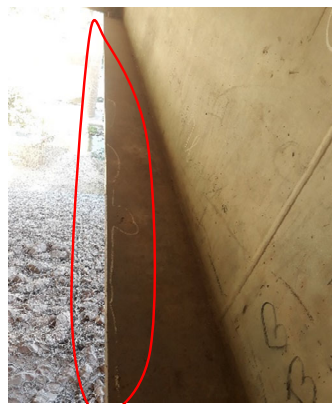
Photo No.	013	Component	Superstructure	Photo No.	014	Component	Superstructure
Element name	Main structure (Girder)			Element name	Main structure (Girder)		
Damage type	01	Damage grade	B	Damage type	01	Damage grade	B

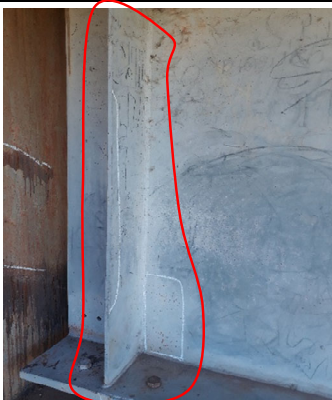
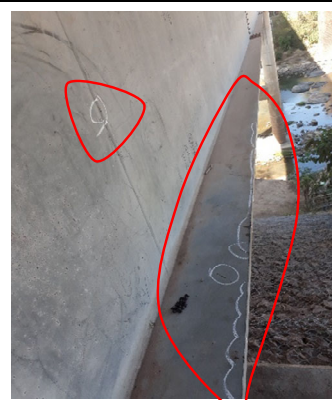
Photo No.	015	Component	Superstructure	Photo No.	016	Component	Superstructure
Element name	Main structure (Girder)			Element name	Main structure (Girder)		
Damage type	01	Damage grade	B	Damage type	01	Damage grade	B

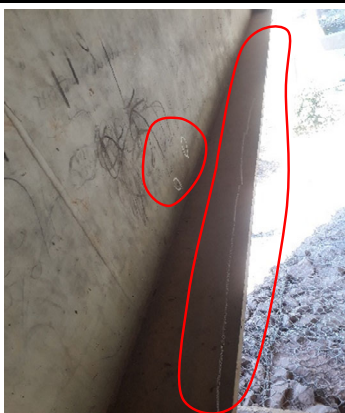
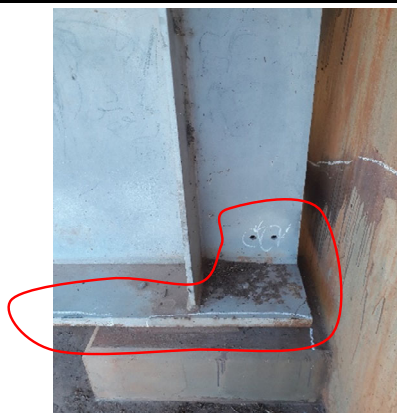
Photo No.	017	Component	Superstructure	Photo No.	018	Component	Superstructure
Element name	Main structure (Girder)			Element name	Main structure (Girder)		
Damage type	01	Damage grade	B	Damage type	01	Damage grade	B

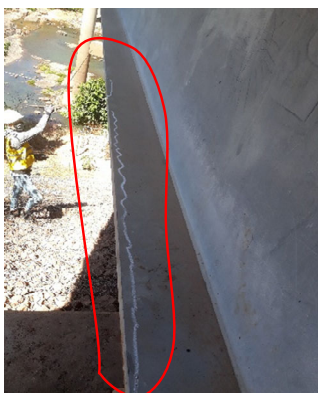
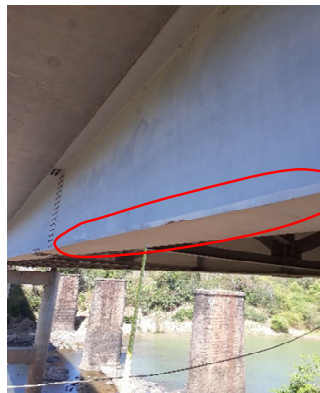
Photo No.	019	Component	Superstructure	Photo No.	020	Component	Superstructure
Element name	Main structure (Girder)			Element name	Main structure (Girder)		
Damage type	01	Damage grade	B	Damage type	01	Damage grade	B

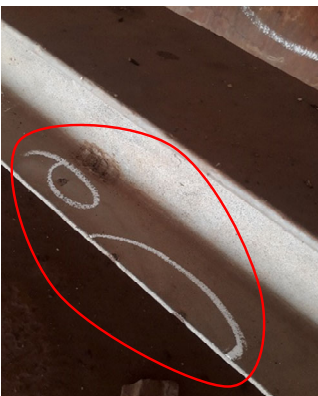
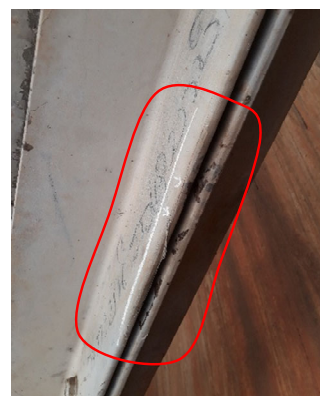
Photo No.	021	Component	Superstructure	Photo No.	022	Component	Superstructure
Element name	Others (Vertical Bracing)			Element name	Others (Vertical Bracing)		
Damage type	01	Damage grade	B	Damage type	01	Damage grade	B

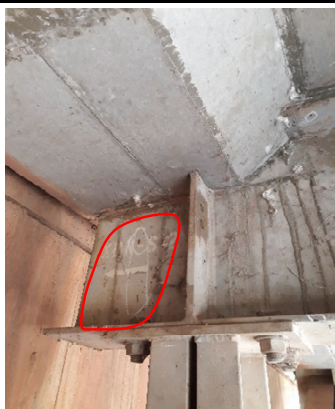
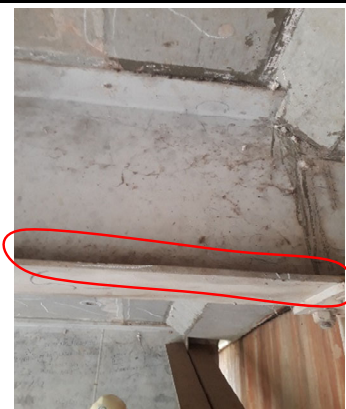
Photo No.	023	Component	Superstructure	Photo No.	024	Component	Superstructure
Element name	Others (Sub Girder)			Element name	Others (Sub Girder)		
Damage type	01	Damage grade	B	Damage type	01	Damage grade	B

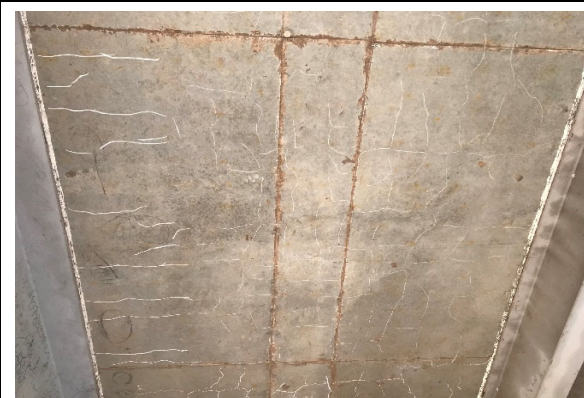
Photo No.	027	Component	Superstructure	Photo No.	028	Component	Superstructure
Element name	Deck			Element name	Deck		
Damage type	11	Damage grade	D	Damage type	11	Damage grade	D

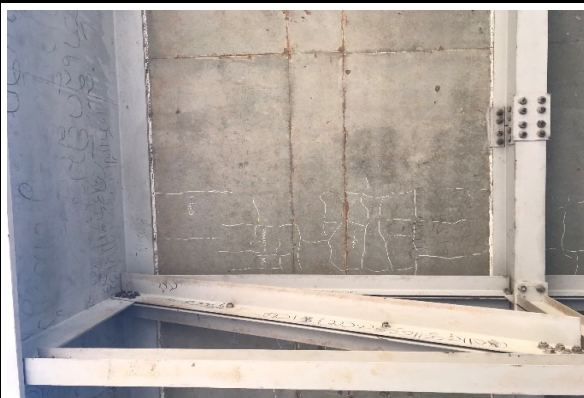
Photo No.	029	Component	Superstructure	Photo No.	030	Component	Superstructure
Element name	Deck			Element name	Deck		
Damage type	11	Damage grade	D	Damage type	11	Damage grade	D

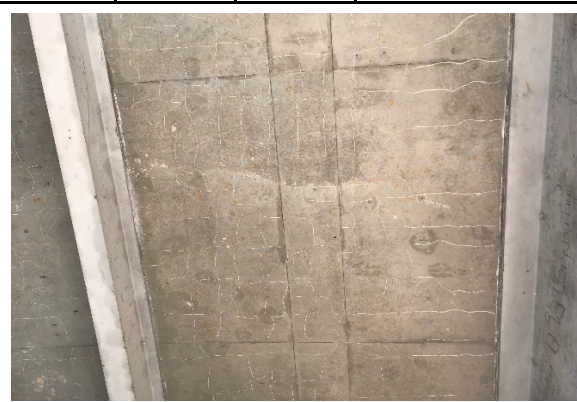
Photo No.	039	Component	Superstructure	Photo No.	040	Component	Superstructure
Element name	Deck			Element name	Deck		
Damage type	11	Damage grade	D	Damage type	11	Damage grade	D

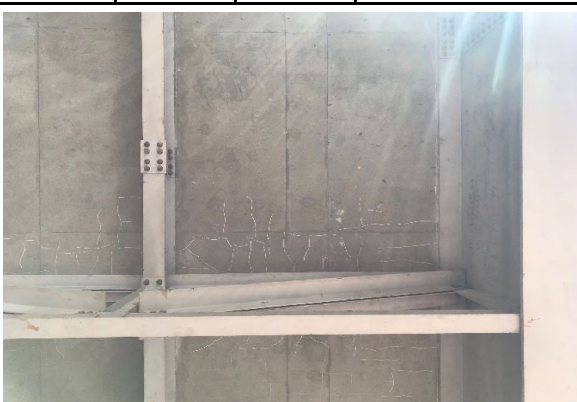
Photo No.	041	Component	Superstructure	Photo No.	042	Component	Superstructure
Element name	Deck			Element name	Deck		
Damage type	11	Damage grade	D	Damage type	11	Damage grade	D

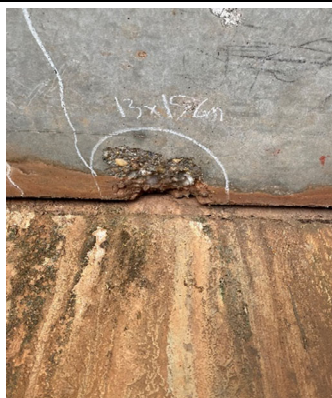
Photo No.	045	Component	Superstructure	Photo No.	046	Component	Superstructure
Element name	Deck			Element name	Deck		
Damage type	07	Damage grade	C	Damage type	07	Damage grade	C

Item	Type of damages	Unit	Quantity	Remark
1	Component: Superstructure			
1.1	Element: Deck; Material: Reinforce Concrete			
1.1.1	07: Peeling/Exposure of Rebar	m ²	0.1020	
	Photo-045	m ²	0.0195	
	Photo-046	m ²	0.0300	
	Photo-047	m ²	0.0225	
	Photo-048	m ²	0.0300

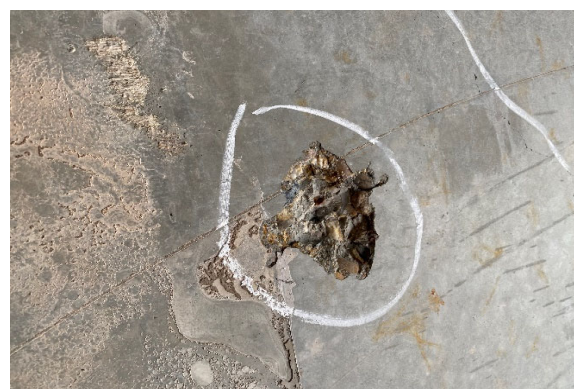
Photo No.	047	Component	Superstructure	Photo No.	048	Component	Superstructure
Element name	Deck			Element name	Deck		
Damage type	07	Damage grade	C	Damage type	07	Damage grade	C

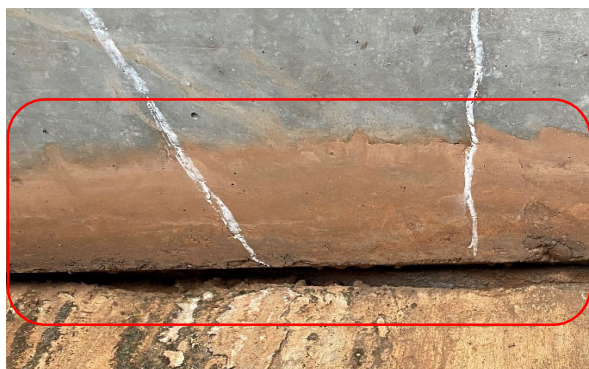
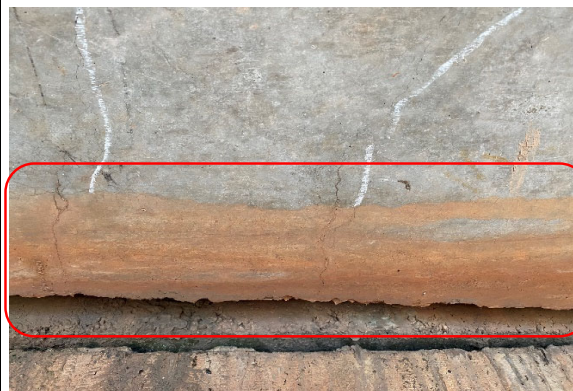
Photo No.	049	Component	Superstructure	Photo No.	050	Component	Superstructure
Element name	Deck			Element name	Deck		
Damage type	20	Damage grade	E	Damage type	20	Damage grade	E

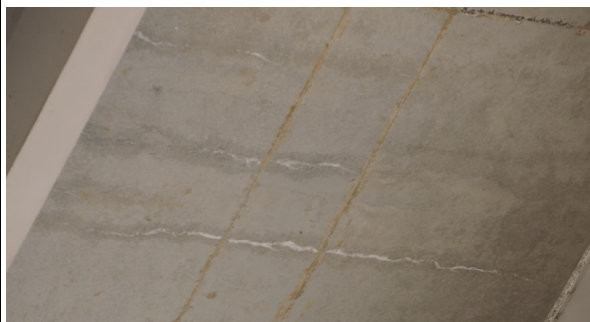
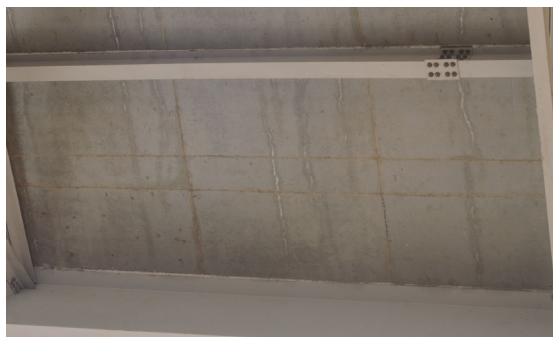
Photo No.	051	Component	Superstructure	Photo No.	052	Component	Superstructure
Element name	Deck			Element name	Deck		
Damage type	08	Damage grade	D	Damage type	08	Damage grade	D

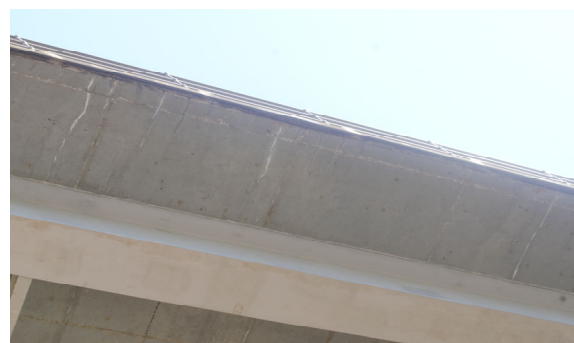
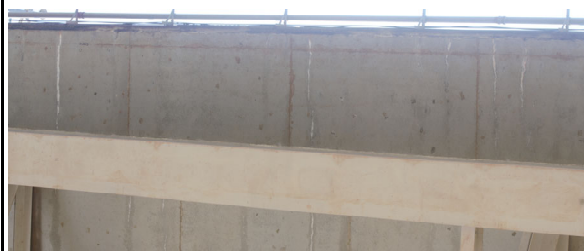
Photo No.	053	Component	Superstructure	Photo No.	054	Component	Superstructure
Element name	Deck			Element name	Deck		
Damage type	08	Damage grade	D	Damage type	08	Damage grade	D

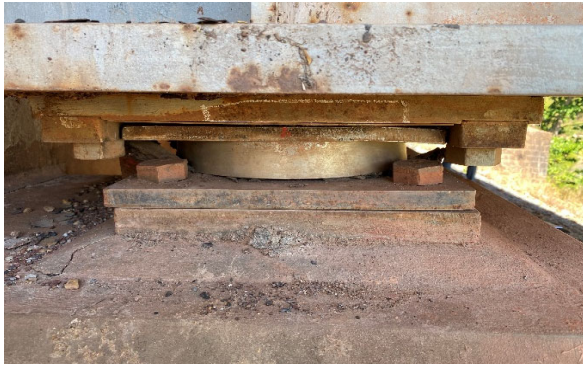
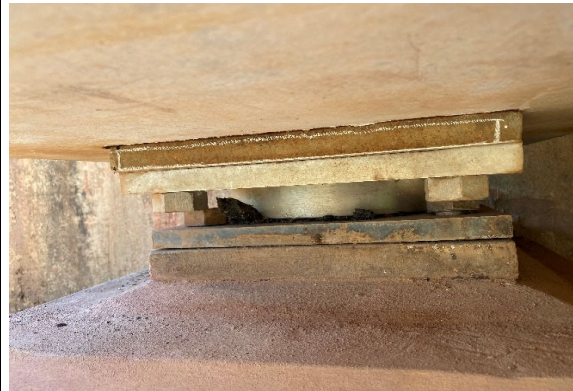
Photo No.	055	Component	Bearing	Photo No.	056	Component	Bearing
Element name	Bearing Body			Element name	Bearing Body		
Damage type	01	Damage grade	C	Damage type	05	Damage grade	C

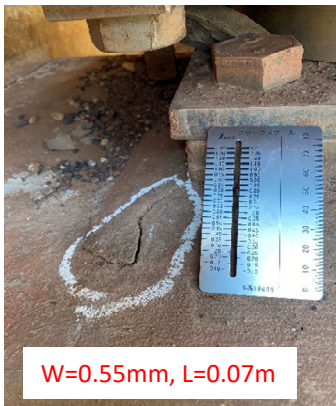
Photo No.	057	Component	Bearing	Photo No.	058	Component	Bearing
Element name	Mortar (Grout Pad)			Element name	Bearing Body		
Damage type	06	Damage grade	E	Damage type	17	Damage grade	E

W=0.55mm, L=0.07m

3.1.5	Lost	Nos	0	None
3.2	Element: Shoe seat, Mortar			
3.2.1	Sediment accumulate	Nos	2	At Abutment A1 and A2
3.2.2	Water is pooled	Nos	0	None
3.2.3	Mortar is cracked and partially lost	Nos	4	At Abutment A1
	Photo-057, W=0.55mm	m	0.070	1 Nos
	Photo-062, W=0.10mm	m	0.080	1 Nos
	Photo-063, W=0.15mm	m	0.070	1 Nos
	Photo-064	m ²	0.057	1 Nos
4	Component: On the Road

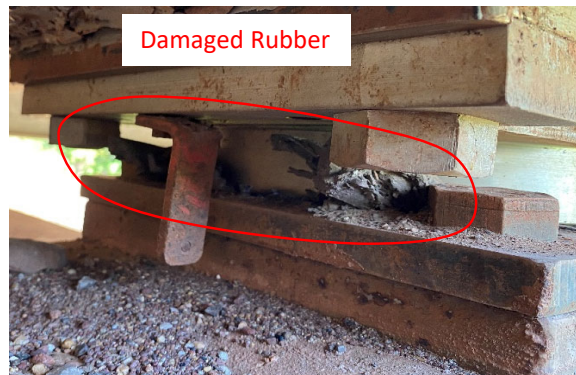
Damaged Rubber

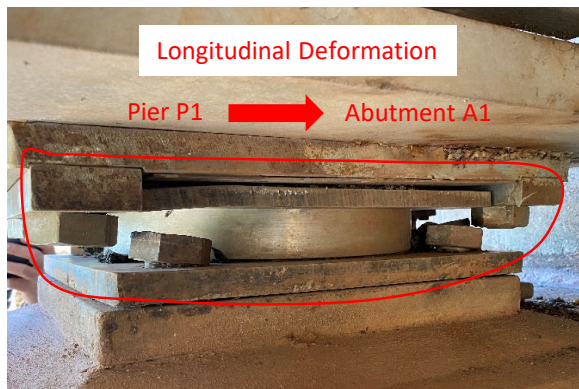
Photo No.	059	Component	Bearing	Photo No.	060	Component	Bearing
Element name	Bearing Anchor Bolt			Element name	Bearing Body		
Damage type	23	Damage grade	E	Damage type	01	Damage grade	C

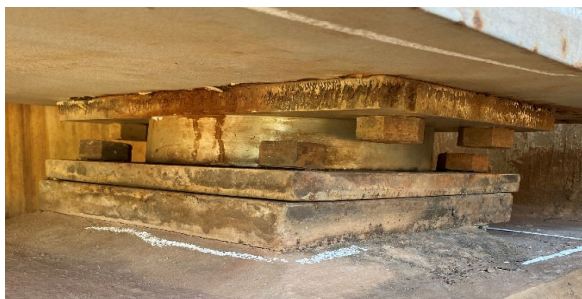
Photo No.	061	Component	Bearing	Photo No.	062	Component	Bearing
Element name	Bearing Body			Element name	Mortar (Grout Pad)		
Damage type	05	Damage grade	C	Damage type	06	Damage grade	B

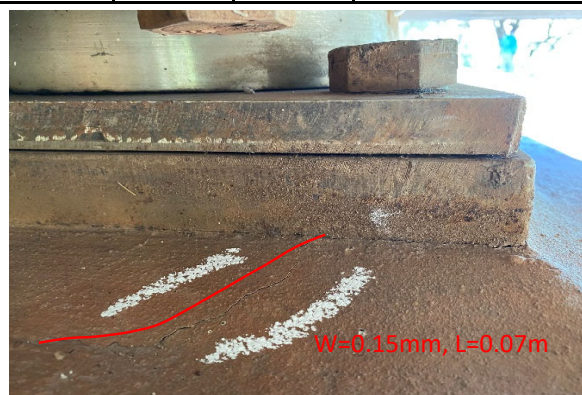
Photo No.	063	Component	Bearing	Photo No.	064	Component	Bearing
Element name	Mortar (Grout Pad)			Element name	Mortar (Grout Pad)		
Damage type	06	Damage grade	B	Damage type	07	Damage grade	C

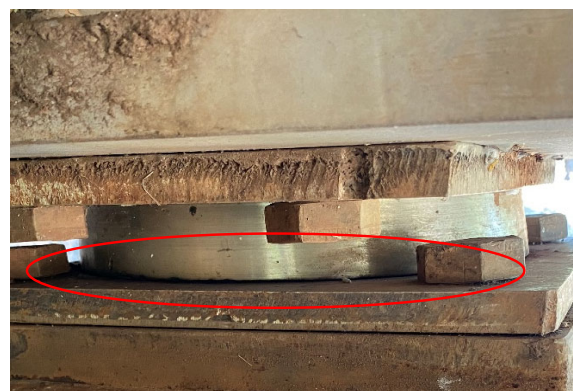
Photo No.	065	Component	Bearing	Photo No.	066	Component	Bearing
Element name	Bearing Body			Element name	Bearing Anchor Bolt		
Damage type	17	Damage grade	E	Damage type	23	Damage grade	C

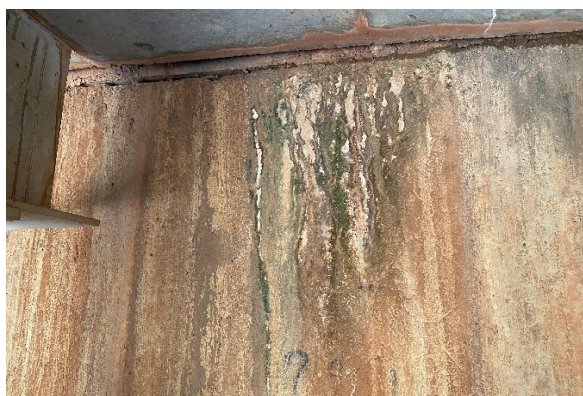
Photo No.	067	Component	Substructure	Photo No.	068	Component	Substructure
Element name	Abutment A1			Element name	Abutment A1		
Damage type	20	Damage grade	E	Damage type	24	Damage grade	E

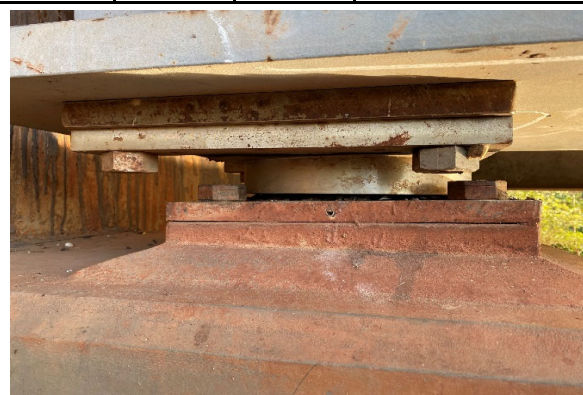
Photo No.	069	Component	Bearing	Photo No.	070	Component	Bearing
Element name	Bearing Body			Element name	Bearing Body		
Damage type	01	Damage grade	C	Damage type	05	Damage grade	C

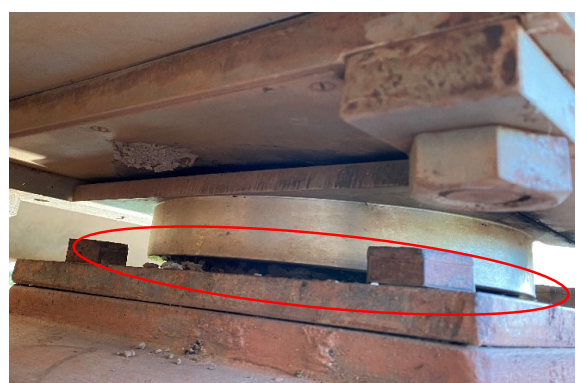
Photo No.	071	Component	Bearing	Photo No.	072	Component	Bearing
Element name	Bearing Body			Element name	Bearing Body		
Damage type	17	Damage grade	E	Damage type	01	Damage grade	C

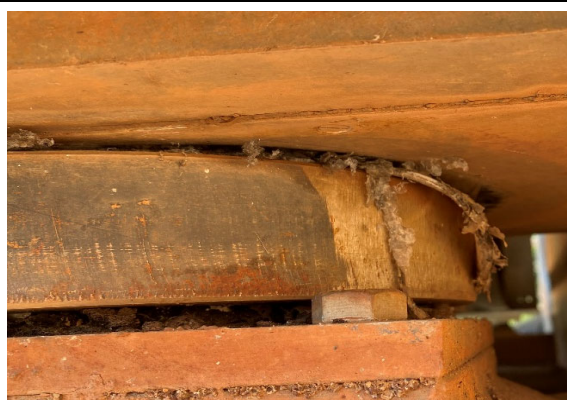
Photo No.	073	Component	Bearing	Photo No.	074	Component	Bearing
Element name	Bearing Body			Element name	Bearing Body		
Damage type	05	Damage grade	C	Damage type	17	Damage grade	E

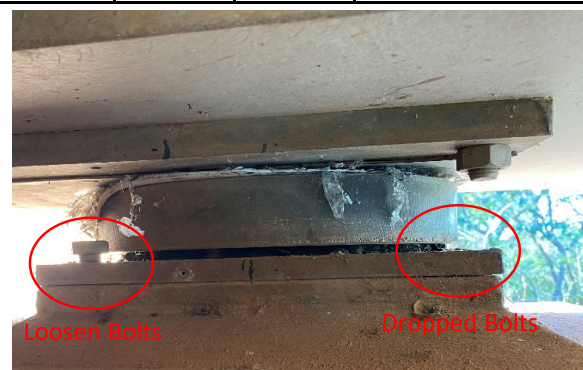
Photo No.	075	Component	Bearing	Photo No.	076	Component	Substructure
Element name	Bearing Anchor Bolt			Element name	Abutment A2		
Damage type	03	Damage grade	E	Damage type	20	Damage grade	E

3.1	Element: Bearing body			
3.1.1	Severely corroded	m ²	0.00	None. But, Slightly corroded were found in every bearing.
3.1.2	Some parts are missing	Nos	1	Anchor bolt is missing at A2/G2
	Photo-075	Nos	1

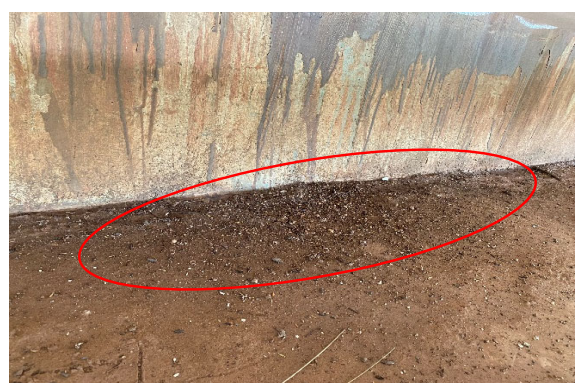
Photo No.	077	Component	Substructure	Photo No.	078	Component	Substructure
Element name	Abutment A2			Element name	Abutment A2, Wing Wall		
Damage type	24	Damage grade	E	Damage type	06	Damage grade	B

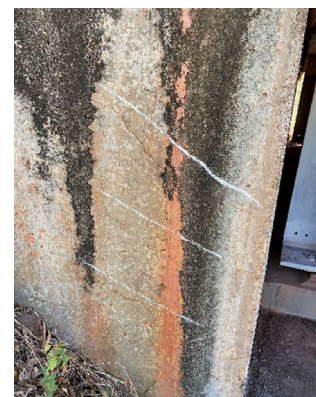
W=0.15mm, L=0.60m

W=0.10mm, L=0.20m

W=0.15mm, L=0.45m

2.1.1	06: Cracks			
2.1.1.1	width ≤ 0.2mm	m	22.18	
	Photo-078, W=0.10-0.15mm	m	1.25	
	Photo-079-084, W=0.1-0.2mm	m	20.23	
	Photo-085, W=0.2mm	m	0.70

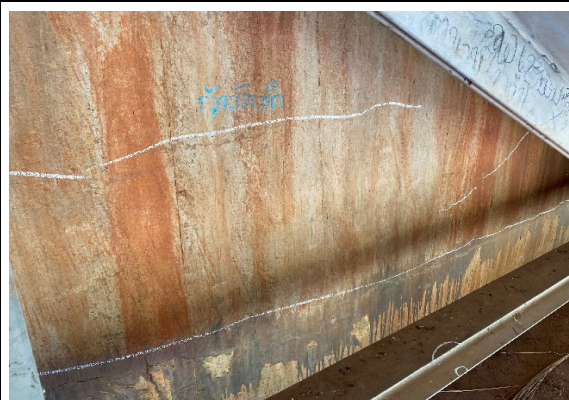
Photo No.	079	Component	Substructure	Photo No.	080	Component	Substructure
Element name Abutment A2, Parapet Wall				Element name Abutment A2, Parapet Wall			
Damage type	06	Damage grade	D	Damage type	06	Damage grade	D

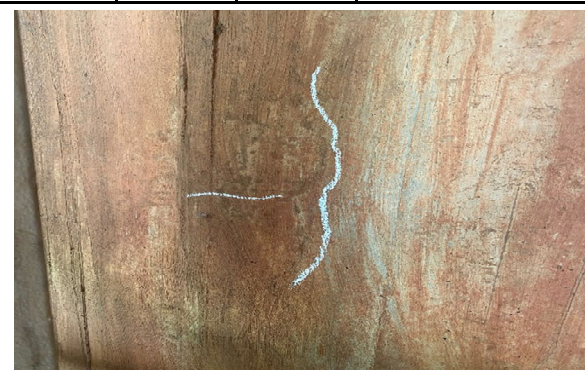
Photo No.	081	Component	Substructure	Photo No.	082	Component	Substructure
Element name Abutment A2, Parapet Wall				Element name Abutment A2, Parapet Wall			
Damage type	06	Damage grade	D	Damage type	06	Damage grade	D

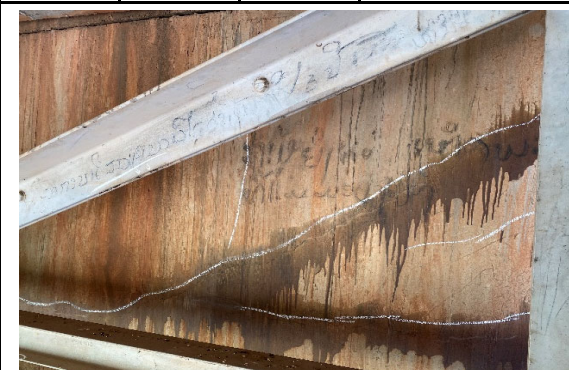
2.1.1.2	0.2mm < width < 1.0mm	m	7.30	
	Photo-082-083, W=0.25mm	m	3.00	
	Photo-086, W=0.50mm	m	2.10	
	Photo-087, W=0.65mm	m	0.10	
	Photo-091, W=0.35mm	m	2.10

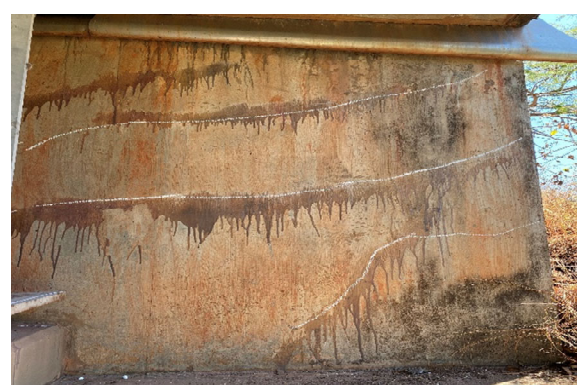
Photo No.	083	Component	Substructure	Photo No.	084	Component	Substructure
Element name Abutment A2, Parapet Wall				Element name Abutment A2, Parapet Wall			
Damage type	06	Damage grade	D	Damage type	06	Damage grade	D

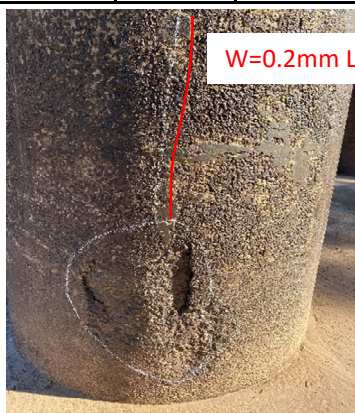
Photo No.	085	Component	Substructure	Photo No.	086	Component	Substructure
Element name	Pier, P1			Element name	Pier, P1		
Damage type	06	Damage grade	C	Damage type	06	Damage grade	E

2.1.1.3	width ≥ 1.0mm	m	0.00	None
2.1.2	07: Peeling/Exposure of Rebar	m ²	0.85	
	Photo-085	m ²	0.42	
	Photo-086	m ²	0.43	
2.1.3	08: Leaching/Free lime	m ²	0.00	None

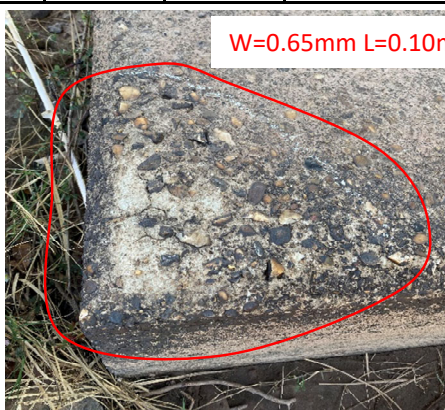
Photo No.	087	Component	Substructure	Photo No.	088	Component	Substructure
Element name	Foundation, P1			Element name	Pier, P1		
Damage type	06	Damage grade	E	Damage type	26	Damage grade	C

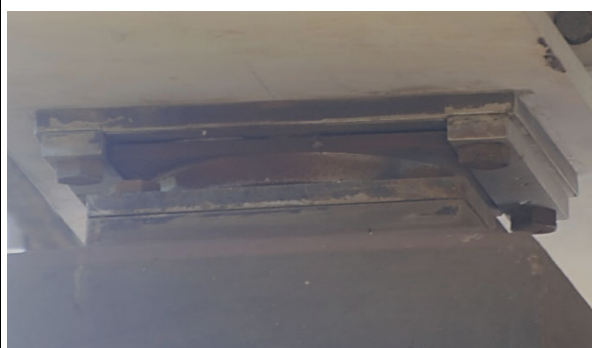
Photo No.	089	Component	Bearing	Photo No.	090	Component	Bearing
Element name	Bearing Body			Element name	Bearing Body		
Damage type	01	Damage grade	C	Damage type	01	Damage grade	C

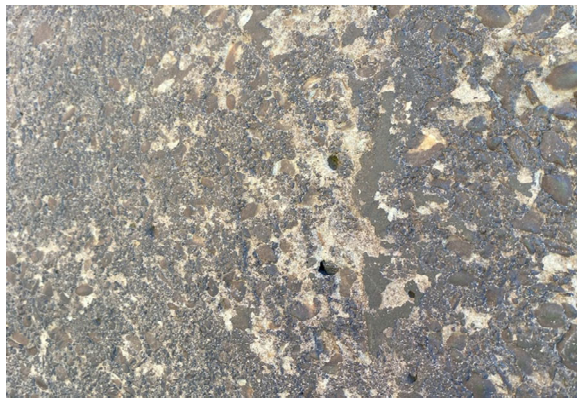
Photo No.	091	Component	Substructure	Photo No.	092	Component	Substructure
Element name	Foundation, P2			Element name	Pier, P2		
Damage type	06	Damage grade	D	Damage type	26	Damage grade	C

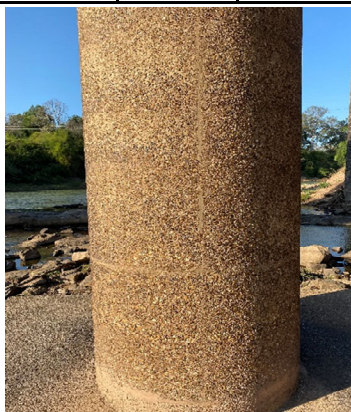
Photo No.	093	Component	Substructure	Photo No.	094	Component	Substructure
Element name	Pier, P2			Element name	Pier, P2		
Damage type	26	Damage grade	C	Damage type	26	Damage grade	C

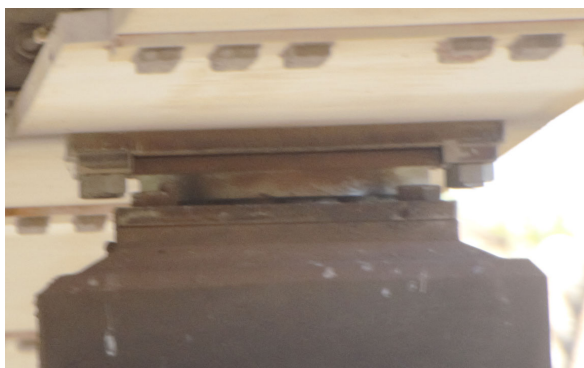
Photo No.	095	Component	Bearing	Photo No.	096	Component	Bearing
Element name	Bearing Body			Element name	Bearing Body		
Damage type	01	Damage grade	C	Damage type	01	Damage grade	C

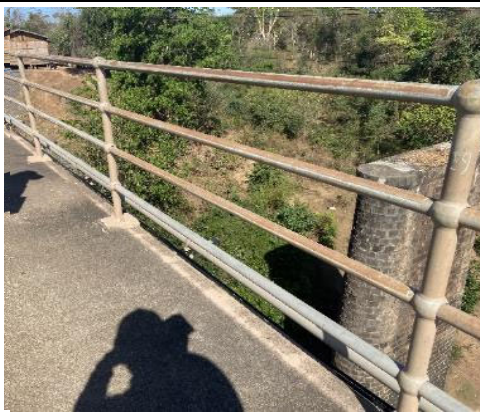
Photo No.	103	Component	On the road	Photo No.	104	Component	On the road
Element name	Railling			Element name	Railling		
Damage type	01	Damage grade	C	Damage type	01	Damage grade	C

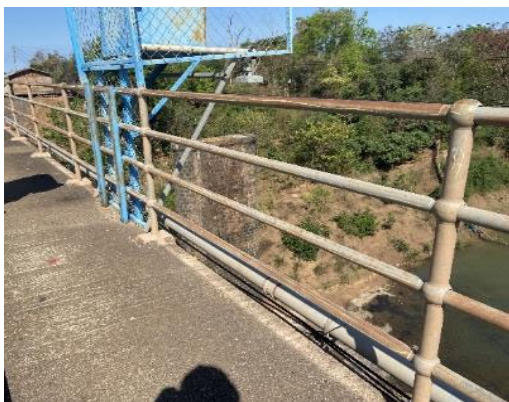
Photo No.	105	Component	On the road	Photo No.	106	Component	On the road
Element name	Railling			Element name	Railling		
Damage type	01	Damage grade	C	Damage type	01	Damage grade	C

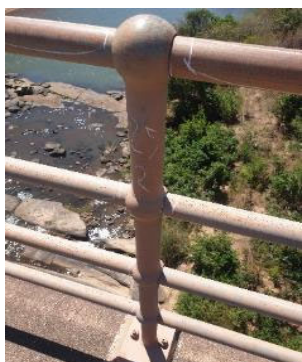
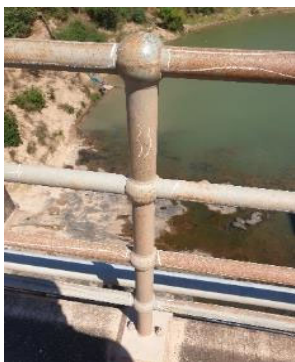
Photo No.	107	Component	On the road	Photo No.	108	Component	On the road
Element name	Railling			Element name	Railling		
Damage type	01	Damage grade	C	Damage type	01	Damage grade	C

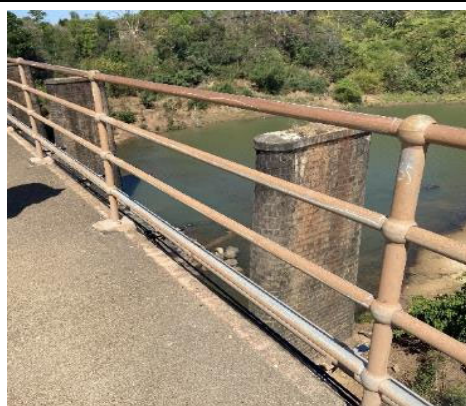
Photo No.	109	Component	On the road	Photo No.	110	Component	On the road
Element name	Railling			Element name	Railling		
Damage type	01	Damage grade	C	Damage type	01	Damage grade	C

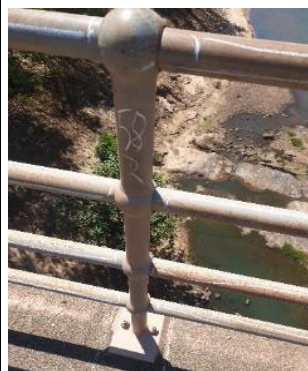
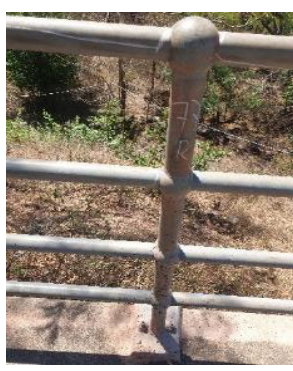
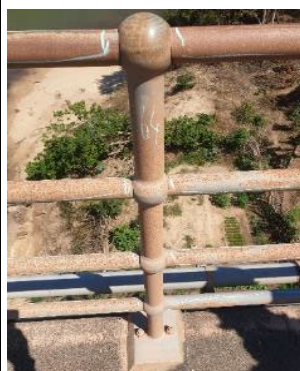
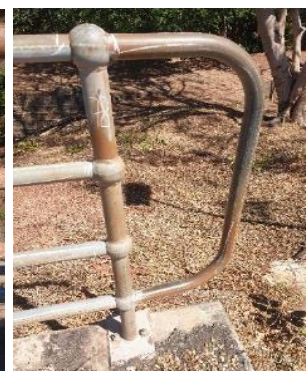
Photo No.	113	Component	On the road	Photo No.	114	Component	On the road
Element name	Railling			Element name	Railling		
Damage type	01	Damage grade	C	Damage type	01	Damage grade	C

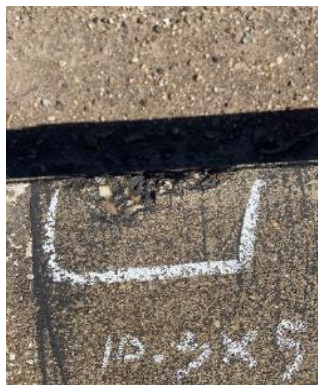
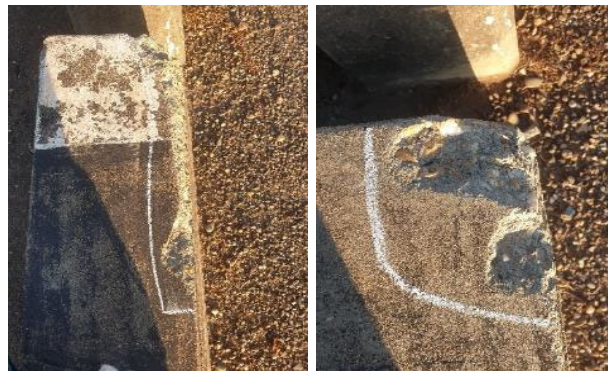
Photo No.	139	Component	On the road	Photo No.	140	Component	On the road
Element name	Wheel Guard			Element name	Wheel Guard		
Damage type	07	Damage grade	C	Damage type	07	Damage grade	C

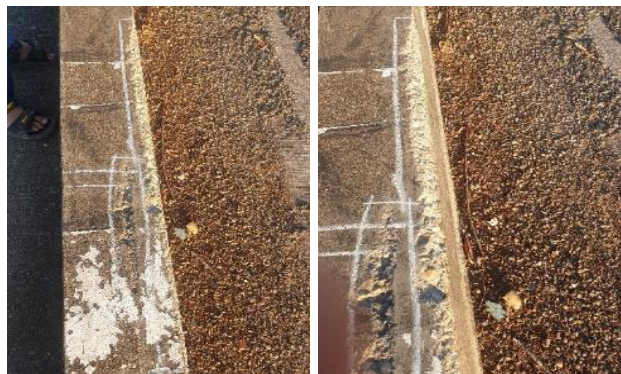
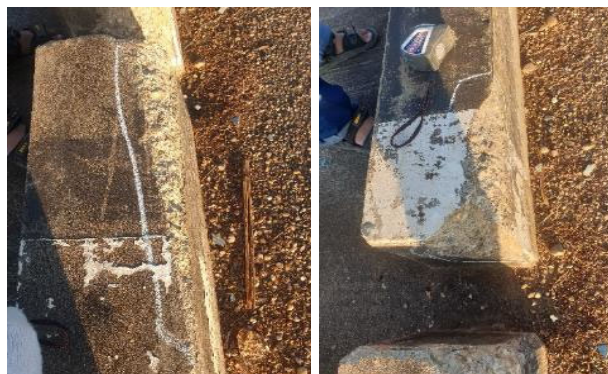
Photo No.	141	Component	On the road	Photo No.	142	Component	On the road
Element name	Wheel Guard			Element name	Wheel Guard		
Damage type	07	Damage grade	C	Damage type	07	Damage grade	C

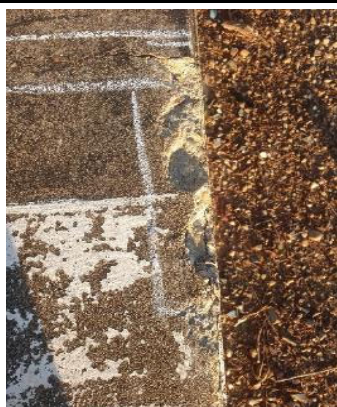
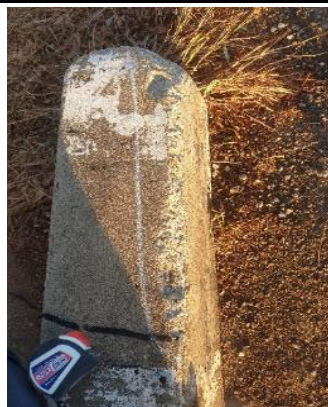
Photo No.	143	Component	On the road	Photo No.	144	Component	On the road
Element name	Wheel Guard			Element name	Wheel Guard		
Damage type	07	Damage grade	C	Damage type	07	Damage grade	C

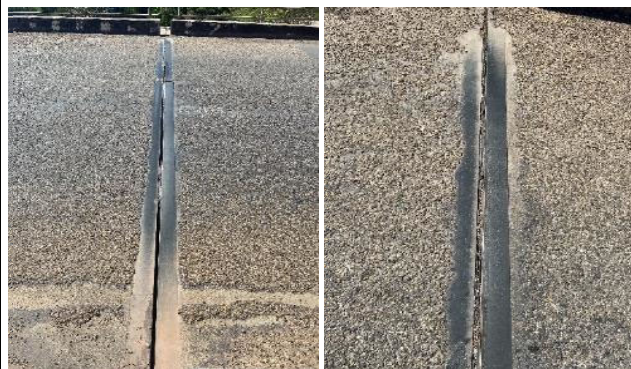
Photo No.	163	Component	Road surface	Photo No.	164	Component	Road surface
Element name	Expansion Joint			Element name	Expansion Joint		
Damage type	14	Damage grade	E	Damage type	14	Damage grade	E

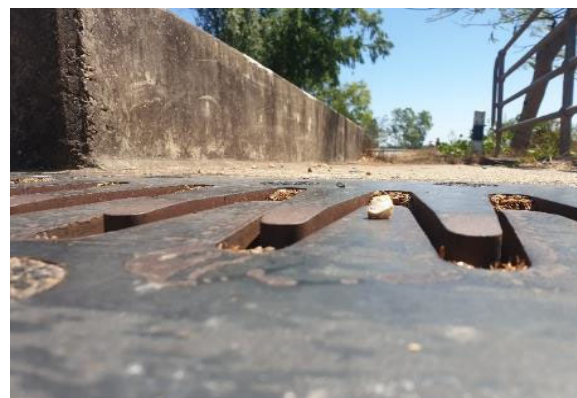
Photo No.	167	Component	Road surface	Photo No.	168	Component	Road surface
Element name	Expansion Joint			Element name	Expansion Joint		
Damage type	14	Damage grade	C	Damage type	14	Damage grade	C

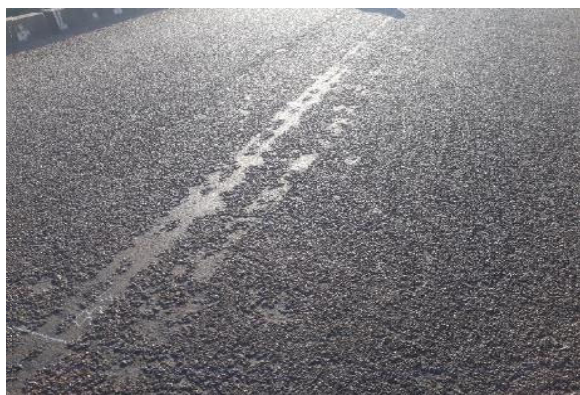
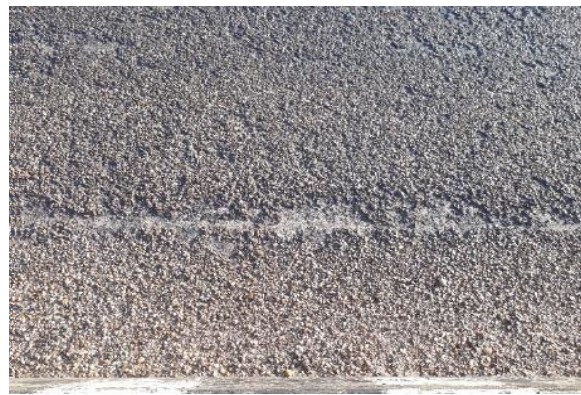
Photo No.	175	Component	Road surface	Photo No.	176	Component	Road surface
Element name	Pavement			Element name	Pavement		
Damage type	14	Damage grade	C	Damage type	14	Damage grade	C

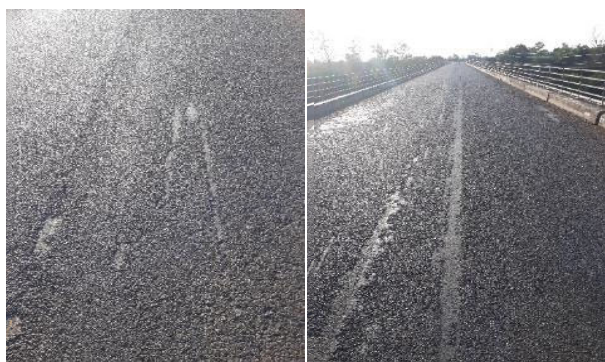
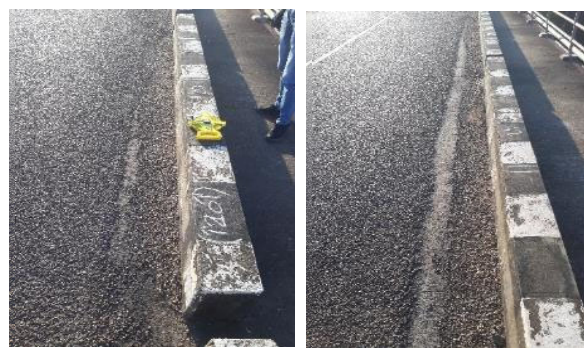
Photo No.	177	Component	Road surface	Photo No.	178	Component	Road surface
Element name	Pavement			Element name	Pavement		
Damage type	14	Damage grade	C	Damage type	14	Damage grade	C

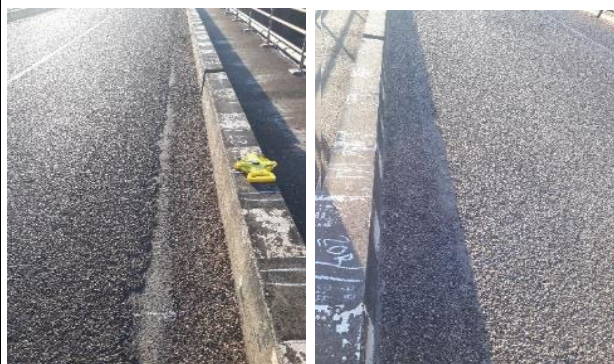
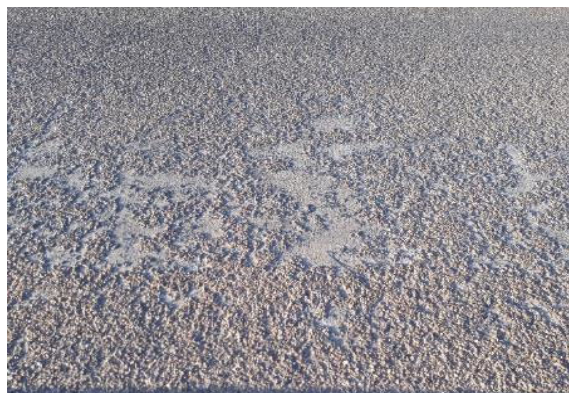
Photo No.	179	Component	Road surface	Photo No.	180	Component	Road surface
Element name	Pavement			Element name	Pavement		
Damage type	14	Damage grade	C	Damage type	14	Damage grade	C

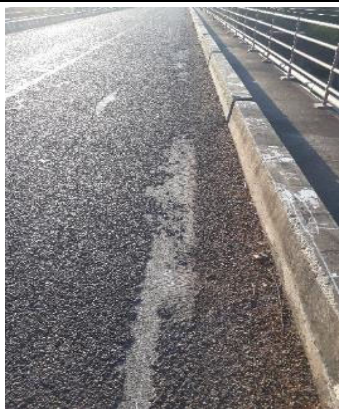
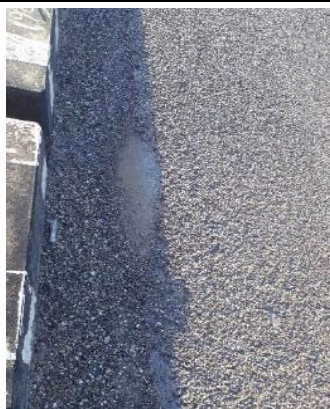
Photo No.	181	Component	Road surface	Photo No.	182	Component	Road surface
Element name	Pavement			Element name	Pavement		
Damage type	14	Damage grade	C	Damage type	14	Damage grade	C

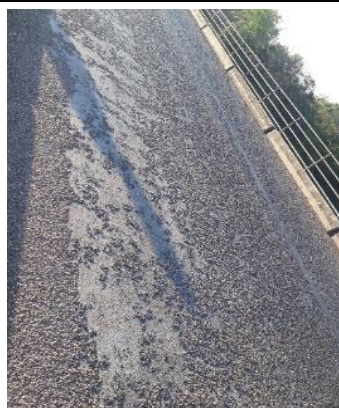
Photo No.	183	Component	Road surface	Photo No.	184	Component	Road surface
Element name	Pavement			Element name	Pavement		
Damage type	14	Damage grade	C	Damage type	14	Damage grade	C

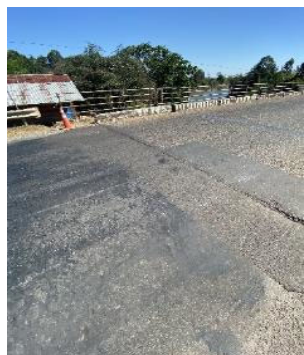
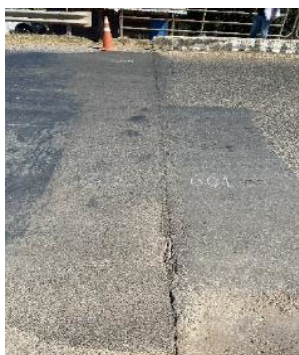
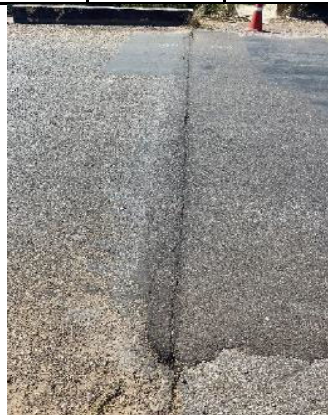
Photo No.	185	Component	Road surface	Photo No.	186	Component	Road surface
Element name	Pavement			Element name	Pavement		
Damage type	14	Damage grade	C	Damage type	14	Damage grade	C

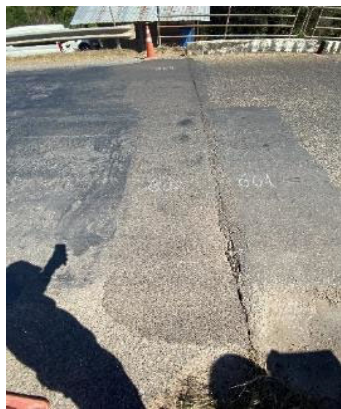
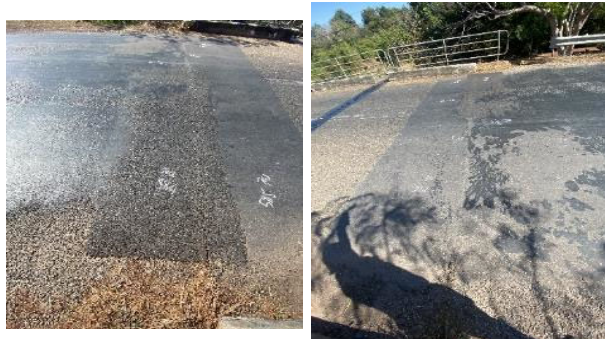
Photo No.	187	Component	Road surface	Photo No.	188	Component	Road surface
Element name	Pavement			Element name	Pavement		
Damage type	14	Damage grade	C	Damage type	14	Damage grade	E

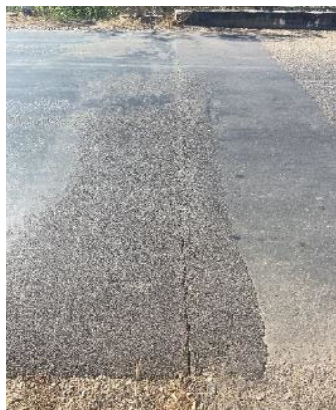
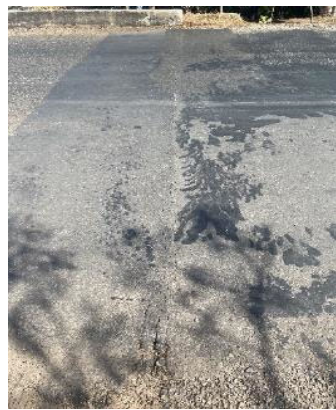
Photo No.	189	Component	Road surface	Photo No.	190	Component	Road surface
Element name	Pavement			Element name	Pavement		
Damage type	14	Damage grade	E	Damage type	14	Damage grade	E

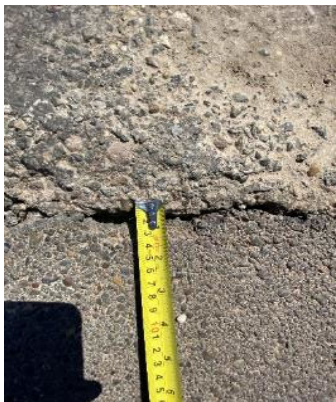
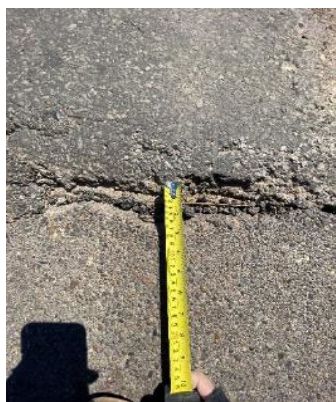
Photo No.	191	Component	Road surface	Photo No.	192	Component	Road surface
Element name	Pavement			Element name	Pavement		
Damage type	14	Damage grade	E	Damage type	14	Damage grade	E

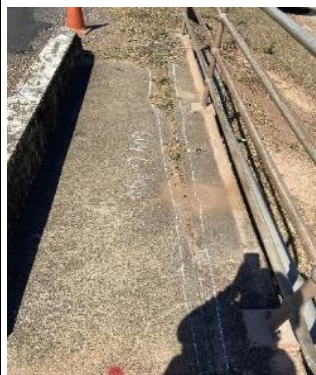
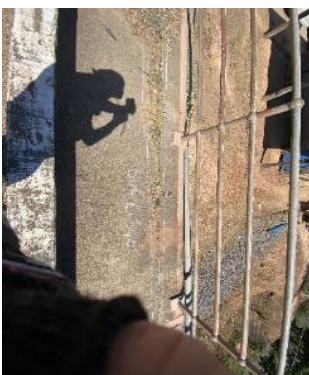
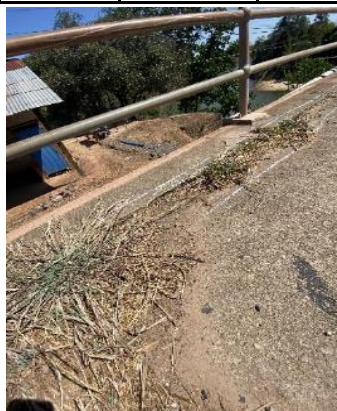
Photo No.	199	Component	Others	Photo No.	200	Component	Others
Element name	Approach Slab			Element name	Approach Slab		
Damage type	17	Damage grade	E	Damage type	17	Damage grade	E

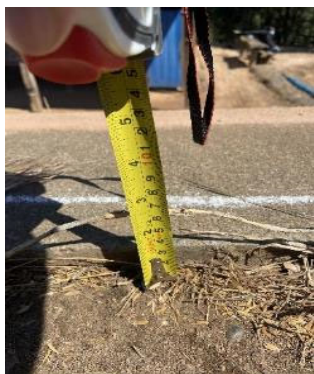
Photo No.	201	Component	Others	Photo No.	202	Component	Road surface
Element name	Approach Slab			Element name	Expansion Joint		
Damage type	17	Damage grade	E	Damage type	24	Damage grade	E

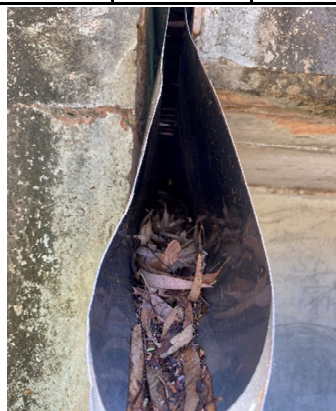
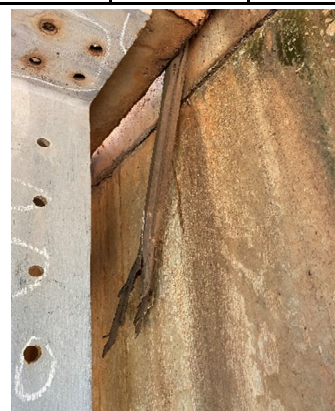
Photo No.	203	Component	Road surface	Photo No.	204	Component	Road surface
Element name	Expansion Joint			Element name	Expansion Joint		
Damage type	24	Damage grade	E	Damage type	17	Damage grade	E
